SWIFT CONFERENCE 2006 PAVEMENT DEFECTS AND REPAIR

Mounir Moughabghab PEng AAE

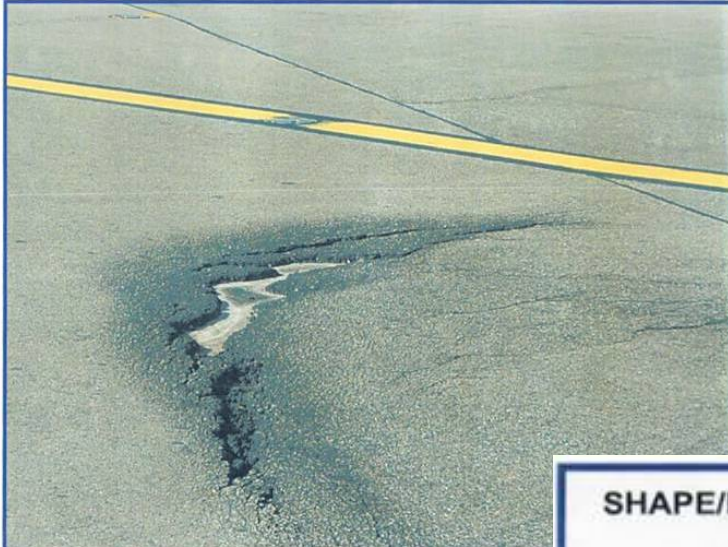
Asphalt Pavement Defects: Slippage Crack

Taxiway Delta
Constructed 1997
Observed November 1, 2000
Repaired November 10, 2000

- SHAPE/PATTERN:** These Crescent shaped cracks resulting from horizontal forces inducted by traffic. The ends of curved crack point in the direction of the thrust of wheels on the pavement surface. This does not mean they invariably point in the direction of traffic flow. If brakes are applied on a vehicle going downhill the thrust of the wheels is reversed due to braking action. Slippage occurring in this circumstance will result in cracks pointing uphill.

- CAUSE:** Slippage cracks result from the lack of bond between the surface layer and the course beneath. The lack of bond may be due to dust, oil, rubber, dirt, water or other non-adhesive material between the two courses. Usually, such a lack of bond exist when no tack coat has been used or when no prime coat was used with thin asphalt lift placed on the aggregate base. Slippage cracks my result from mixtures having a high sand content, as well as due to improper compaction.

- REPAIR METHOD:** Remove the affected asphalt layer(s) and replace with surface patch. Apply recommended rates of prime or tack coats as applicable.

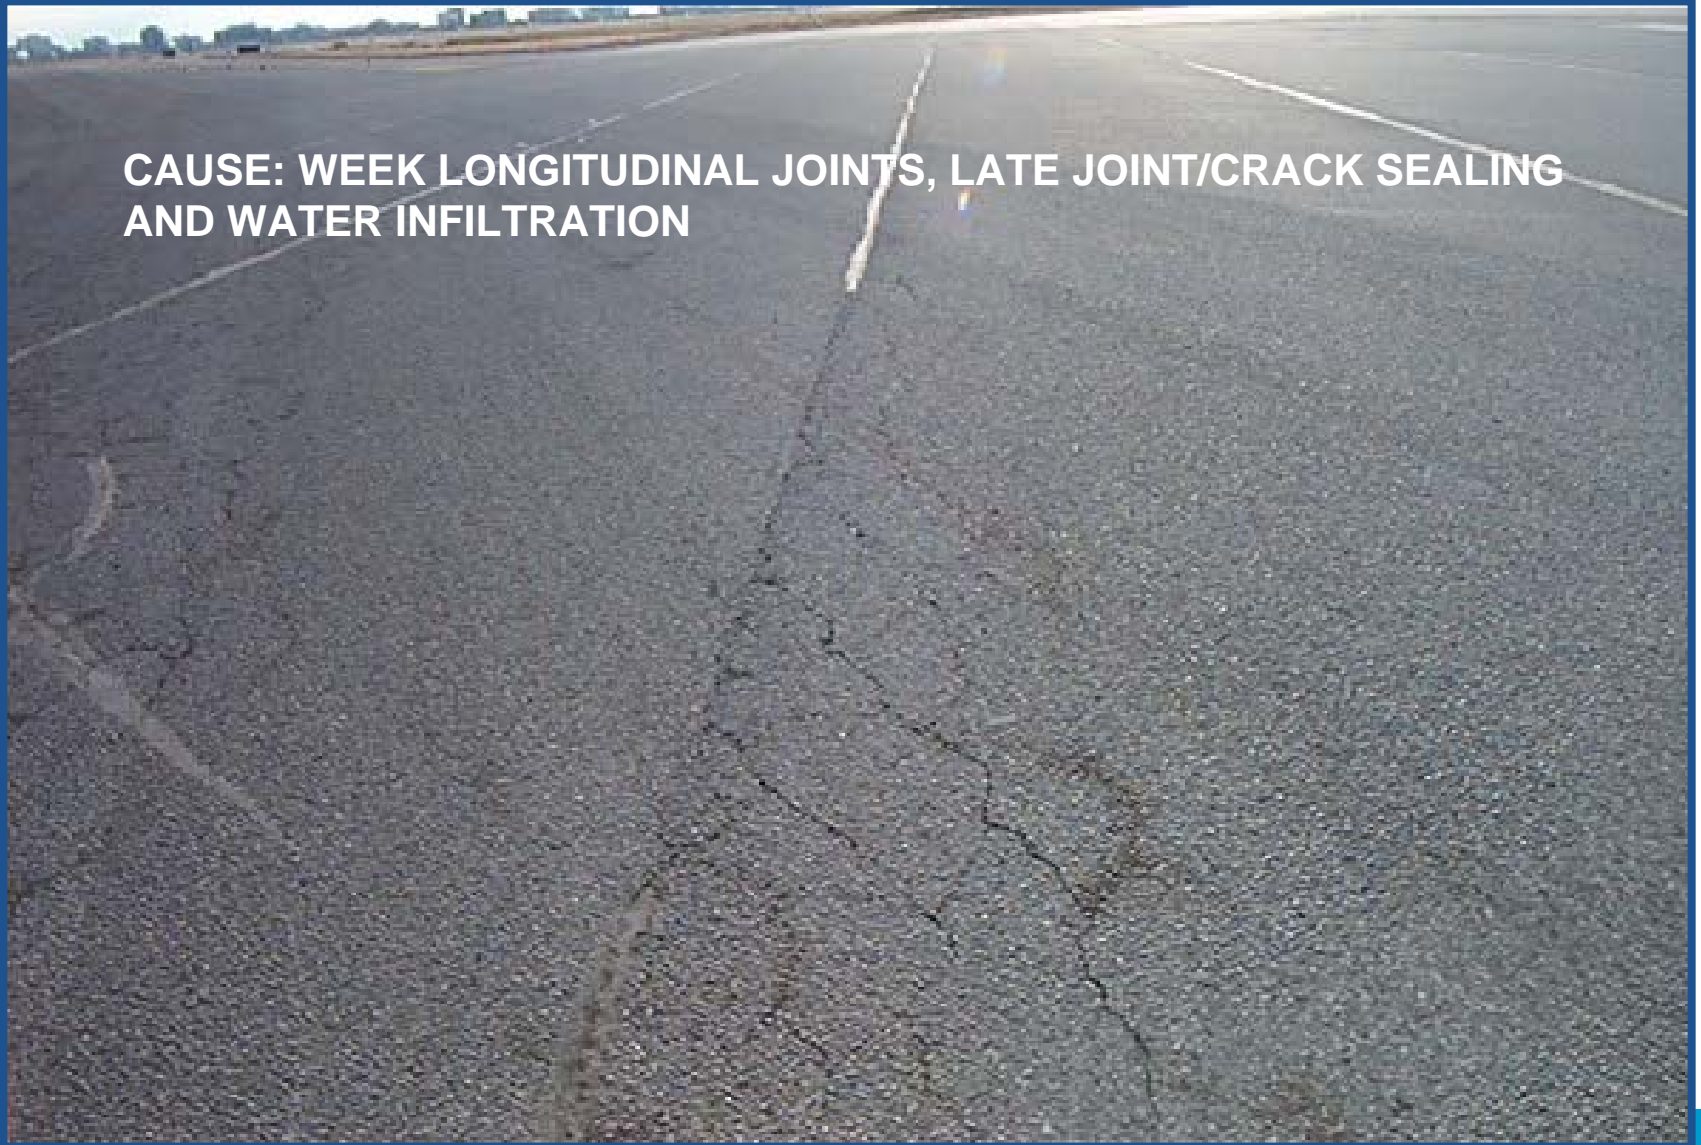
Asphalt Pavement Defects: Cracks at Longitudinal Joints

CAUSE: WEEK LONGITUDINAL JOINTS, LATE JOINT/CRACK SEALING AND WATER INFILTRATION

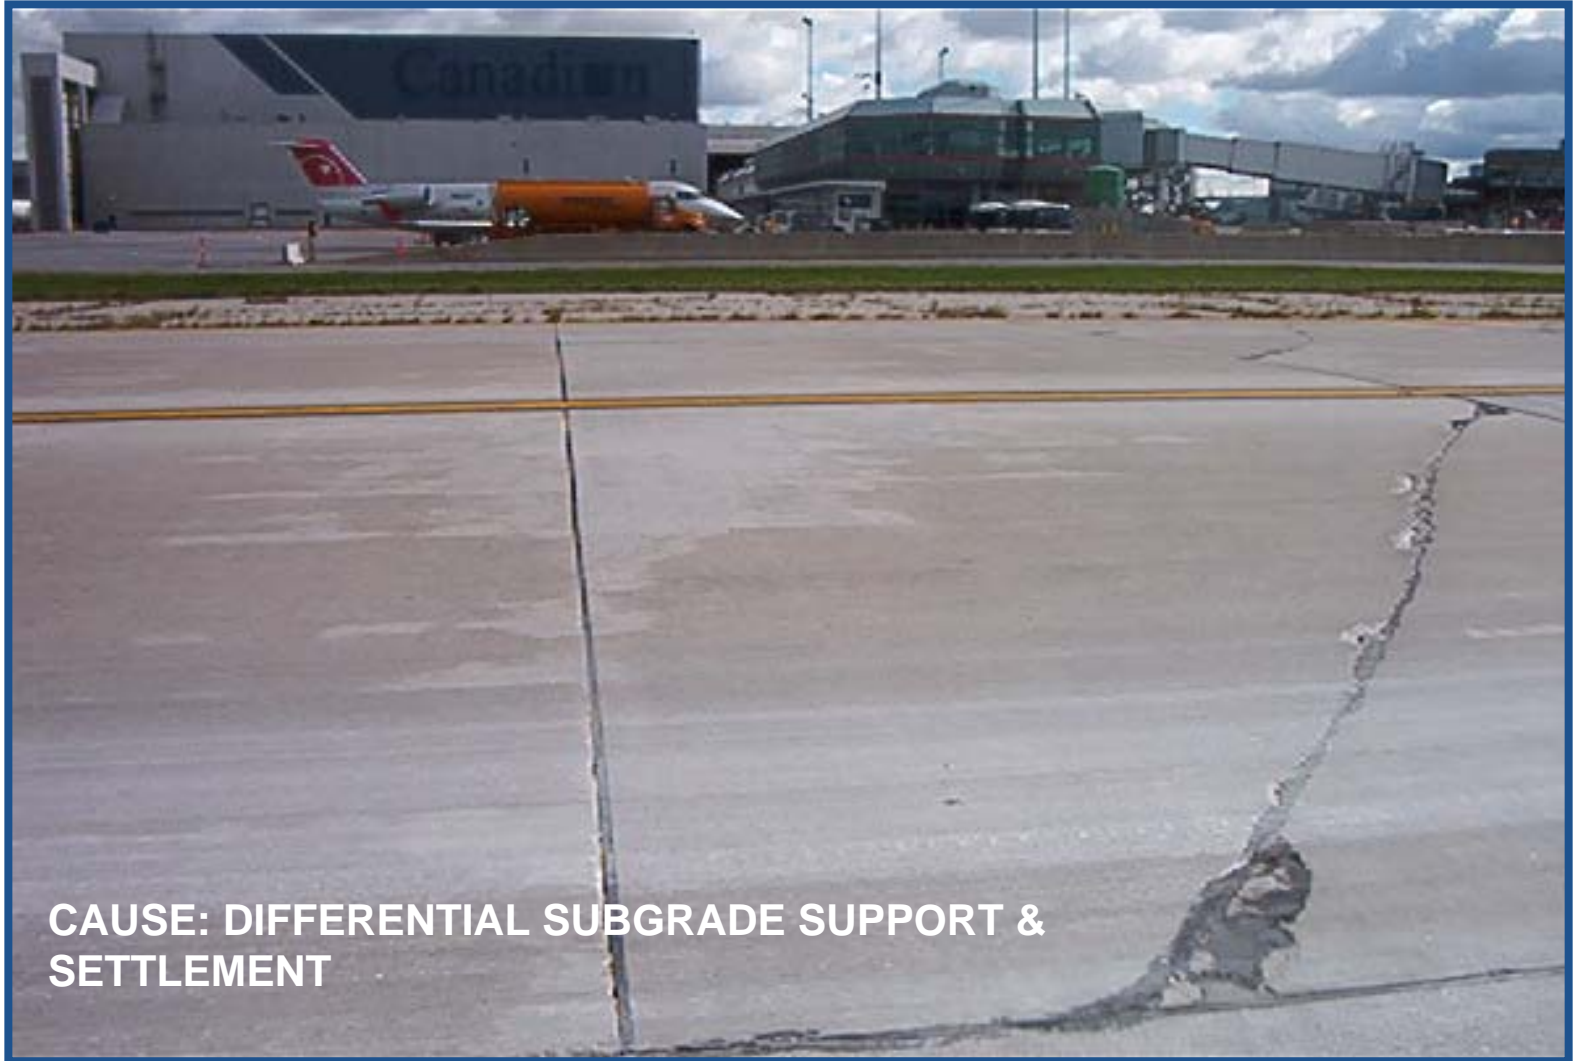
PCC Pavement Defects: Diagonal Cracks

CAUSE: DIFFERENTIAL SUBGRADE SUPPORT & SETTLEMENT

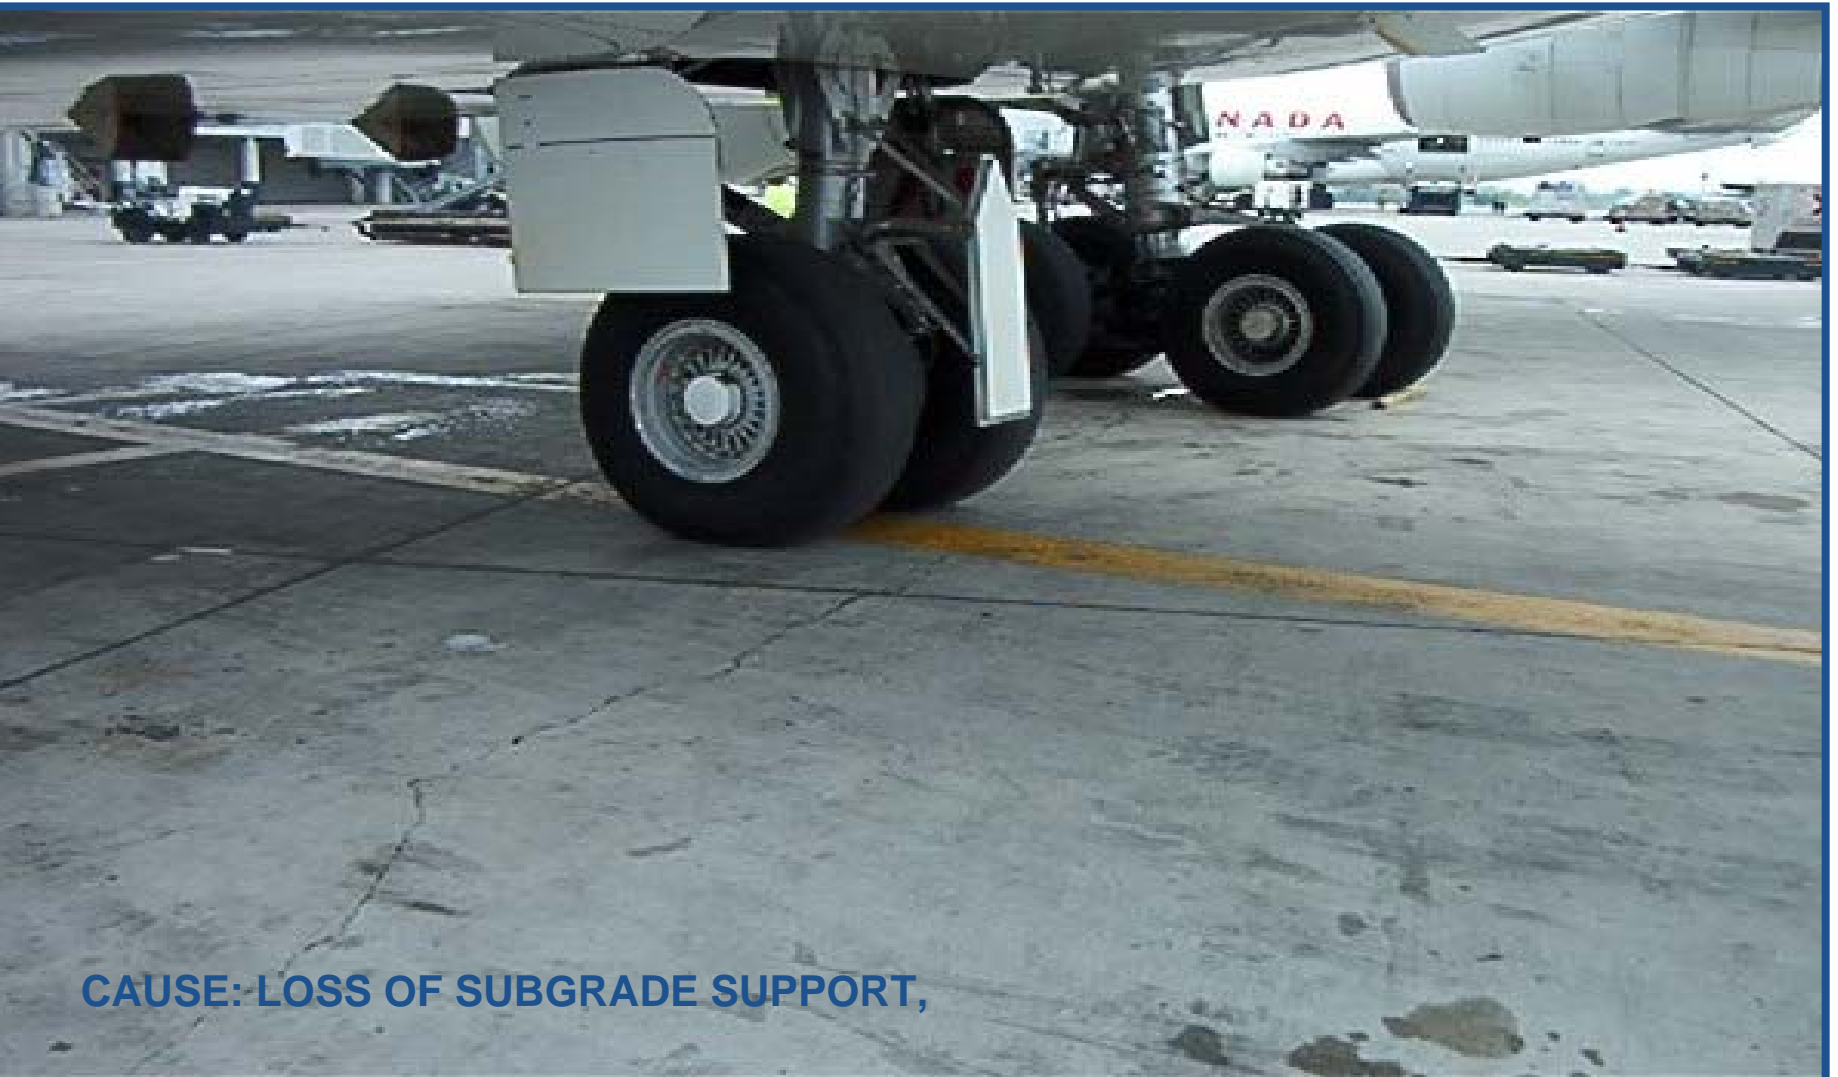
PCC Pavement Defects: Transverse Cracks

CAUSE: LOSS OF SUBGRADE SUPPORT,

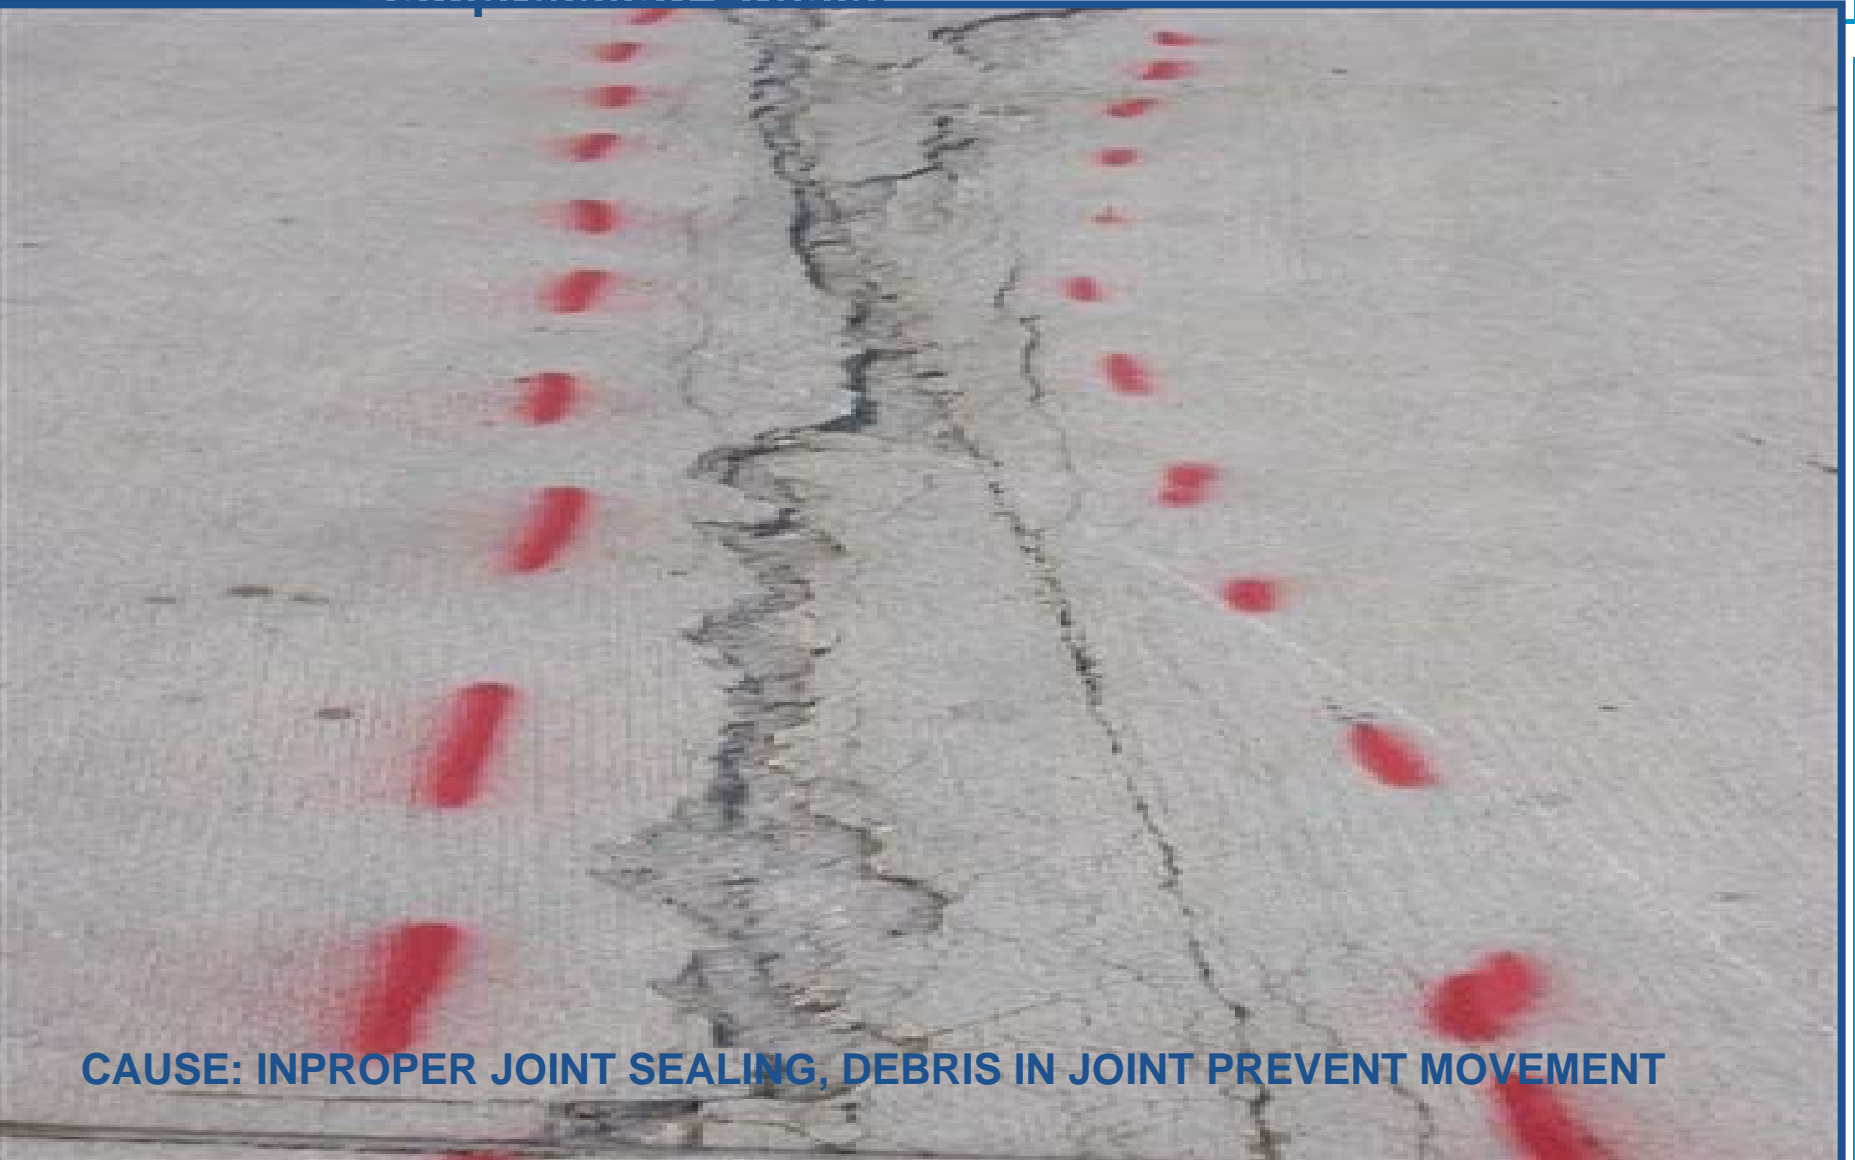
PCC Pavement Defects: Spalling at Joints & Compression Cracks

CAUSE: INPROPER JOINT SEALING, DEBRIS IN JOINT PREVENT MOVEMENT

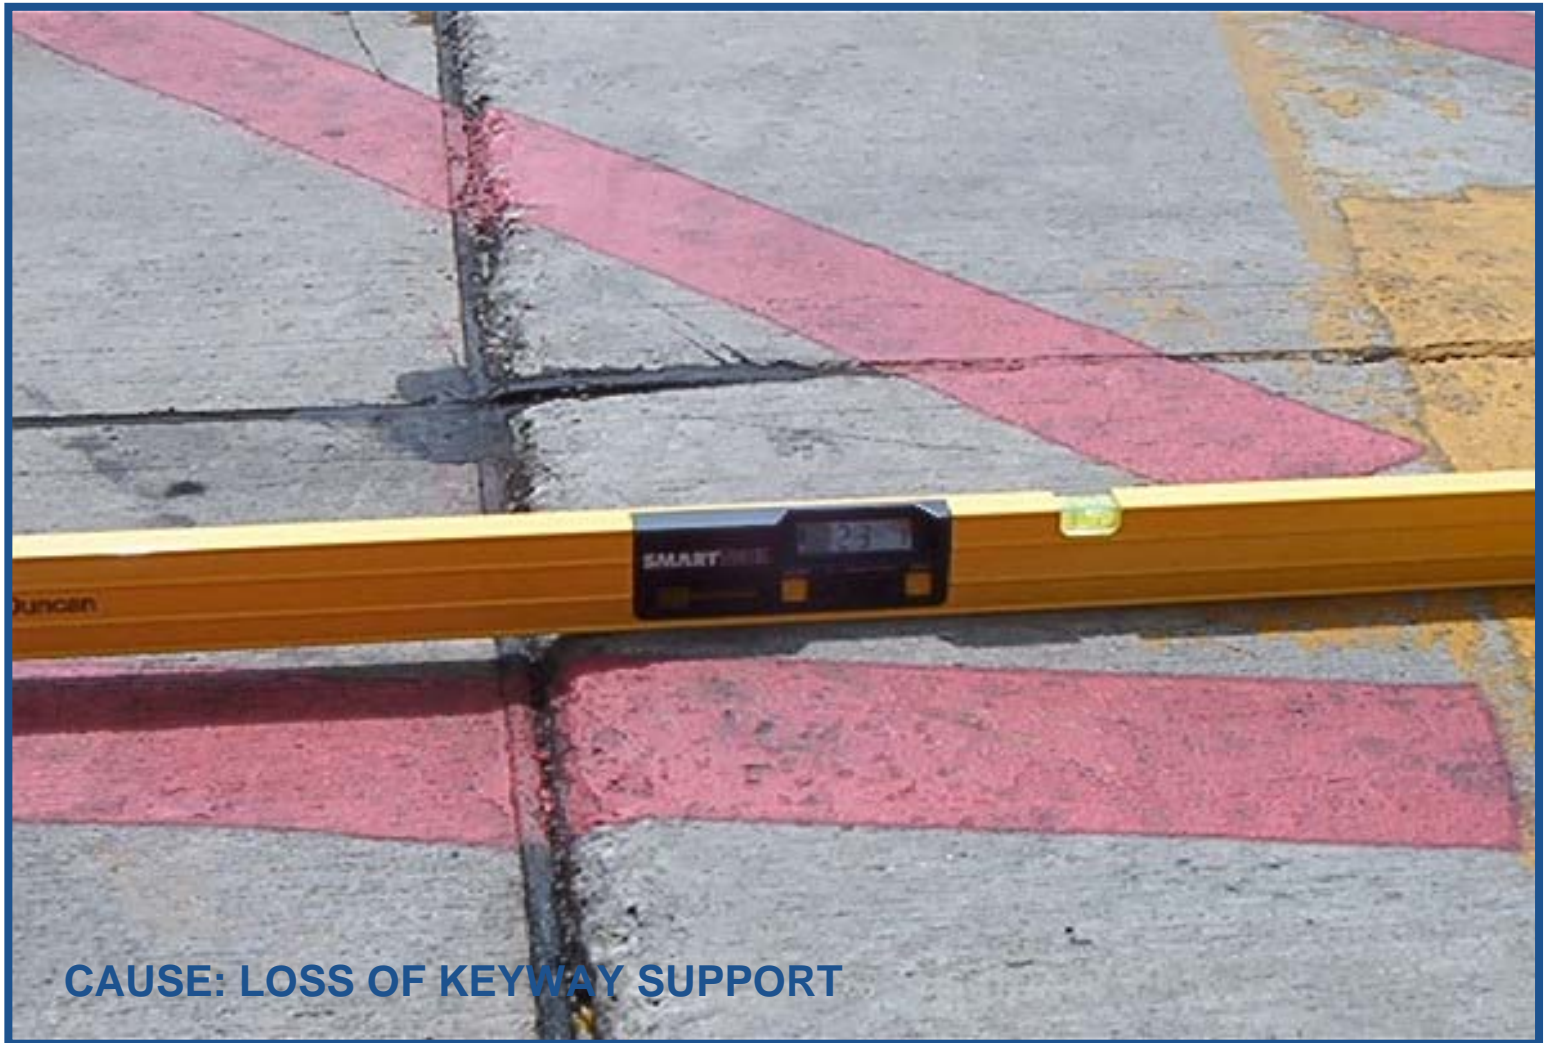
PCC Pavement Defects: Joint Faulting/Stepping

CAUSE: LOSS OF KEYWAY SUPPORT

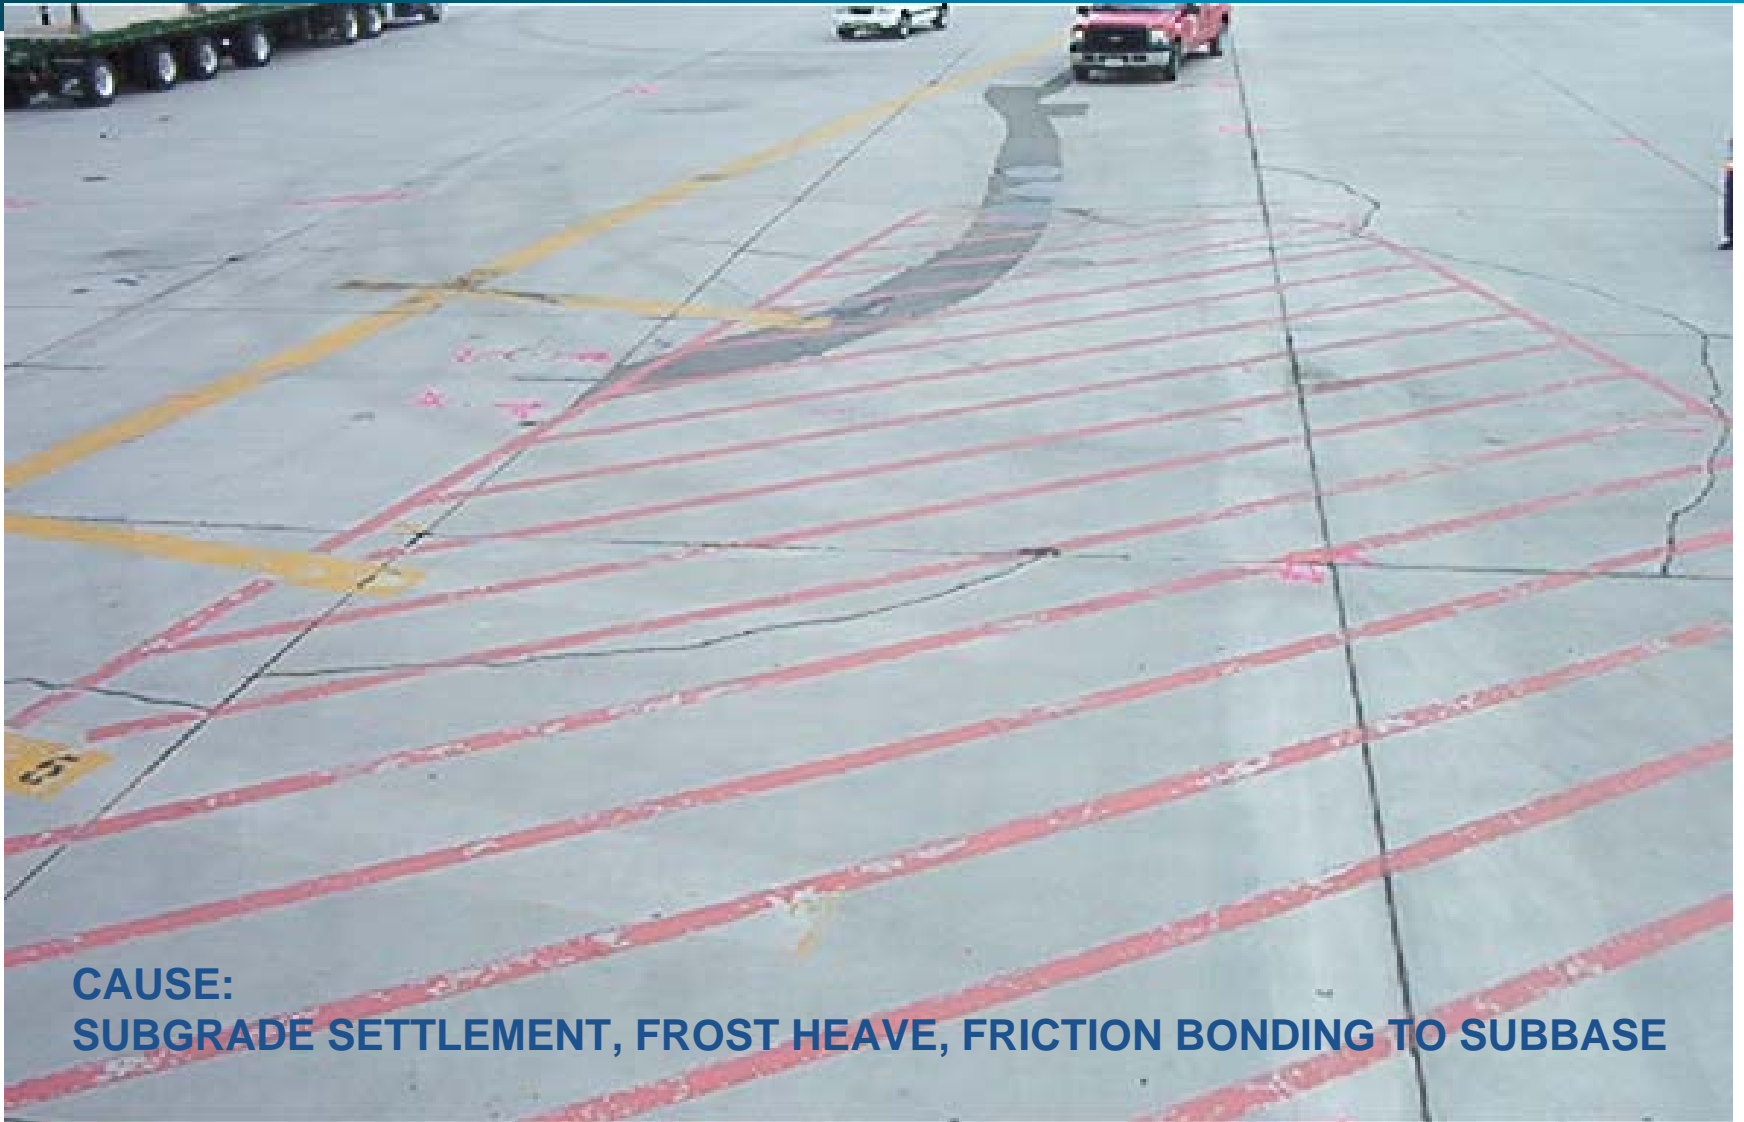
GATE 522 INFIELD TERMINAL: ERRATIC CRACKS

**CAUSE:
SUBGRADE SETTLEMENT, FROST HEAVE, FRICTION BONDING TO SUBBASE**

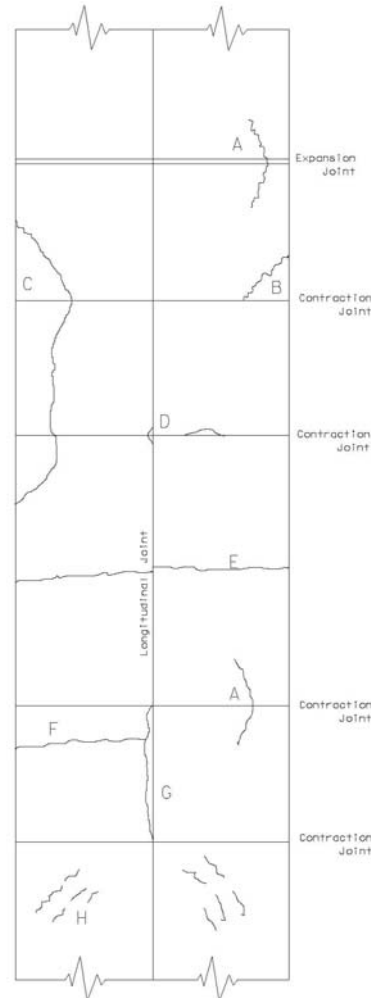
These may be parallel to the pavement edge or at an angle. They may be caused by failure to extend expansion-joint filler to the edge of the pavement, or by infiltration of foreign material into the end of either expansion or contraction joints.

These cracks, which generally form a rough isosceles triangle with sides at least 450mm long, are caused by overstressing the pavement.

These are caused by a differential in subgrade support. This may be due to settlement or volume change of the subgrade (frost heave/settlement).

These may develop at any joint or at an intersection of two joints. They may be caused by improper joint construction or infiltration of foreign material at the top of the joint.

These may be caused by the omission of a contraction joint or by using a joint spacing too great to control cracking.

These cracks, which occur 1.2m to 2.4m ahead of the joint, are usually caused by loss of subgrade support due to pumping.

These are caused by the omission of intermediate longitudinal joints in wide construction lanes.

These are caused by rapid loss of water from the fresh concrete, which may be due to lack of early curing, rapid evaporation from the surface, or loss of water because of a dry subgrade or a dry, absorptive aggregate.

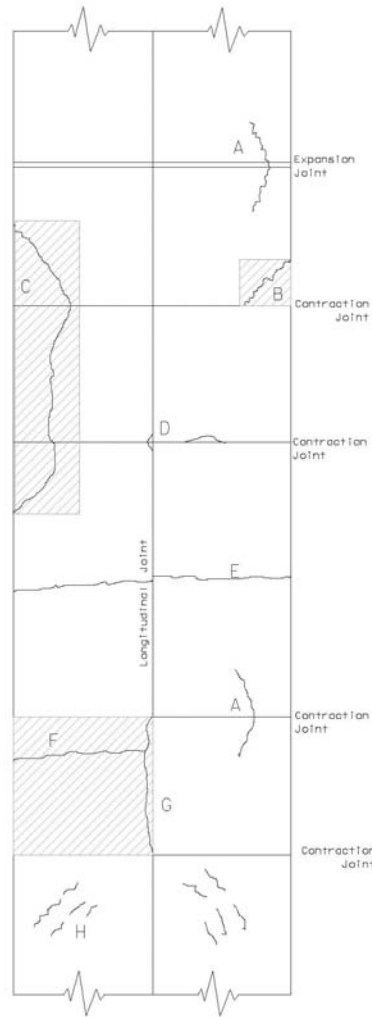
These may be parallel to the pavement edge or at an angle. They may be caused by failure to extend expansion-joint filler to the edge of the pavement, or by infiltration of foreign material into the end of either expansion or contraction joints.

These cracks, which generally form a rough isosceles triangle with sides at least 450mm long, are caused by overstressing pavement corner and loss of support.

These are caused by a differential in subgrade support. This may be due to settlement or volume change of the subgrade (frost heave/settlement)

These may develop at any joint or at an intersection of two joints. They may be caused by improper joint construction or infiltration of foreign material at the top of the joint. It is less observed with chamfered joints.

These may be caused by the omission of a contraction joint or by using a joint spacing too great to control cracking.

These cracks, which occur 1.2m to 2.4m ahead of the joint, are usually caused by loss of subgrade support due to pumping.

These are caused by the omission of intermediate longitudinal joints in wide construction lanes.

These are caused by rapid loss of water from the fresh concrete, which may be due to lack of early curing, rapid evaporation from the surface, or loss of water because of a dry subgrade or dry absorptive aggregate.

Clean and reestablish joints

Partial slab replacement when crack exceeds 20mm

Partial slab replacement and recompact subgrade

Clean and seal joints

Rout and seal joints

Replace slab and compact subgrade

Rout and seal cracks

Do nothing but monitor with time
