Presenters

Airfield Pavement

Impact of Inset Lighting Installation on Airfield Pavement

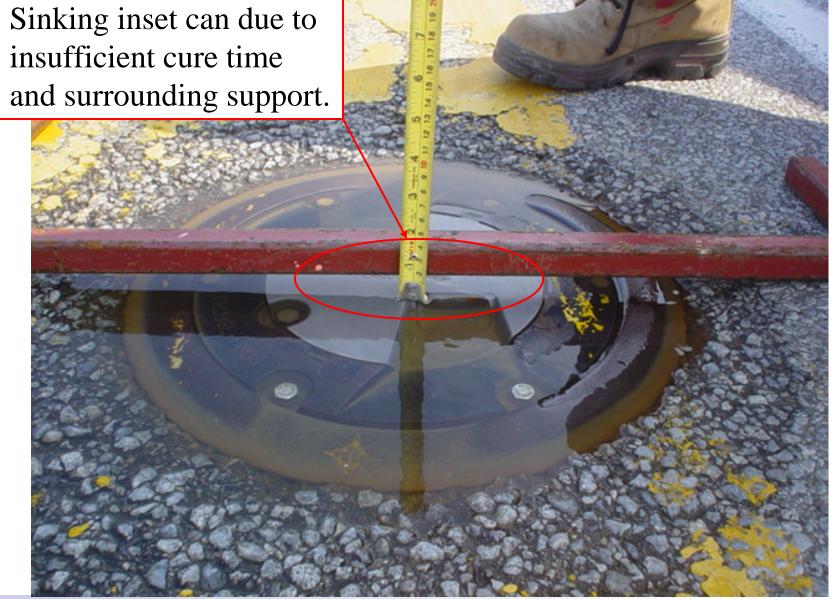
Inset Can Installations

- Insufficient underlying and surrounding support
 - Settlement
- □ Cure time is not enough for achieving full strength → Sinking inset can

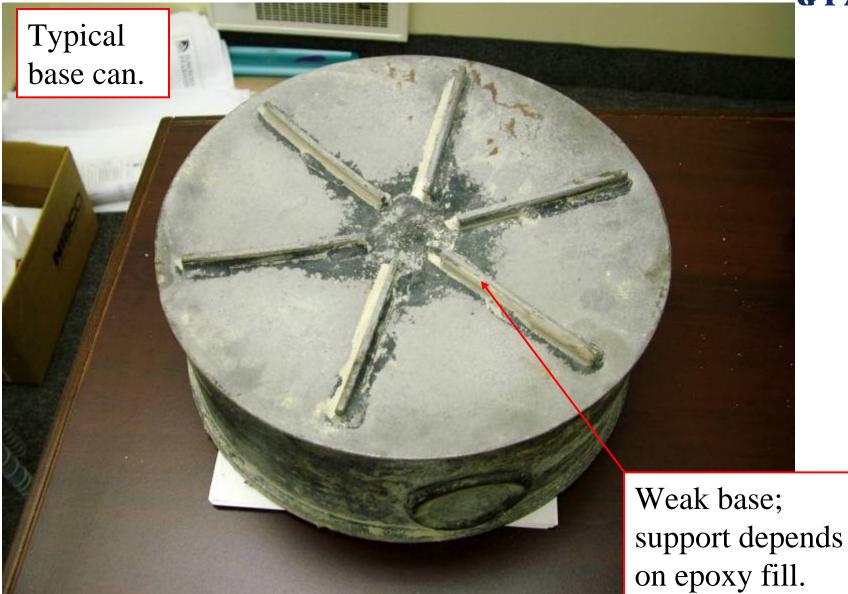
Concaved base due to

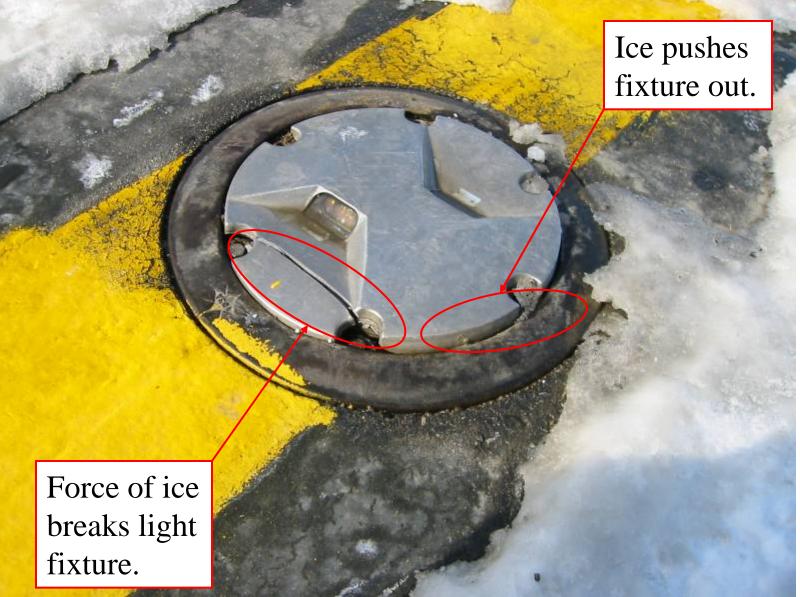
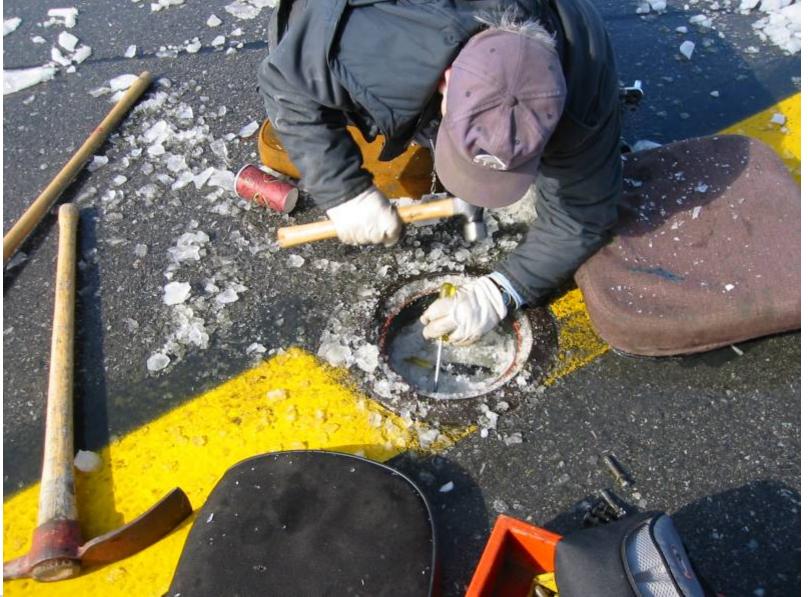
- □ No drainage for inset cans
- □ Can fills with water → freezing water (ice) expands and pushes light fixtures upward

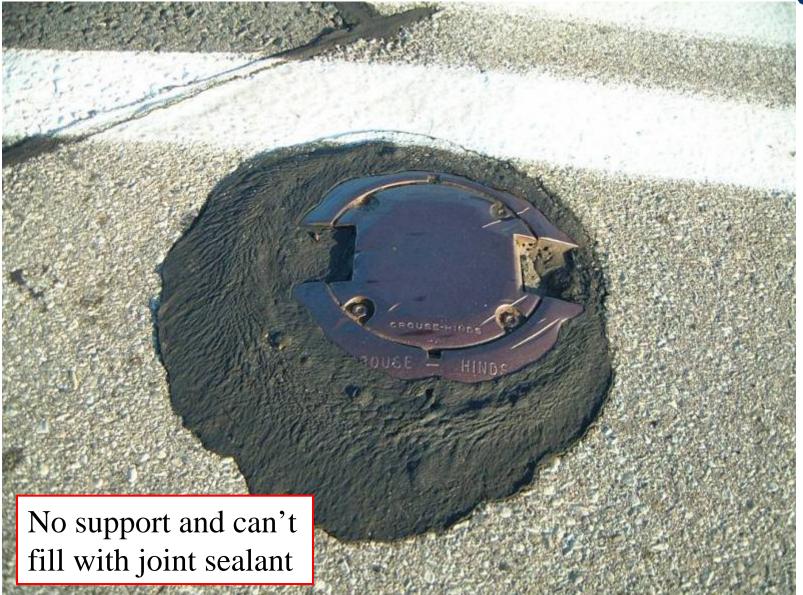
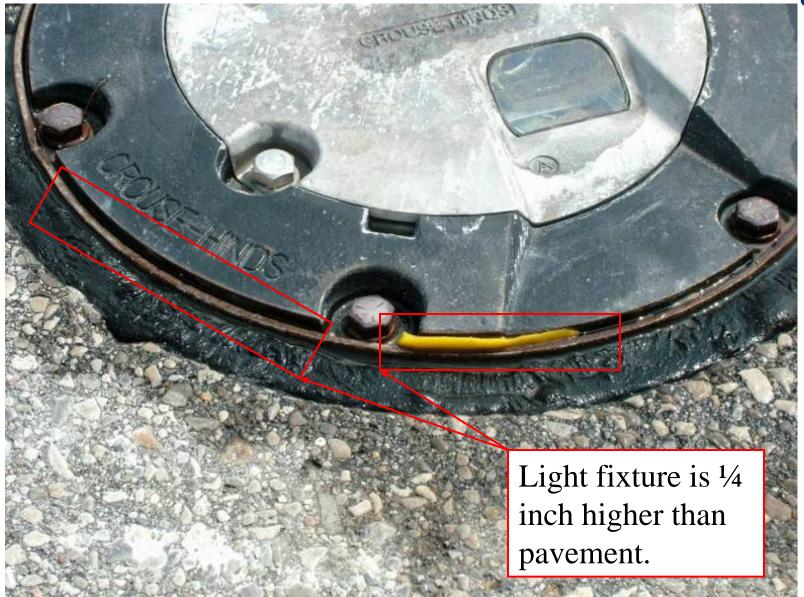
- Pavement settlement
- Pavement around can deteriorates sooner than life cycle of Runway/Taxiway/Apron pavement

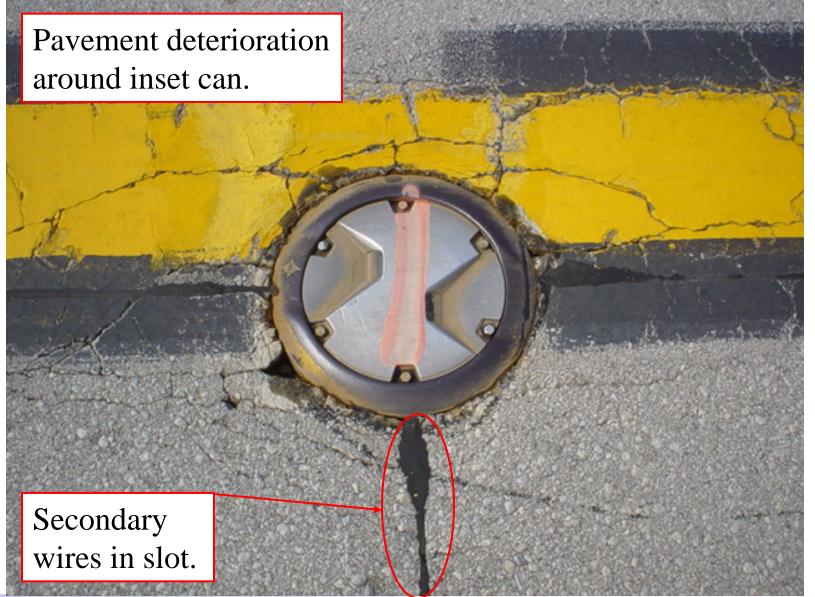
Conduit Chases and Trenches
 Pavement failure along trenches
 Impacts on pavement
 Reduced life cycle

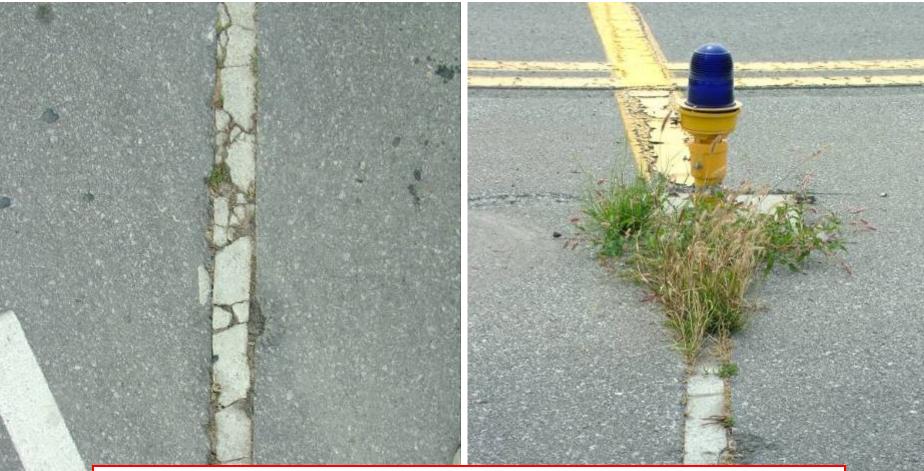
Pavement failure along trenches as a result of inadequate backfill material (Rapid set mortar, which solidifies in one week to provide full strength).

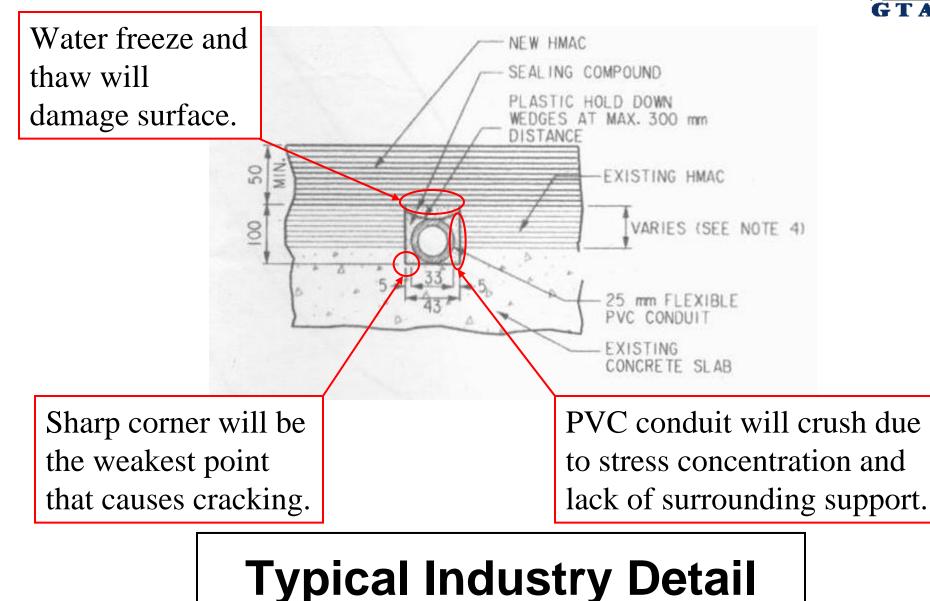
Reflective cracking over an embedded conduit in PCC with HMAC overlay.

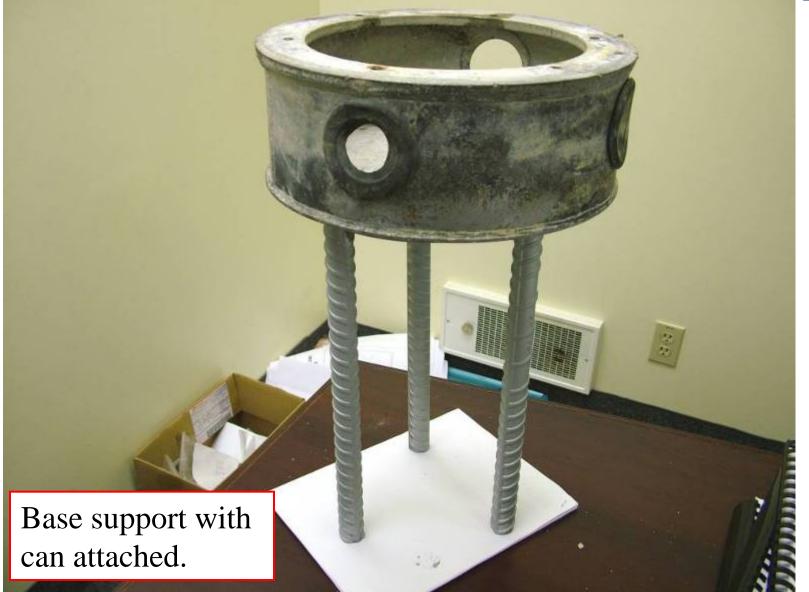
6" of concrete to support light can

Reduce Concentrated Stresses Adequate inset can base and lateral support

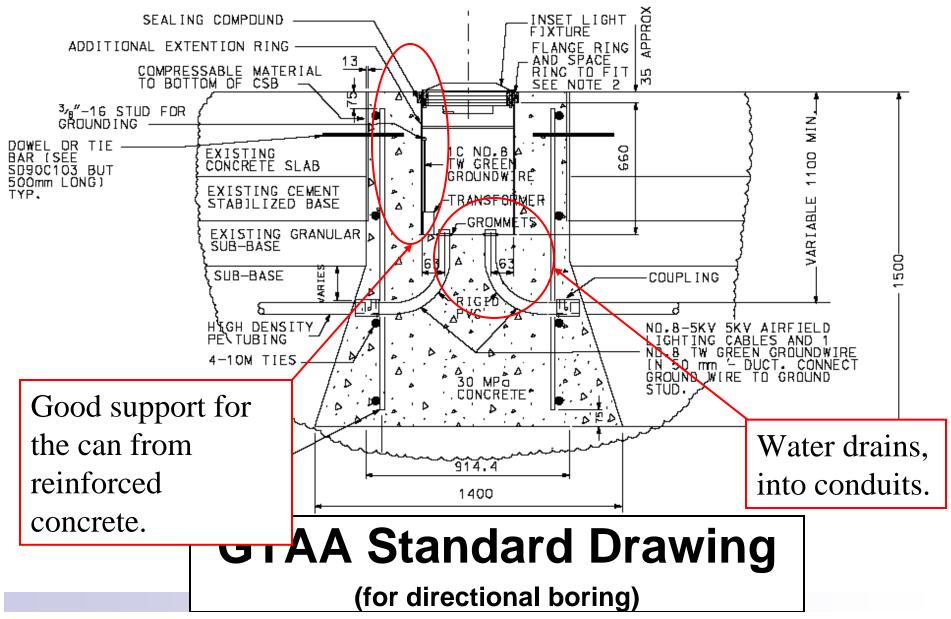
Detailed Installation Drawing

- Drainage! Drainage! Drainage!
- Adequate installation for drainage (needs specific design)
- Better can support
 rebar into concrete
- All Details to scale
 - Designer can then visualize the feasibility of design
 - Cost and time savings (contractor does not have to re-draw)

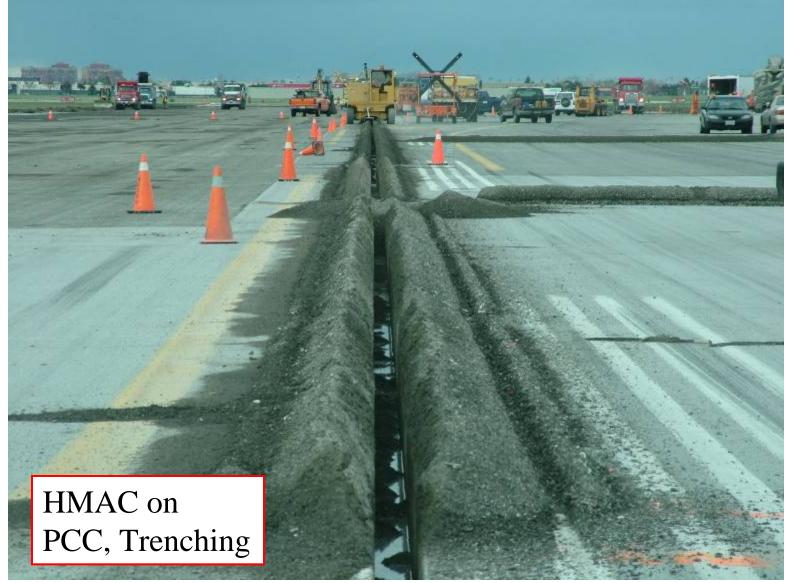
- Rounded corners in trenching, and;
- Sufficient room around conduit for concrete support/protection
- Rough and clean surface for better bonding
- CLEAN, surface MUST be clean.

Rough surface for better bonding.

Lots of room to fill with designed material.

Rounded corner avoids cracking.

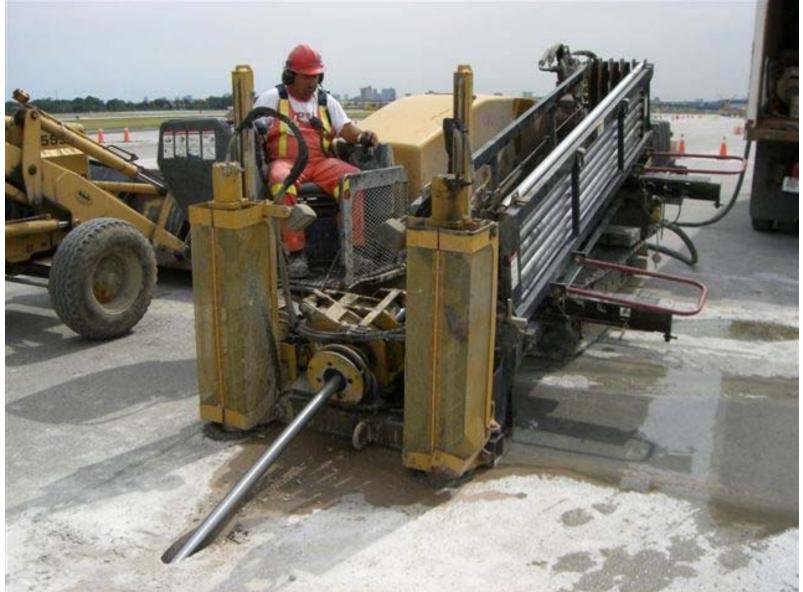
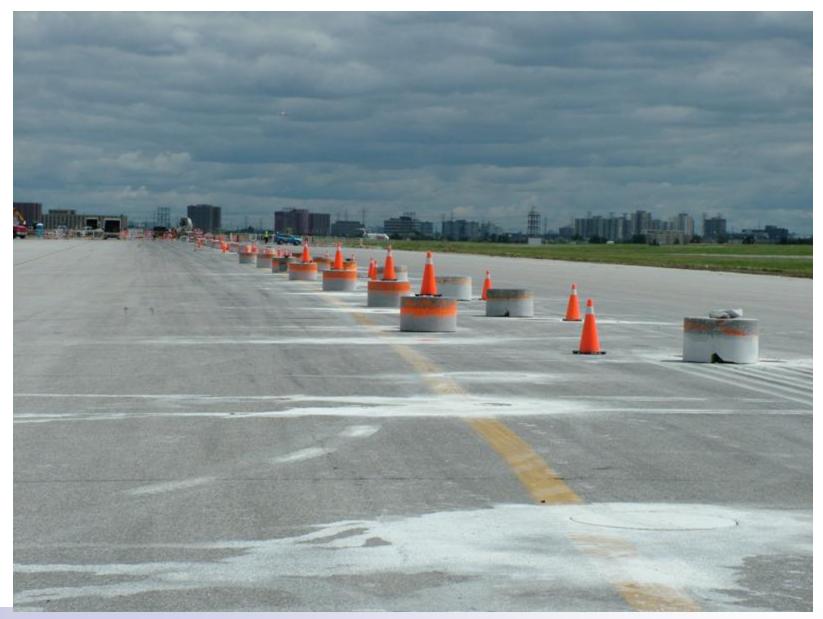
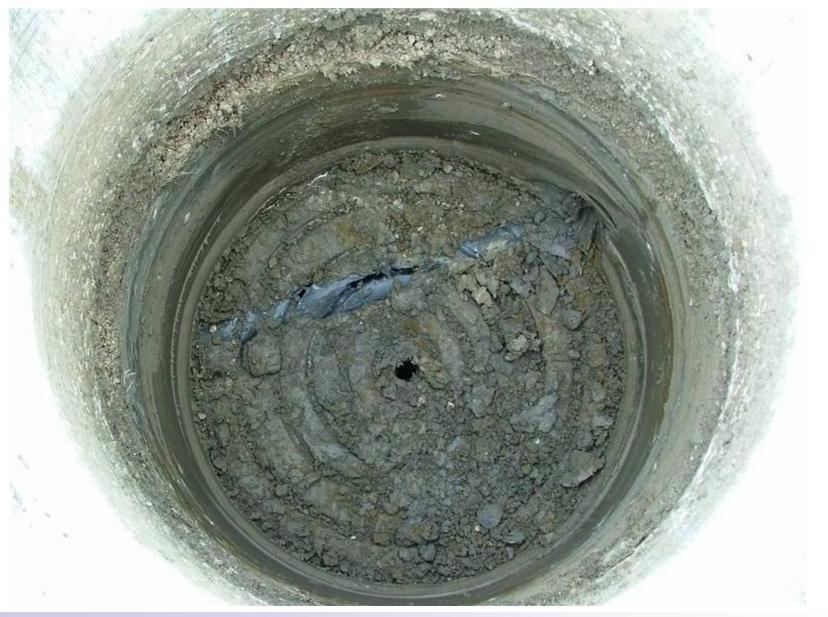
Overview of construction (PCC)

- Directional Boring Technology
 Under existing PCC pavement conduit installations
 - Less impact on pavement structure
- Applications

There must be suitable sub-grade (cohesive soil)

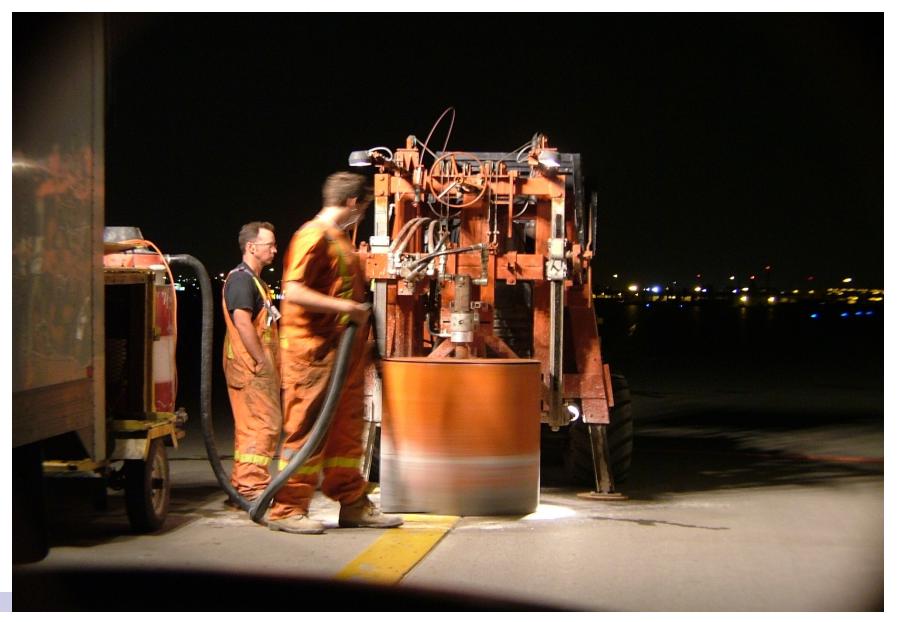
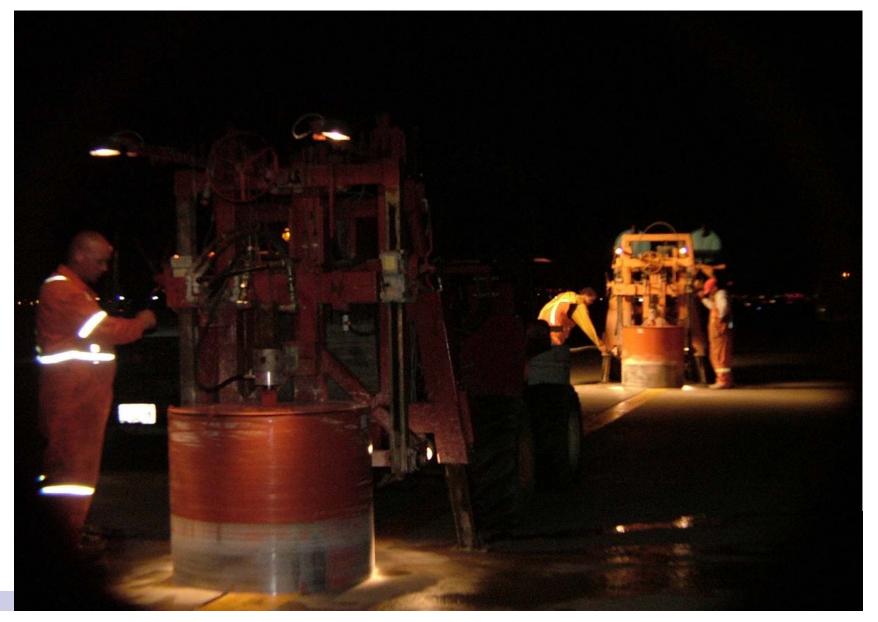
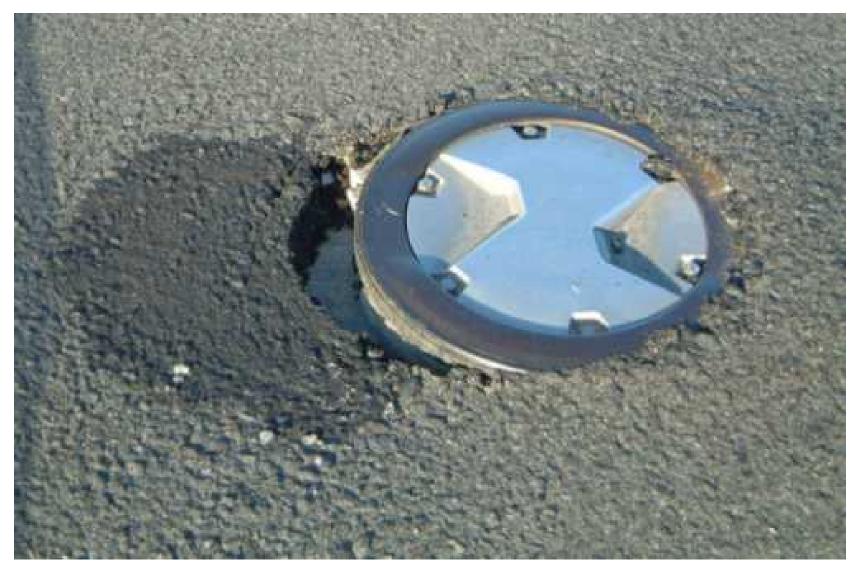
Inset Light Protection

- Development of specialized equipment needed
- Installation of Flange Rings and Snowplow Rings
 - Protection against snow plow blades
 - Snowplow ring deflects the impact of blades
