USE OF INFRARED HEATERS IN ASPHALT PAVEMENT CONSTRUCTION & REPAIR

2013 SWIFT CONFERENCE
OTTAWA, CANADA
SEPT 10, 2013
Bob Kieswetter P. Eng

USE OF INFRARED HEATERS IN AIRPORT PAVEMENTS

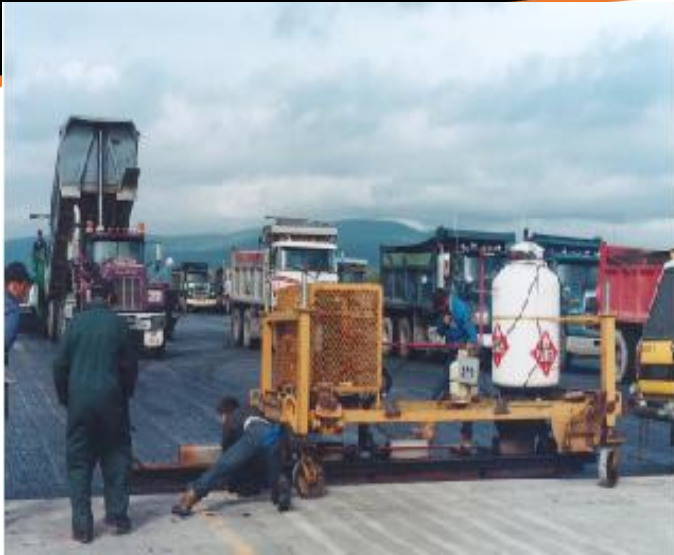
Jean Lesage International Airport,
Quebec City, in 1995

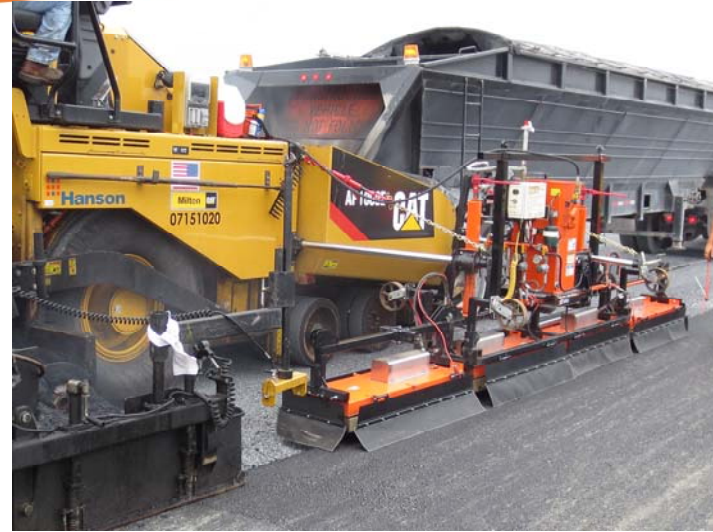
Fort Drum Air Base, NY, in 2013

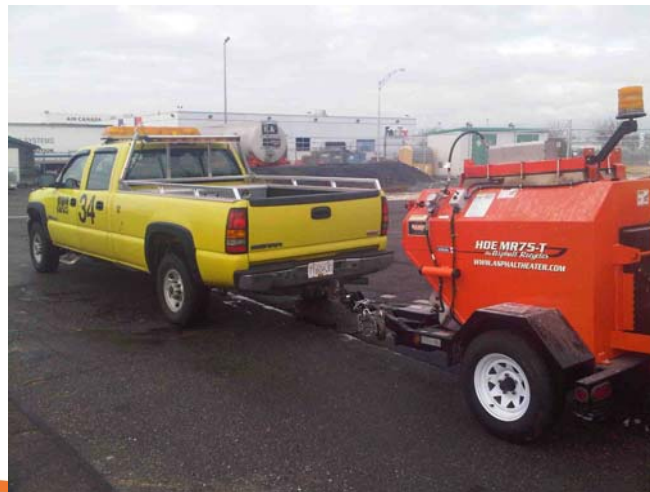
Mini Recycler at
Vancouver YVR

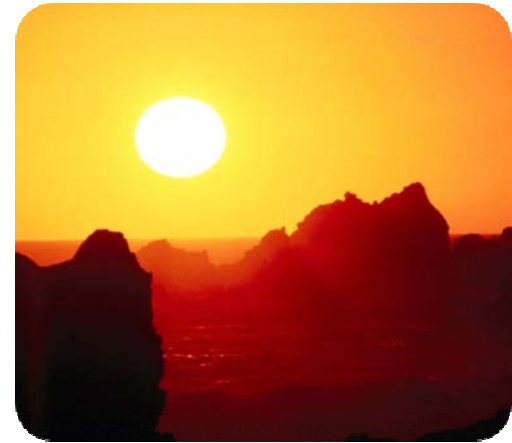
Infrared heating :the transfer of radiant energy from a hot surface through the air to cooler surfaces, without the use of an air mover.

No energy loss until the infrared rays hit the asphalt then energy is transformed to penetrating heat.

1500 F surface

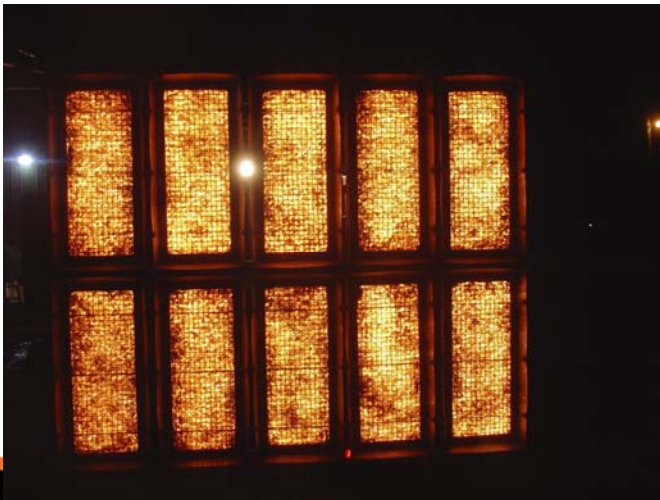
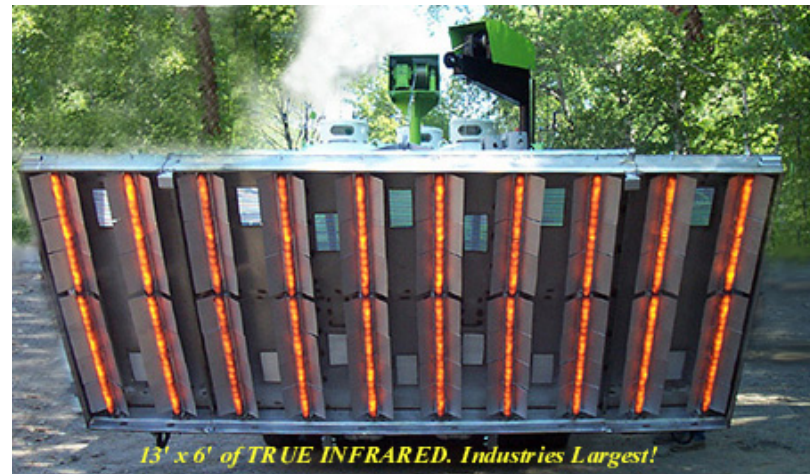
- Ignition of propane occurs behind emitting surface.. ... no direct flame
- The 1400 to 1500 F infrared surface emits high intensity infrared rays
- The radiation is absorbed by asphalt, quickly penetrates and turns to heat
- No deterioration of asphalt same as re-heating up a lab sample
- No open flame that will burn surface before heat penetration
- On the left below is a ceramic mat, on the right a tube heater

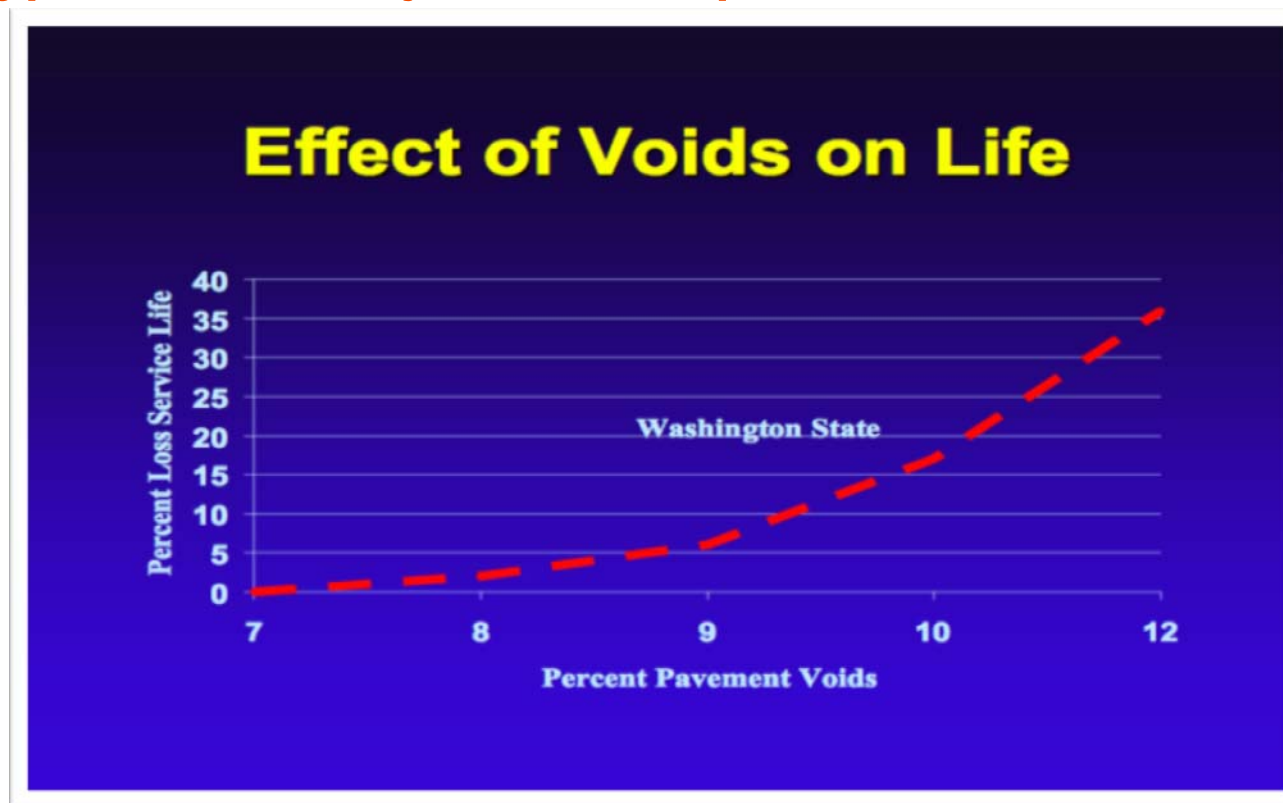
**Poor Compaction means high voids
Higher voids means shorter service life
Typical voids at a joint +12% equates to -35% service life**

* slide from Vince Aurillio , Asphalt Institute presentation to Swift Conference 2005

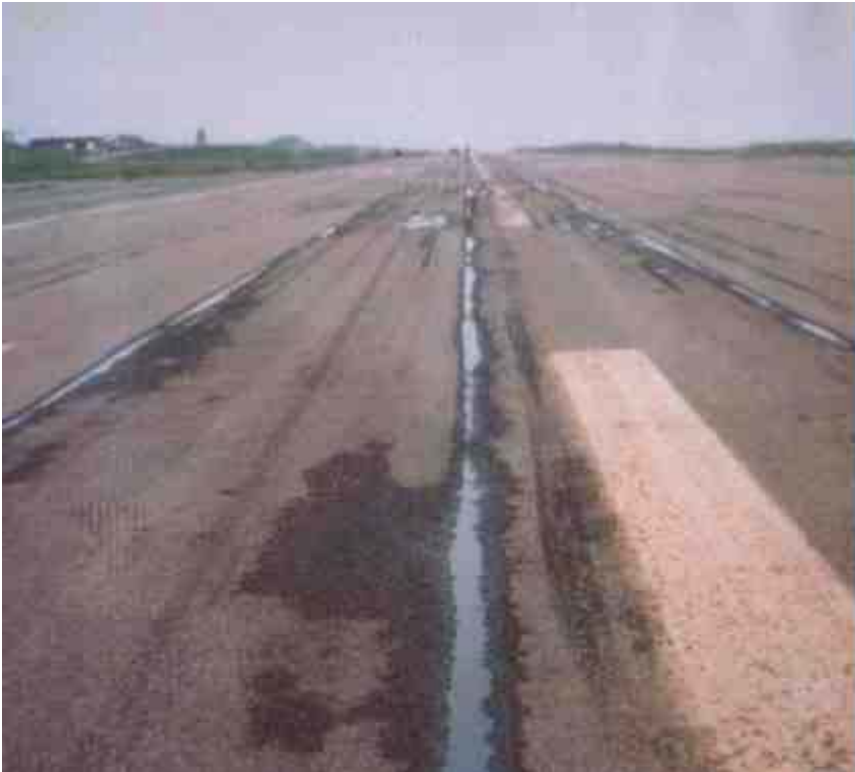
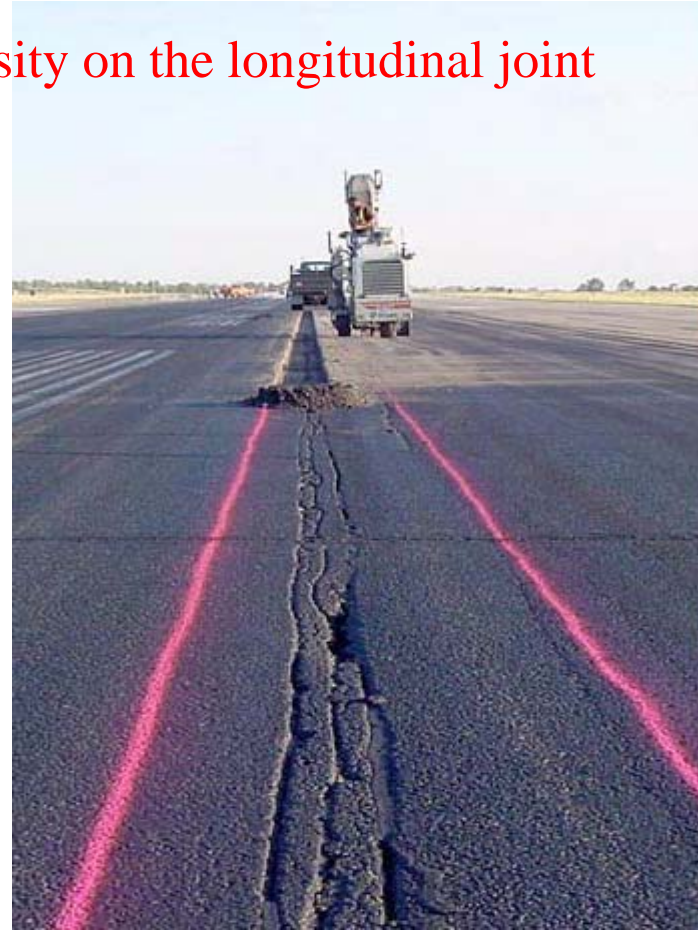
- Here we show Longitudinal Joint Failure as a result of poor compaction

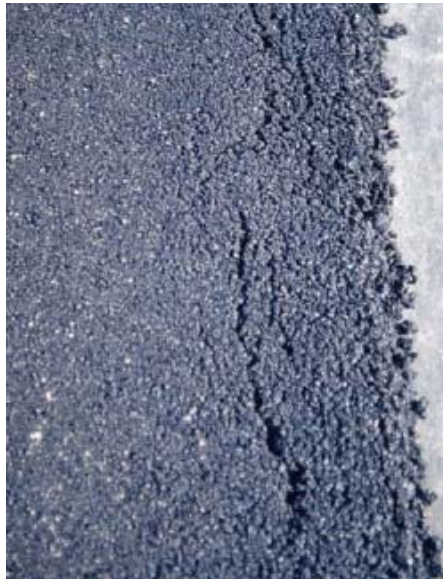
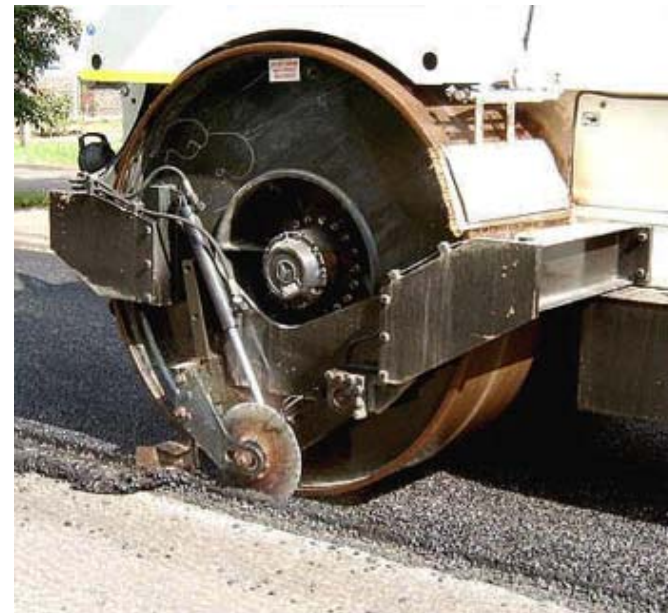
- Extreme example of poor edge
- FAA recommends cutting of the un-compacted edge, not always done

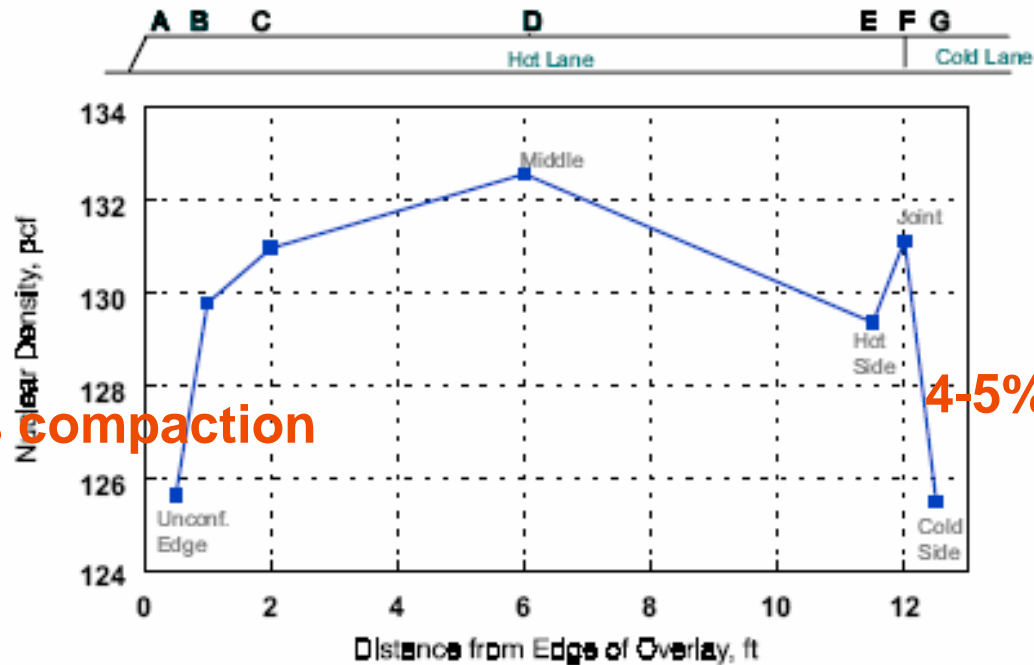
- Density at Unconfined Edge: Typical Mat Density

4-5% less compaction

Ref: Texas Transportation Institute

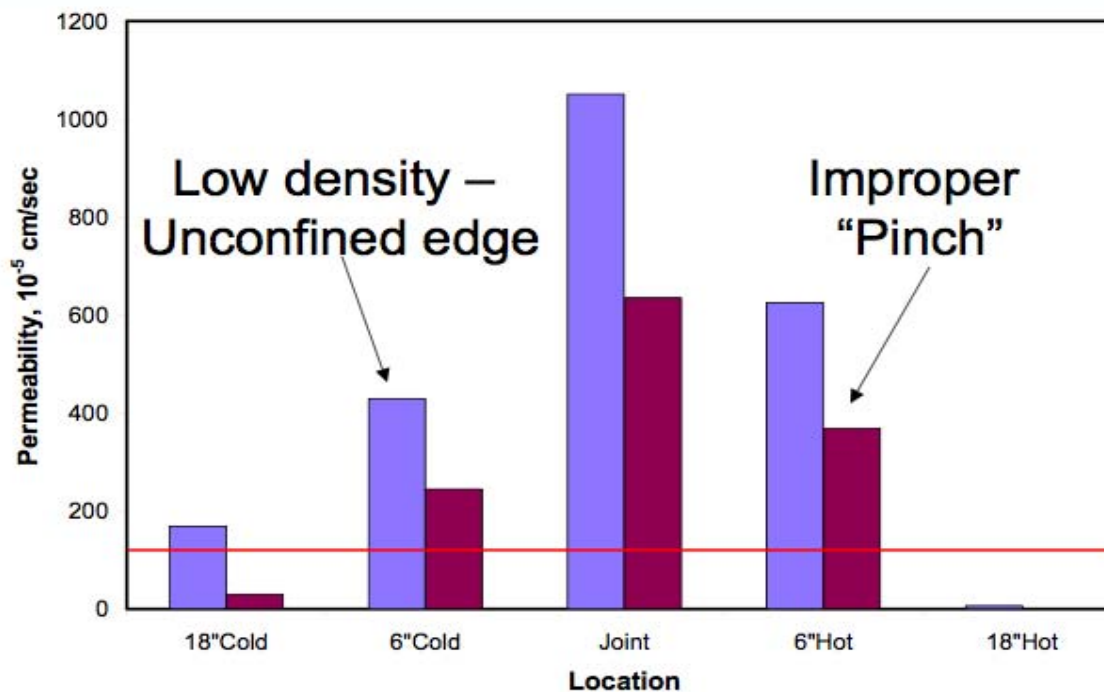
Field Permeability Measurements

- High permeability at a typical joint

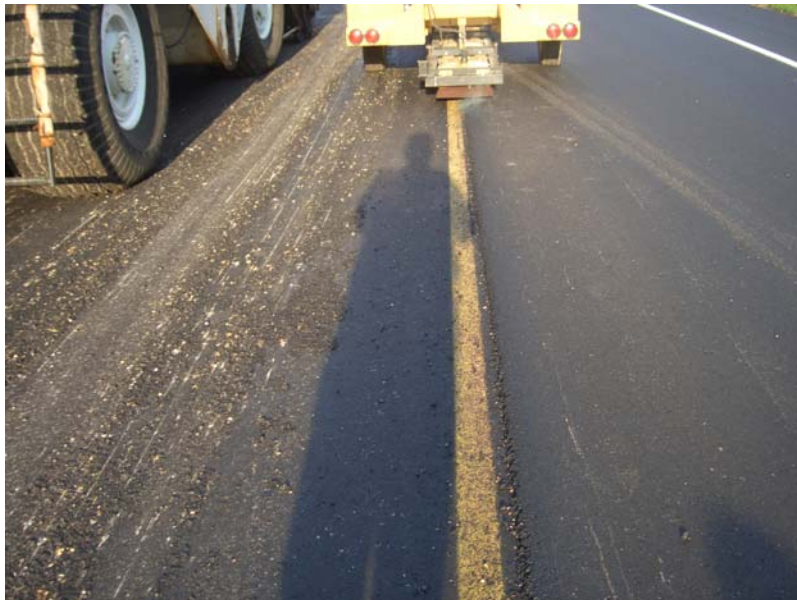
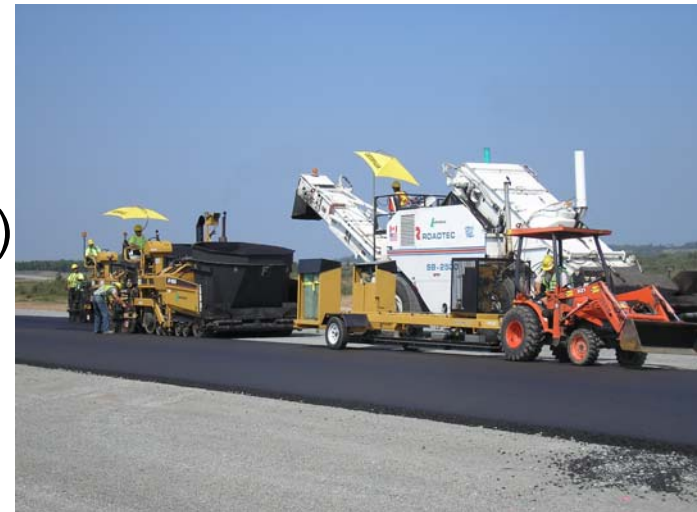
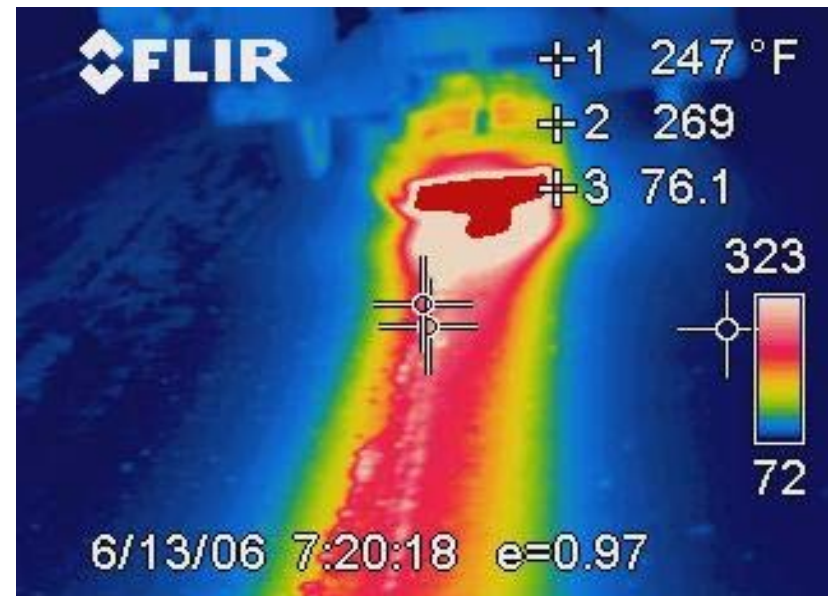
- Heat the JOINT to 200 to 250F (95 to 120C)
- Recompact with the New Hot Lane

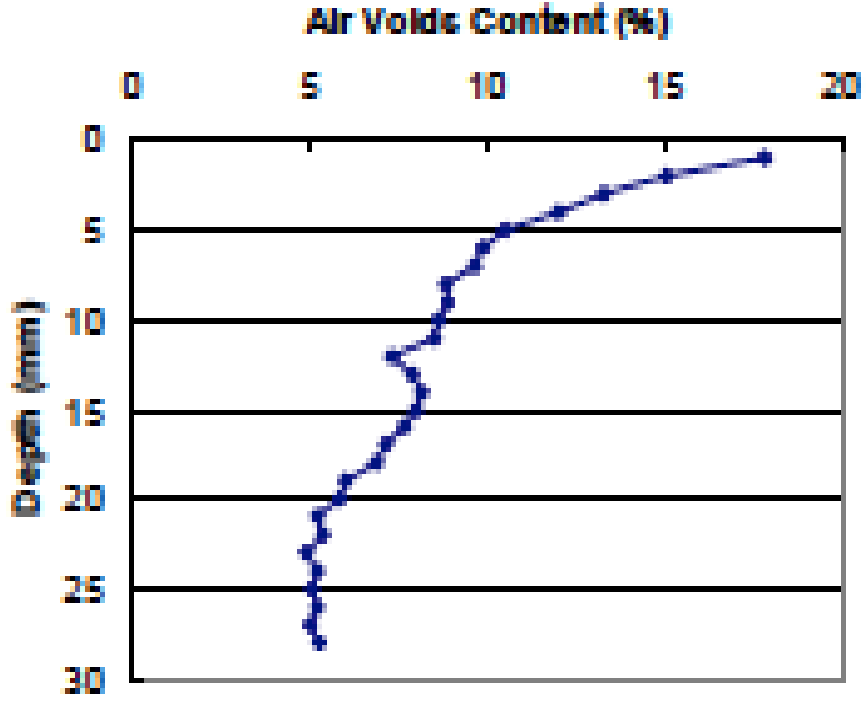
(d) Infrared heater, joint

X-Ray for density in core top to bottom

Air Voids Content (%)

The air voids distribution obtained from the X-ray CT images shows that the effectiveness of infrared heater in improving joint quality was through increasing the compaction degree of longitudinal joint deep to the overlay bottom and thus making the joint denser.

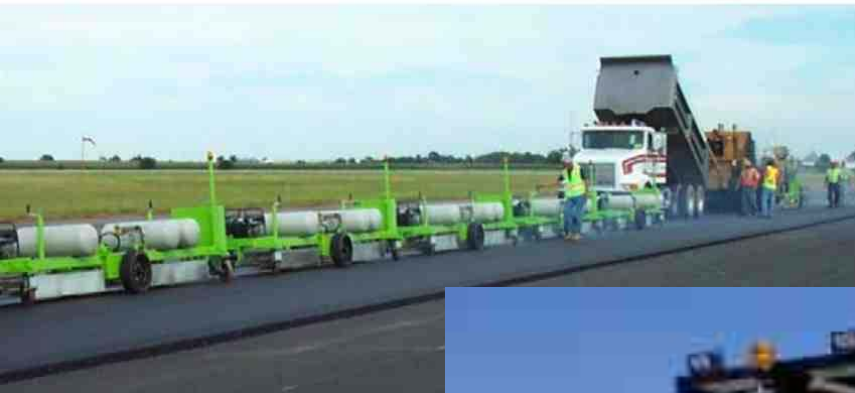
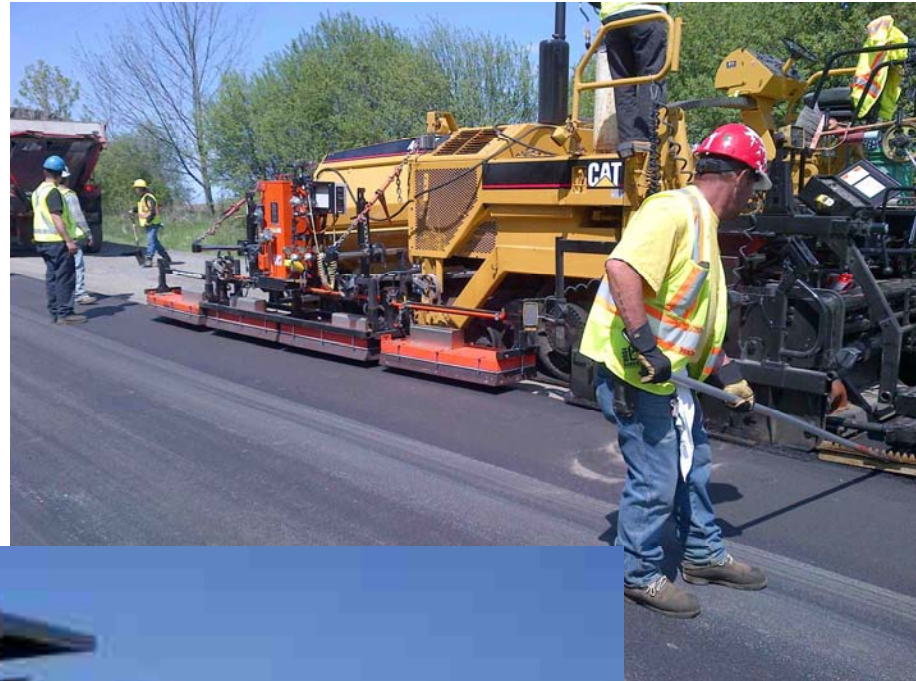
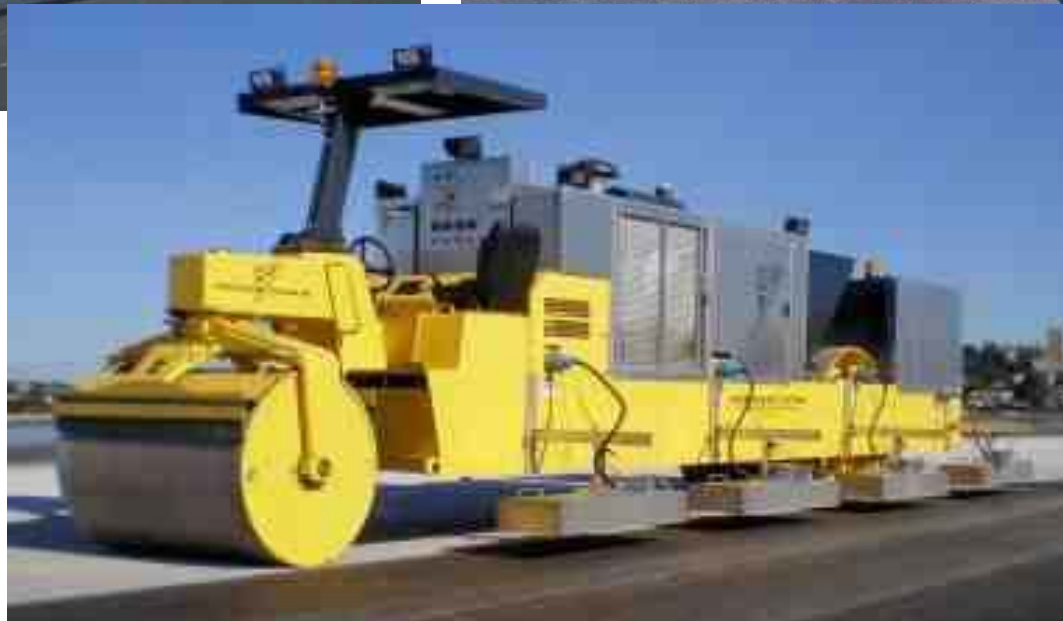
JOINT HEATING : Various equipment suppliers, same goal

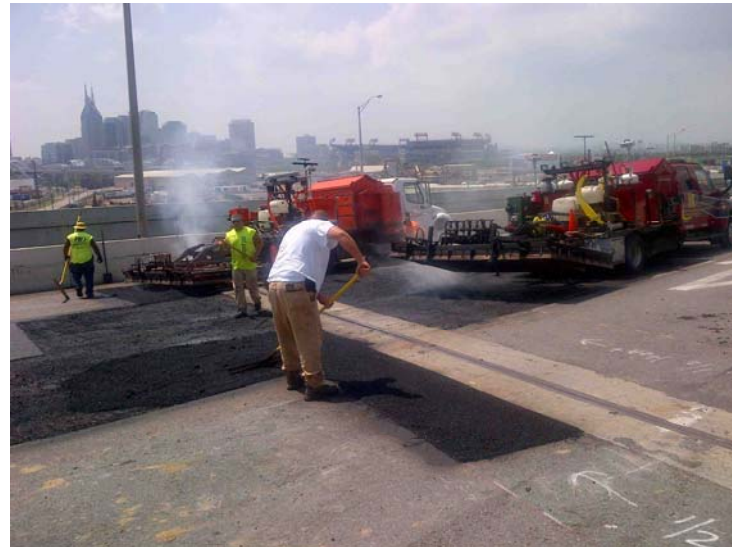
HOT-IN-PLACE *INFRARED PATCHING*

The Process

- 1. Identify repair area**
- 2. Heating deck is lit and positioned overtop of damaged area.**
- 3. Allow heat to penetrate for *5-10 minutes*. Check temperature of surface. *Range 220-275 F.***

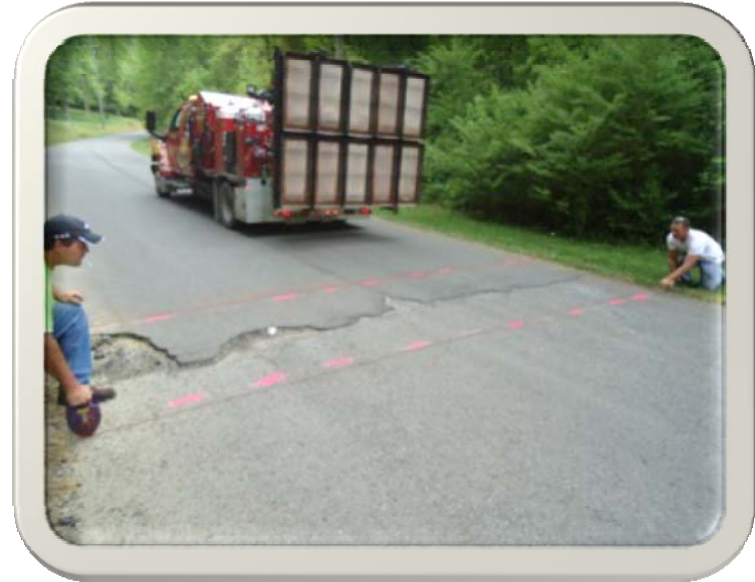
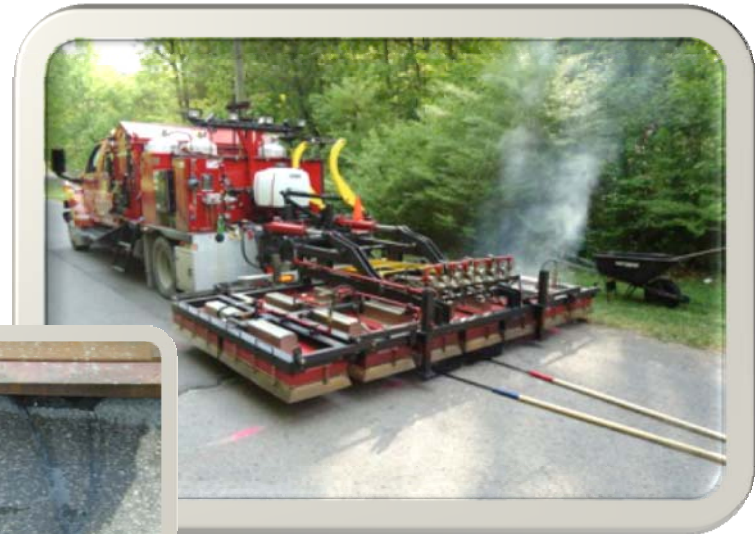
INFRARED PATCHING

4. Define edges of repair area, keeping it square. Leave 2" (50mm) hot border at edge.

5. Cracks and imperfections are raked out.

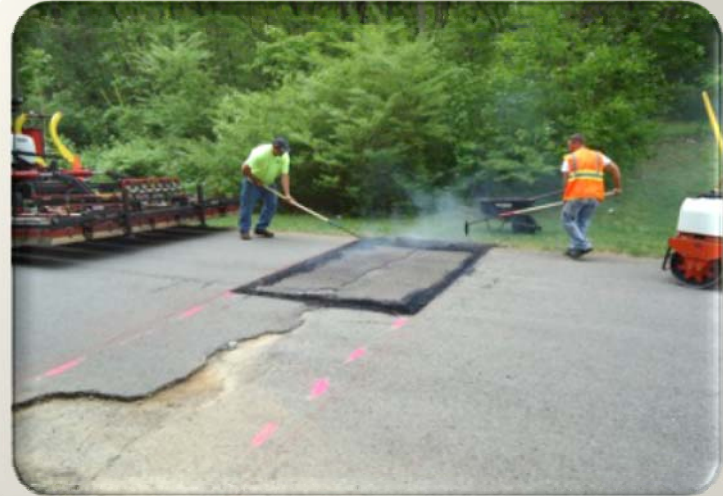
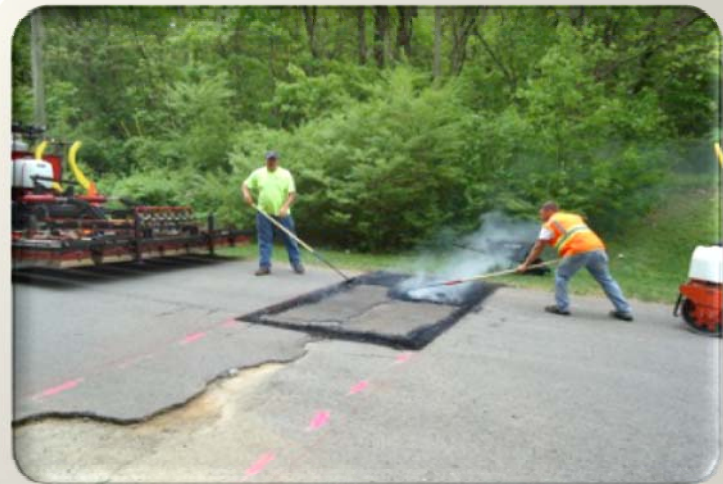
INFRARED *PATCHING*

6. Spray heated area with rejuvenating agent.

7. Fresh asphalt is then added and luted to the correct grade. *Use finer mix than original.*

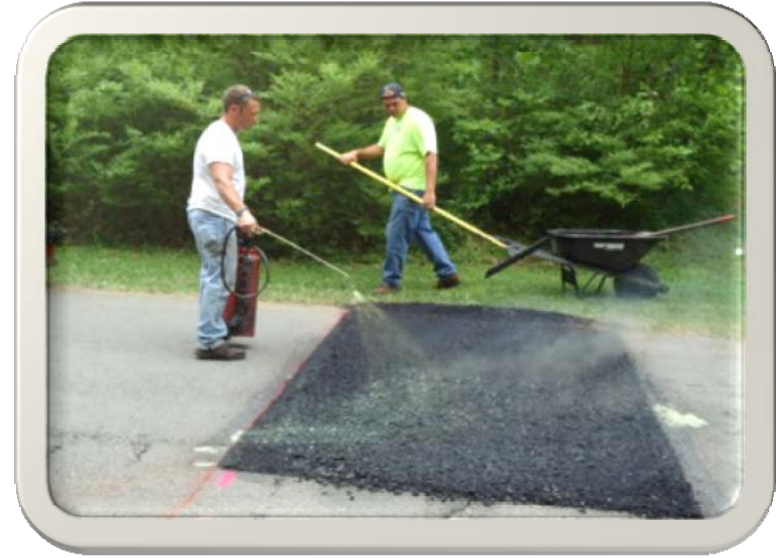
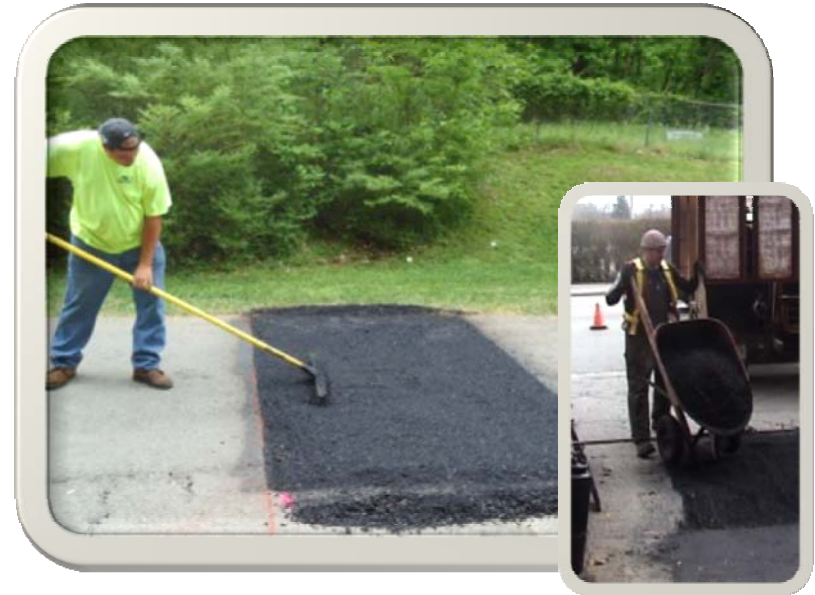
INFRARED PATCHING

8. Edges of repair area are compacted.

**9. Patch is integral part of existing pavement.
Good load transfer, no water penetration**

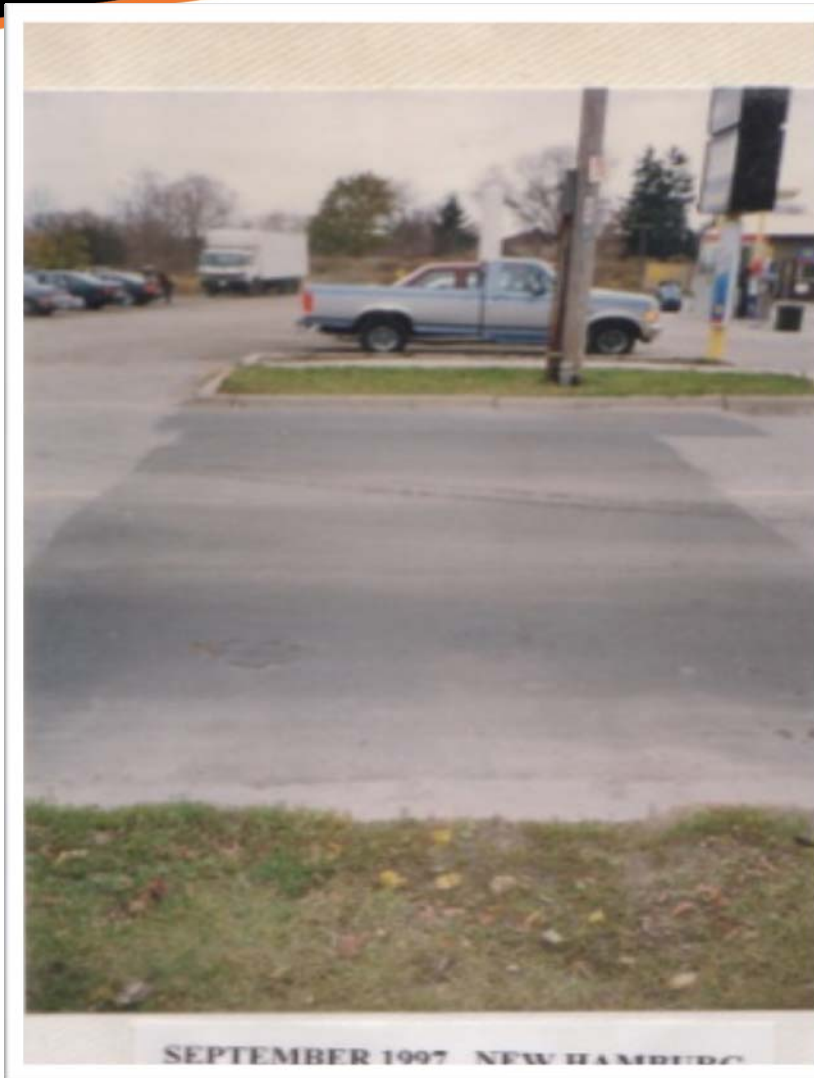
How Long can an Infrared Patch Last?

Goal is to extend life to match the adjacent pavement

1997 - Water St. New Hamburg Ontario, Canada
Settlement in trench caused severe bump so was fixed with infrared patch

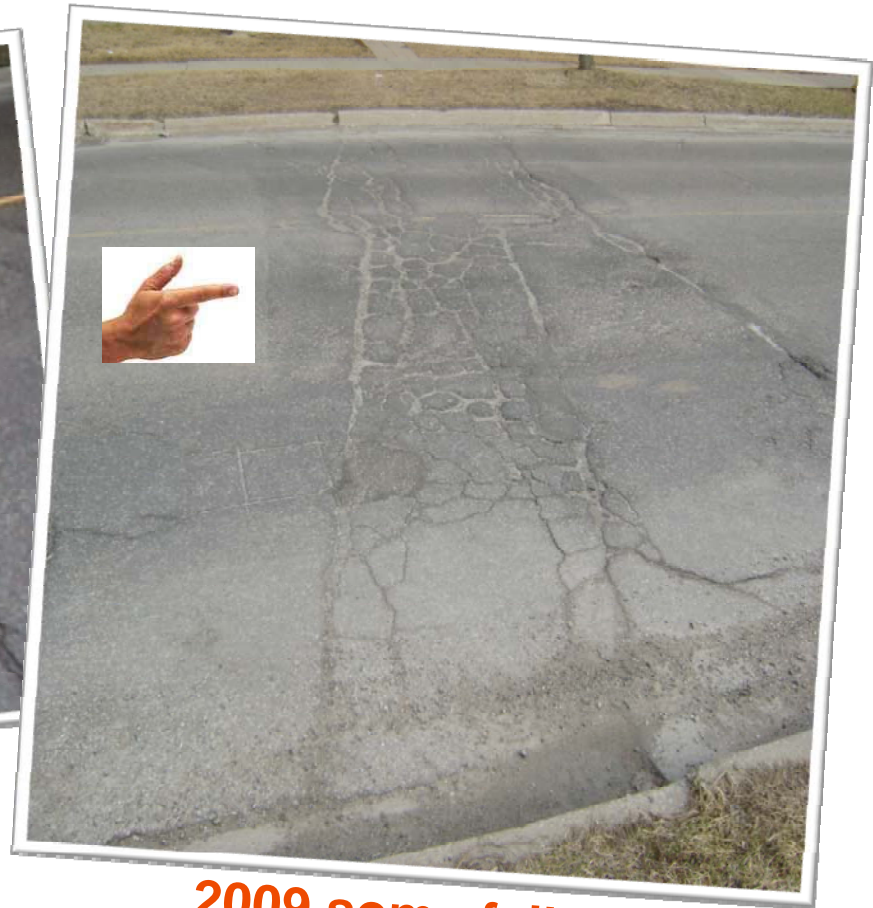
**2009 some failure,
minor cold mix added
Hot seam still intact!
Still no bump!**

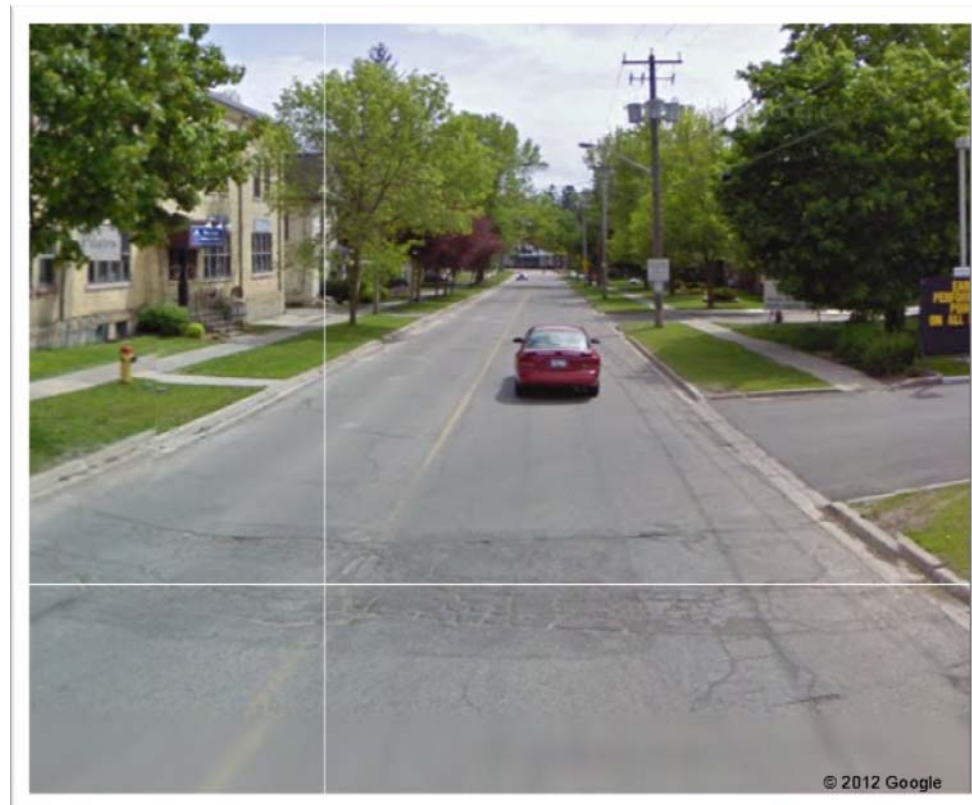
*IN 2012 Road was repaved, patch survived 15 years without growing beyond original envelope, no major potholes
The patch didn't look pretty, BUT THE ROAD BUDGET WAS!*

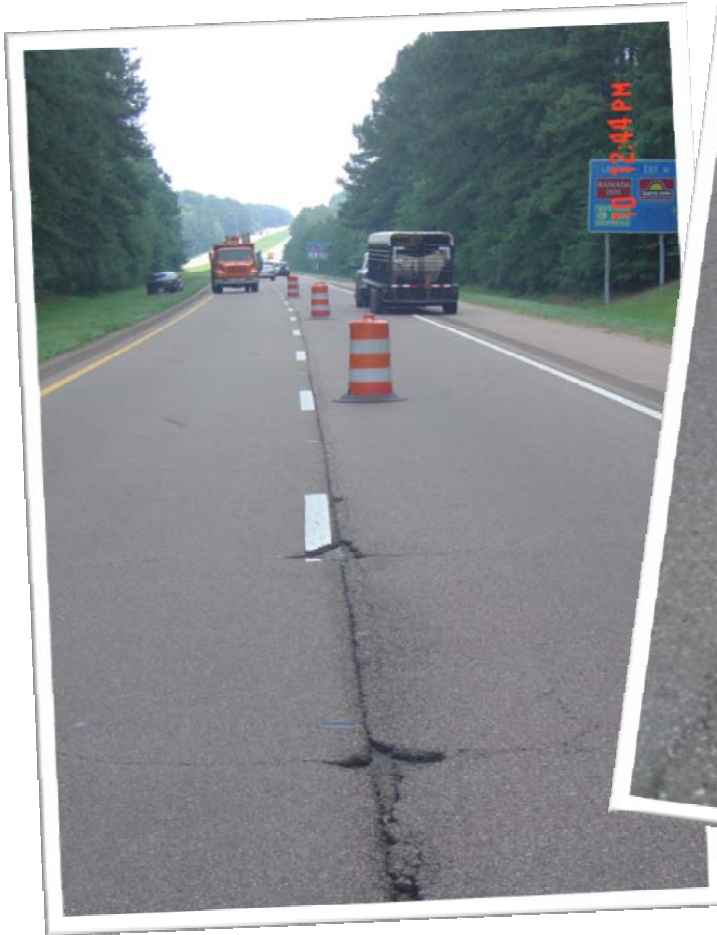
Typical failed joint, Mississippi

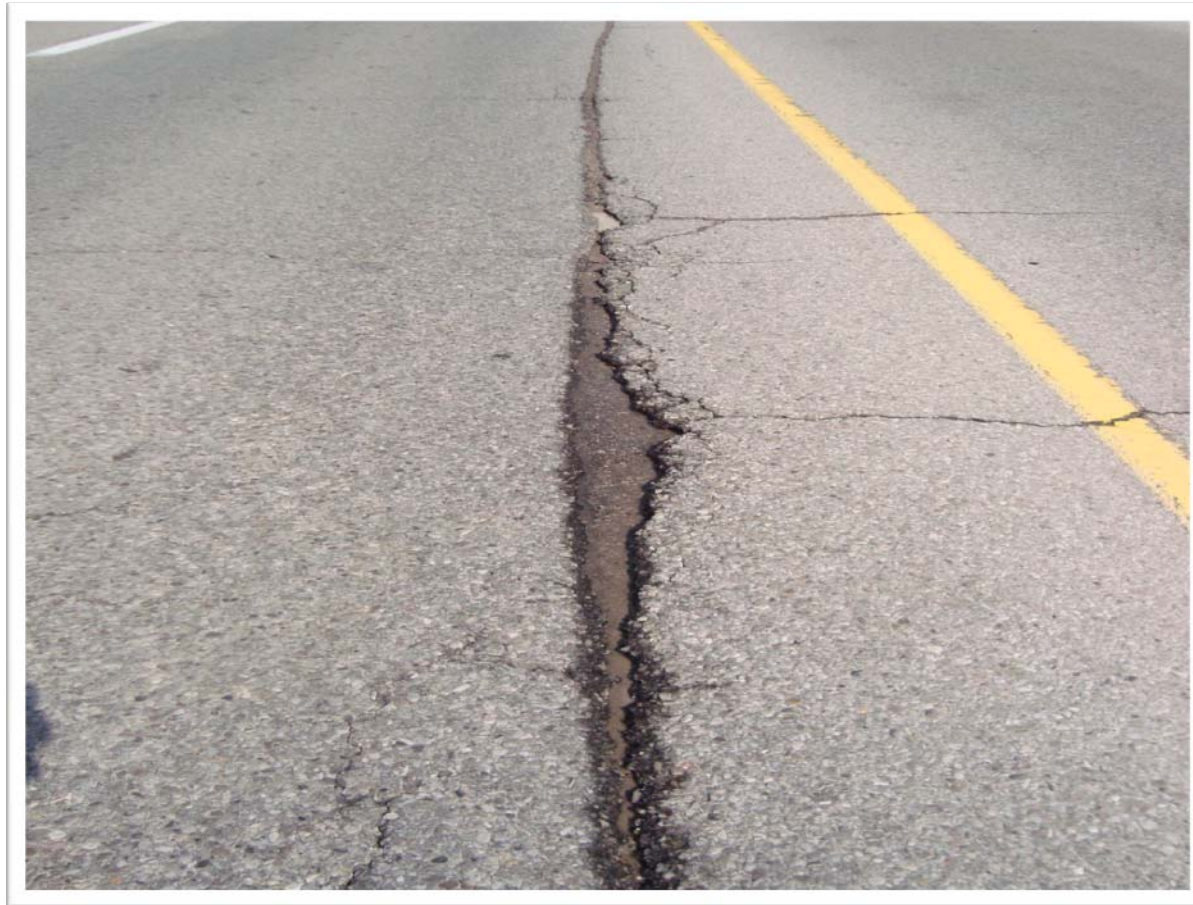
The traditional repair, the mill and fill method. It leaves a crack on either side, and explains this repair lasting only 4 years!

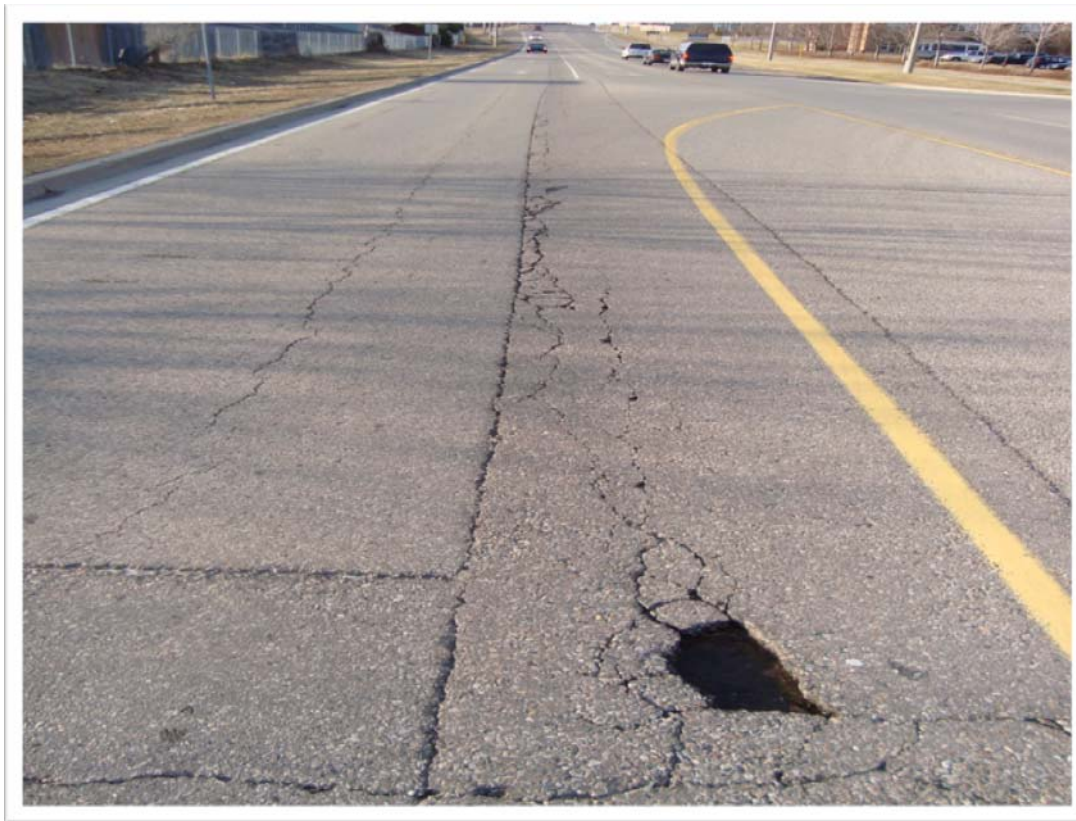
INFRARED LONGITUDINAL JOINT REPAIR

*Major Mackenzie & Hwy 400, Toronto,
2004*

- 2100' of unacceptable joint
- reheated with infrared
- material removed and replaced
- extended one year warranty provided by contractor
- after warranty period 20 feet required to be redone
- previous joint repair could not be easily identified
- **TODAY YOU CAN'T FIND THE JOINT!**

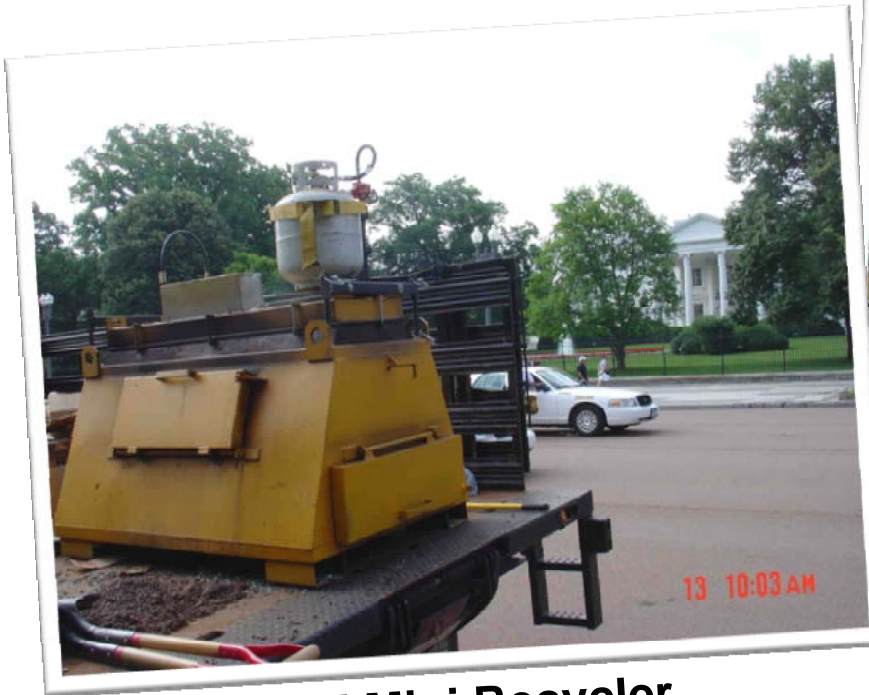
MR75 Mini Recycler
100,000 Btu infrared heater over
a 2" screen deck
Heated fresh material to be added to
failed joint

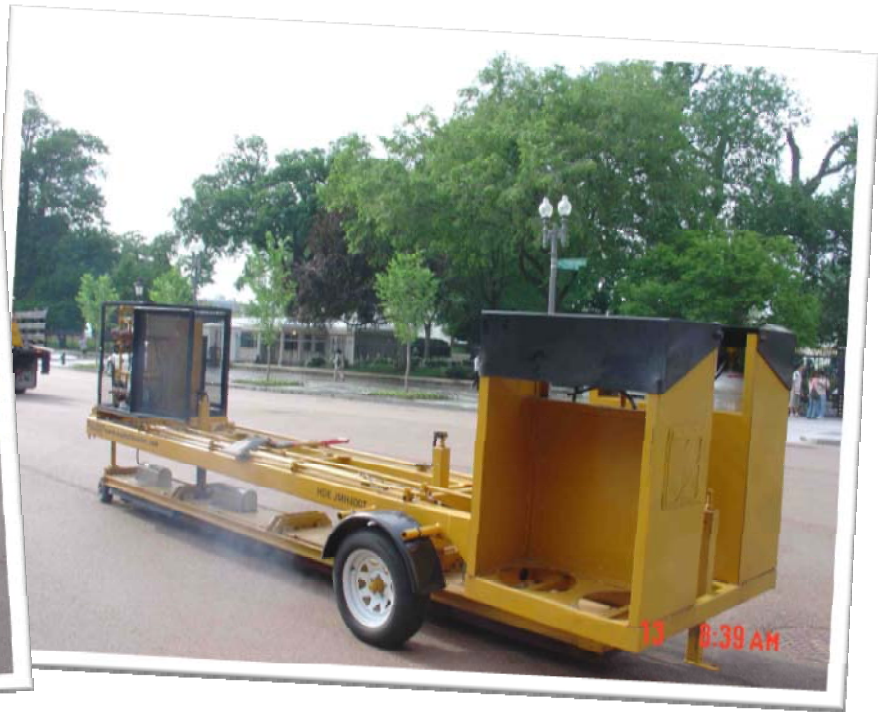
JMH 400T, 400,000 Btu
Heated joint for pre-set time
Monitored temperature closely
Synthetic resin binder stickier,
lower burn point than conventional
Turned black easily if overheated

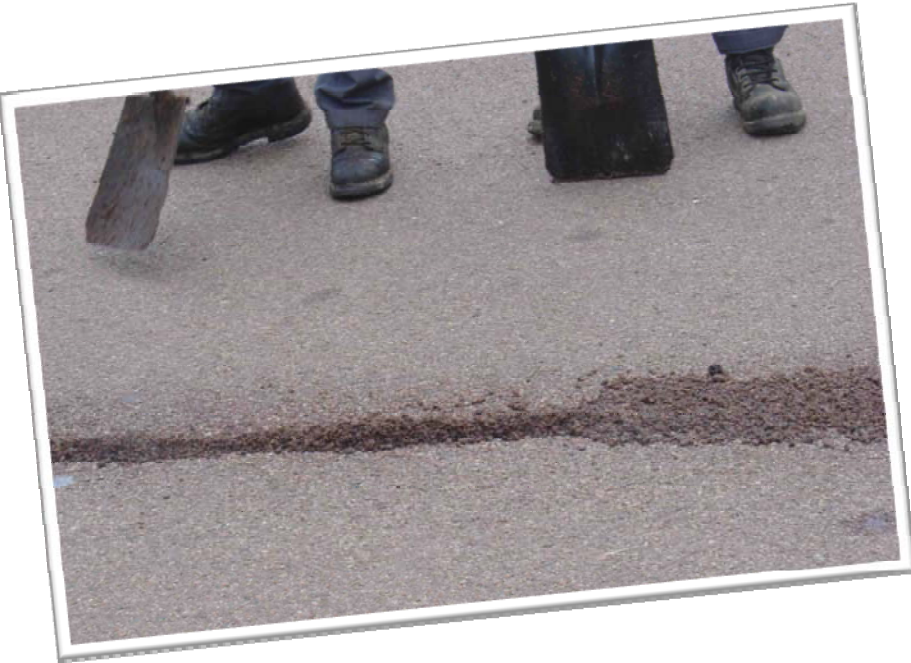
Heated fresh material is added to the heated deteriorated joint

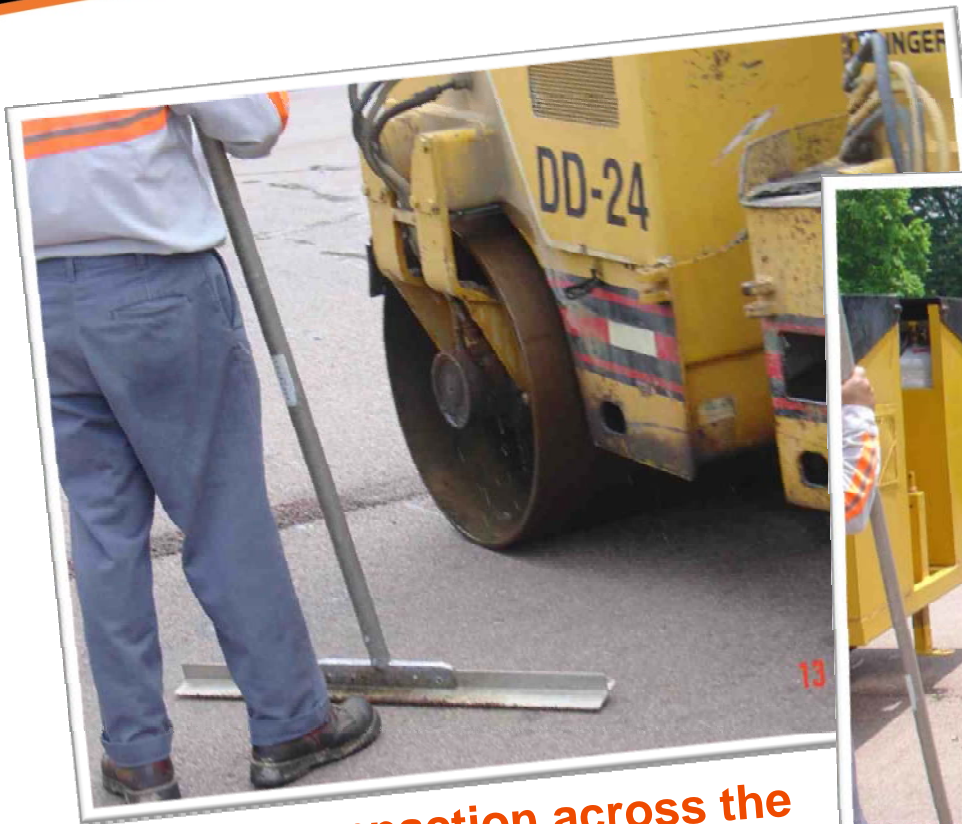
Vibratory compaction across the
joint
DD24 Dual Drum by Dura Pac

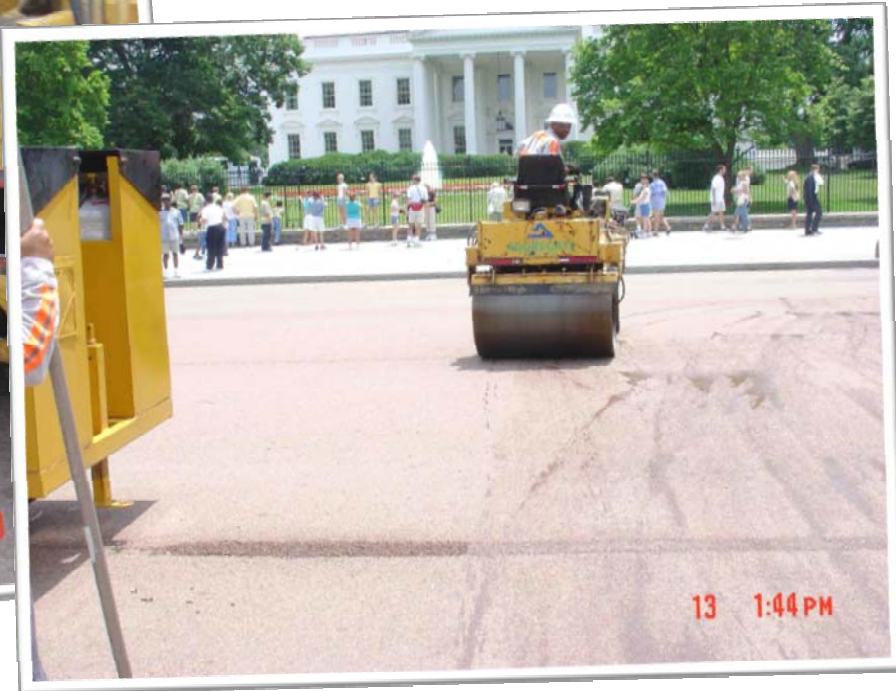
Compaction occurred close behind
heater
