USE OF INFRARED HEATERS IN ASPHALT PAVEMENT CONSTRUCTION & REPAIR

2013 SWIFT CONFERENCE
OTTAWA, CANADA
SEPT 10, 2013
Bob Kieswetter P. Eng

USE OF INFRARED HEATERS IN AIRPORT PAVEMENTS

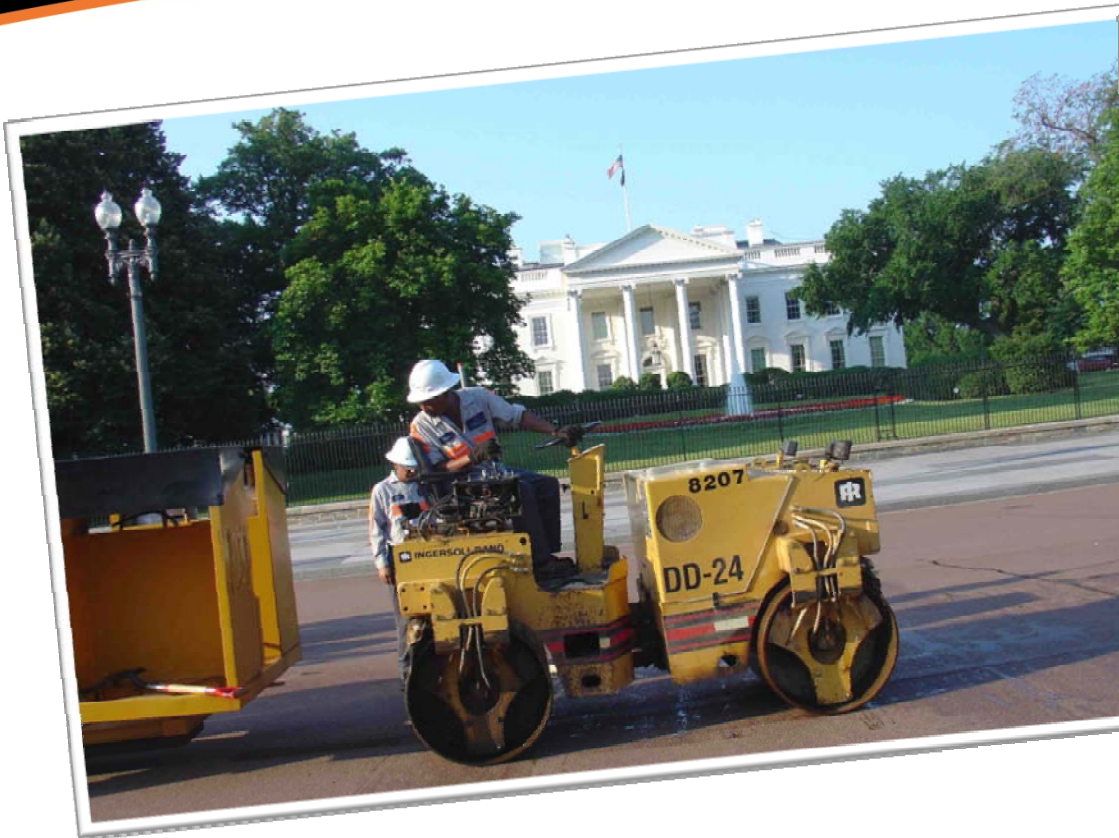
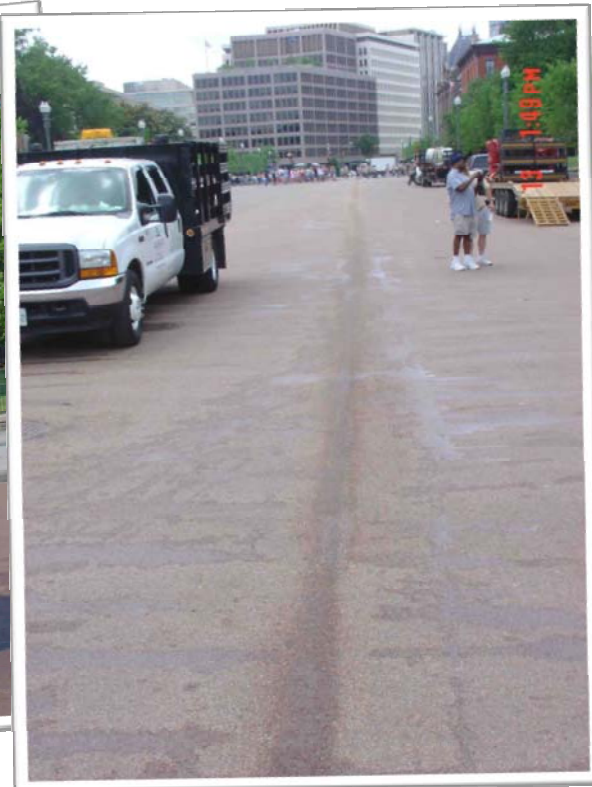
**Final compaction along joint for smoothness
Federal Highways accepted the job and contractor got his money**

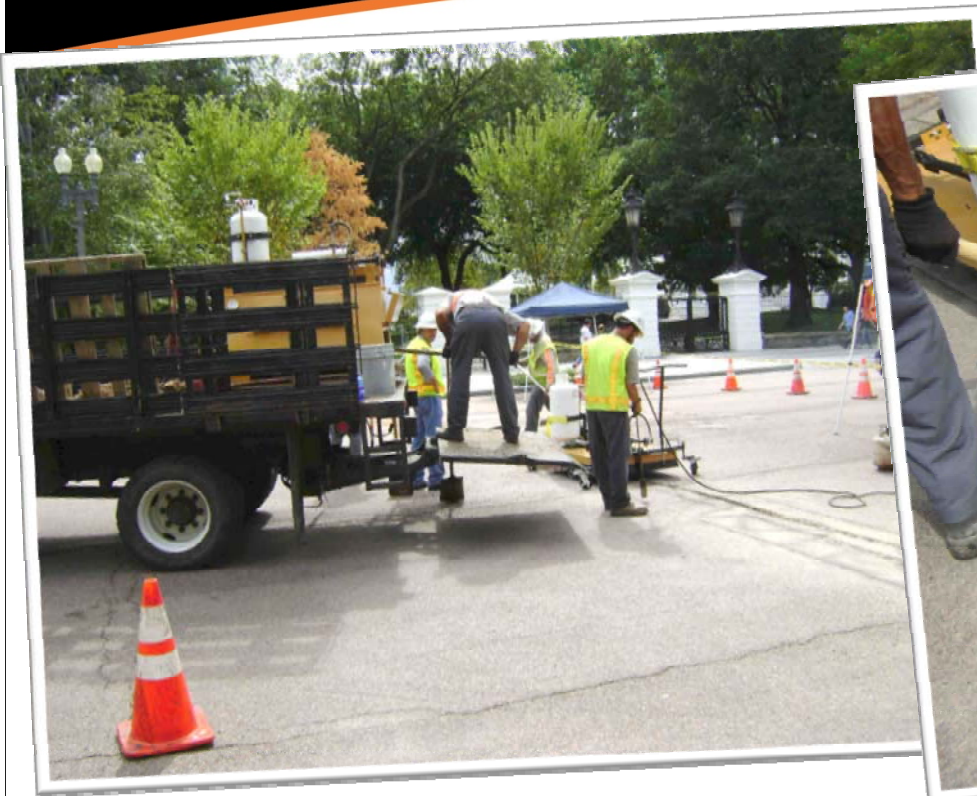
Engineers specified saw-cut 36 inches wide centered on crack

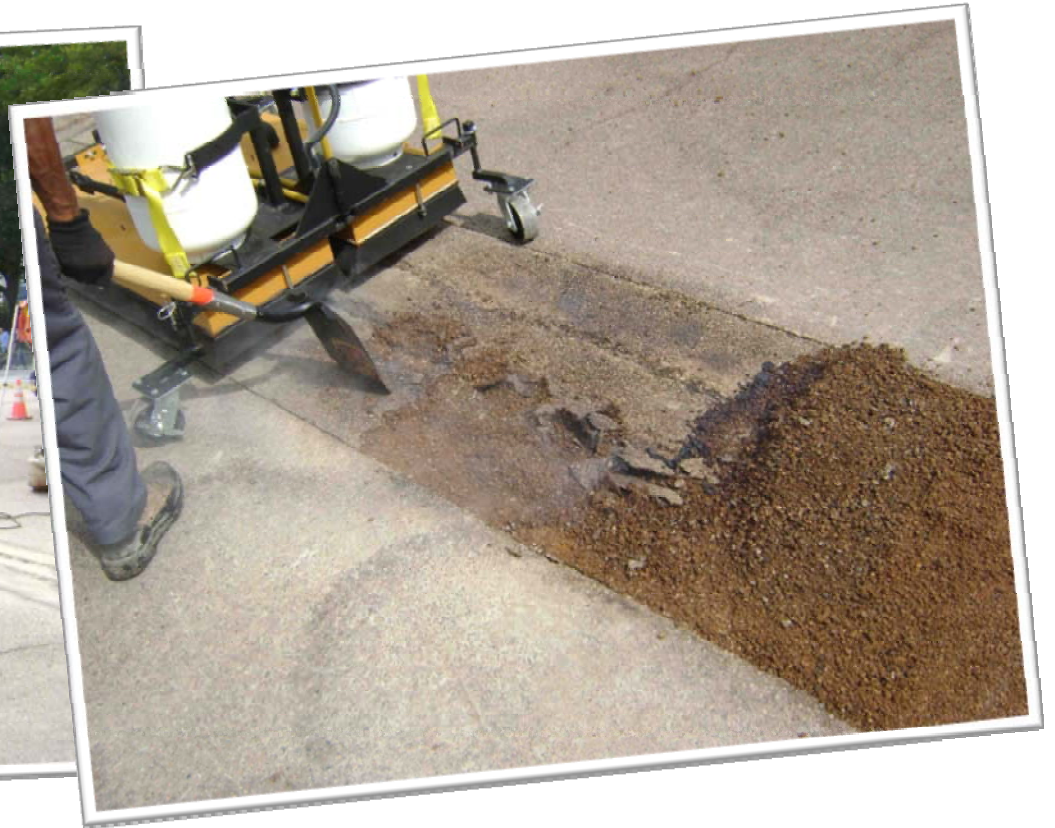
36" cut area then heated, then scarified to 1 inch

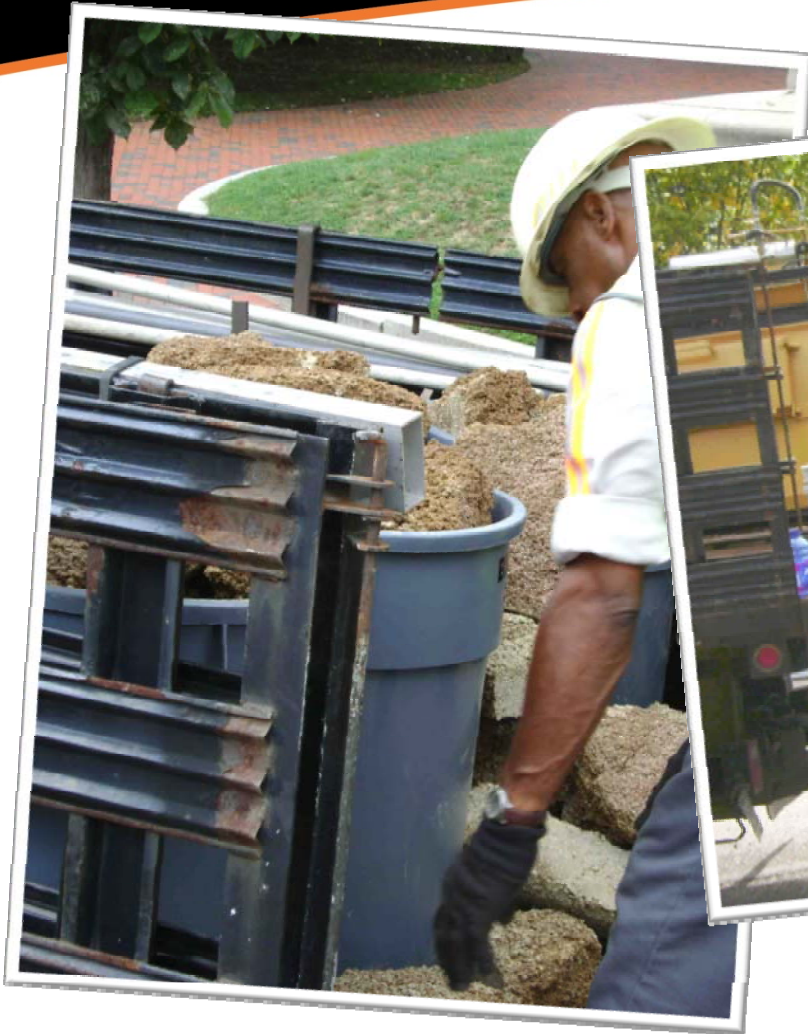
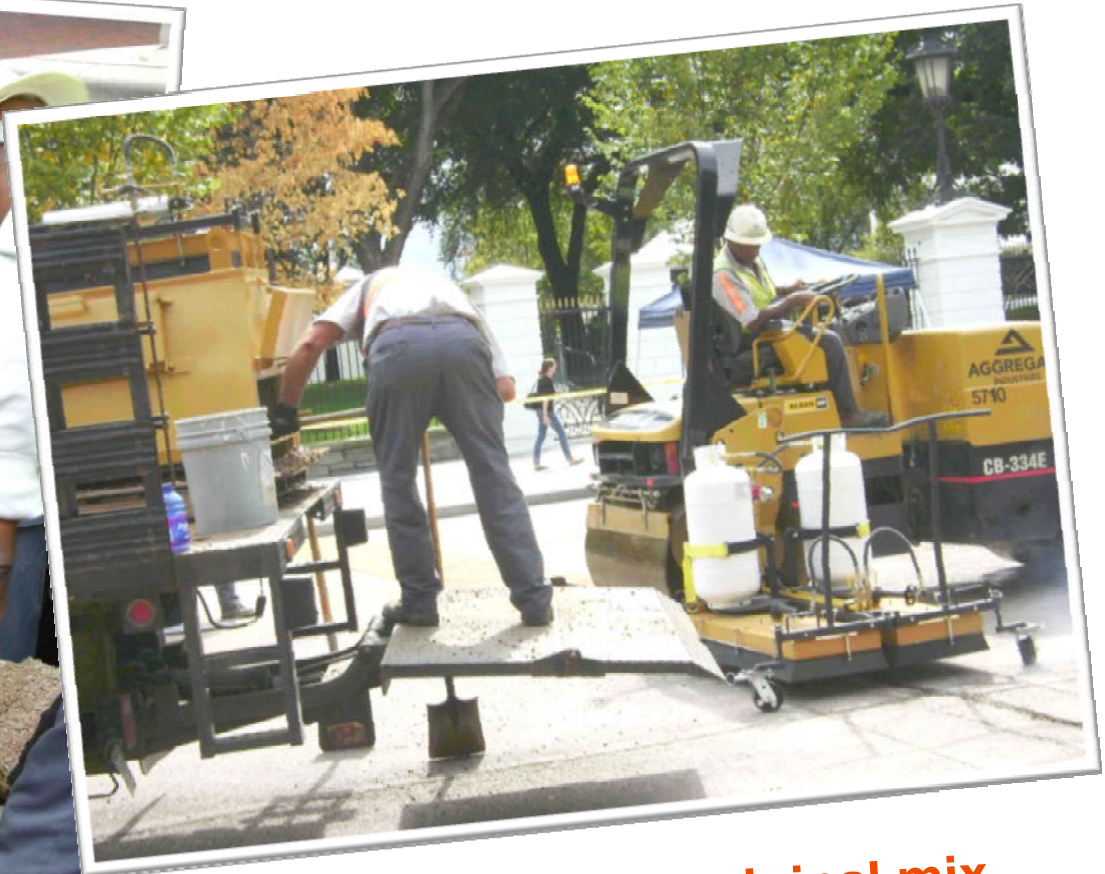
Fresh mix from original mix design is loaded into infrared recycler where it is re-heated

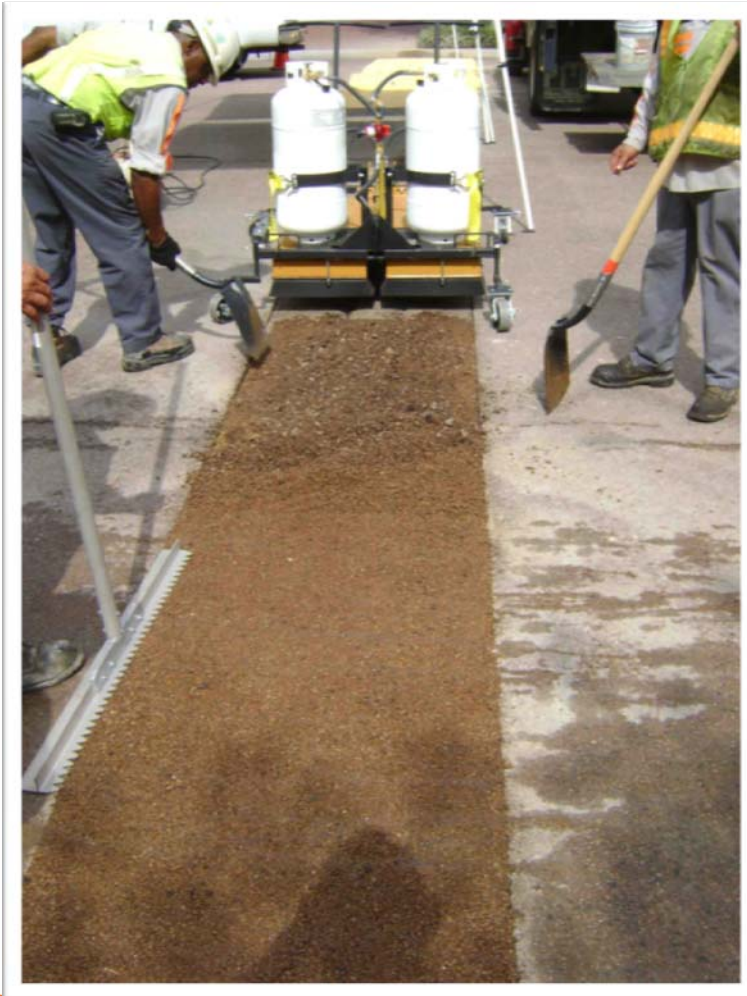
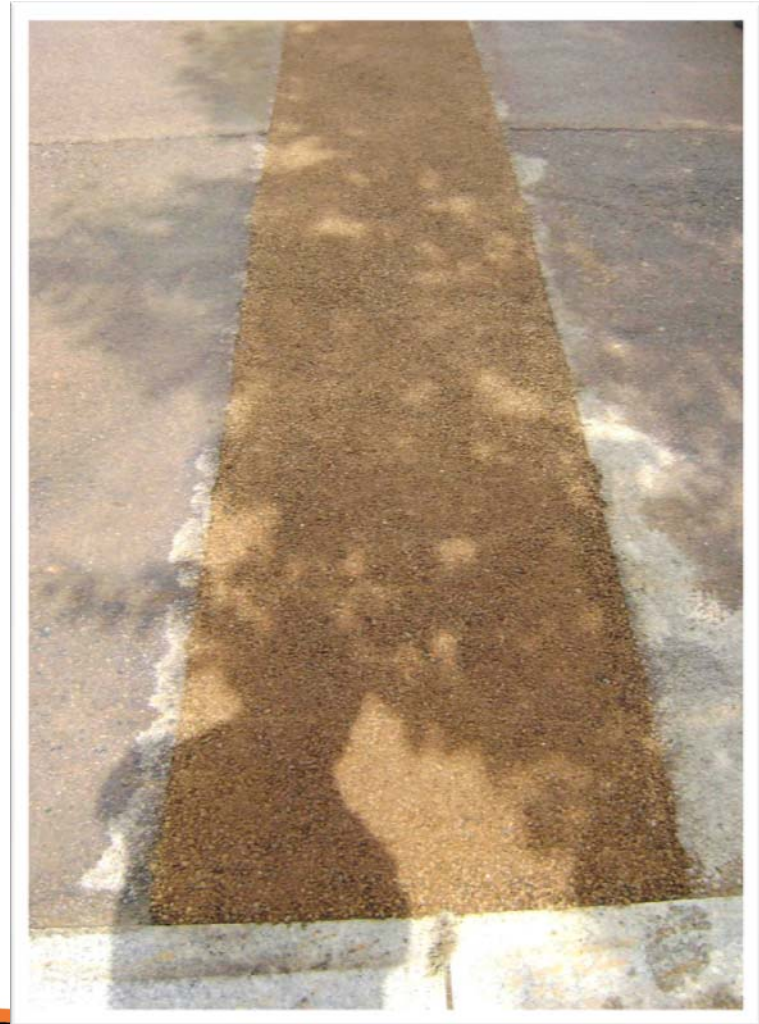
Then placement, luting, compaction
THEN ON TO THE PARADE!

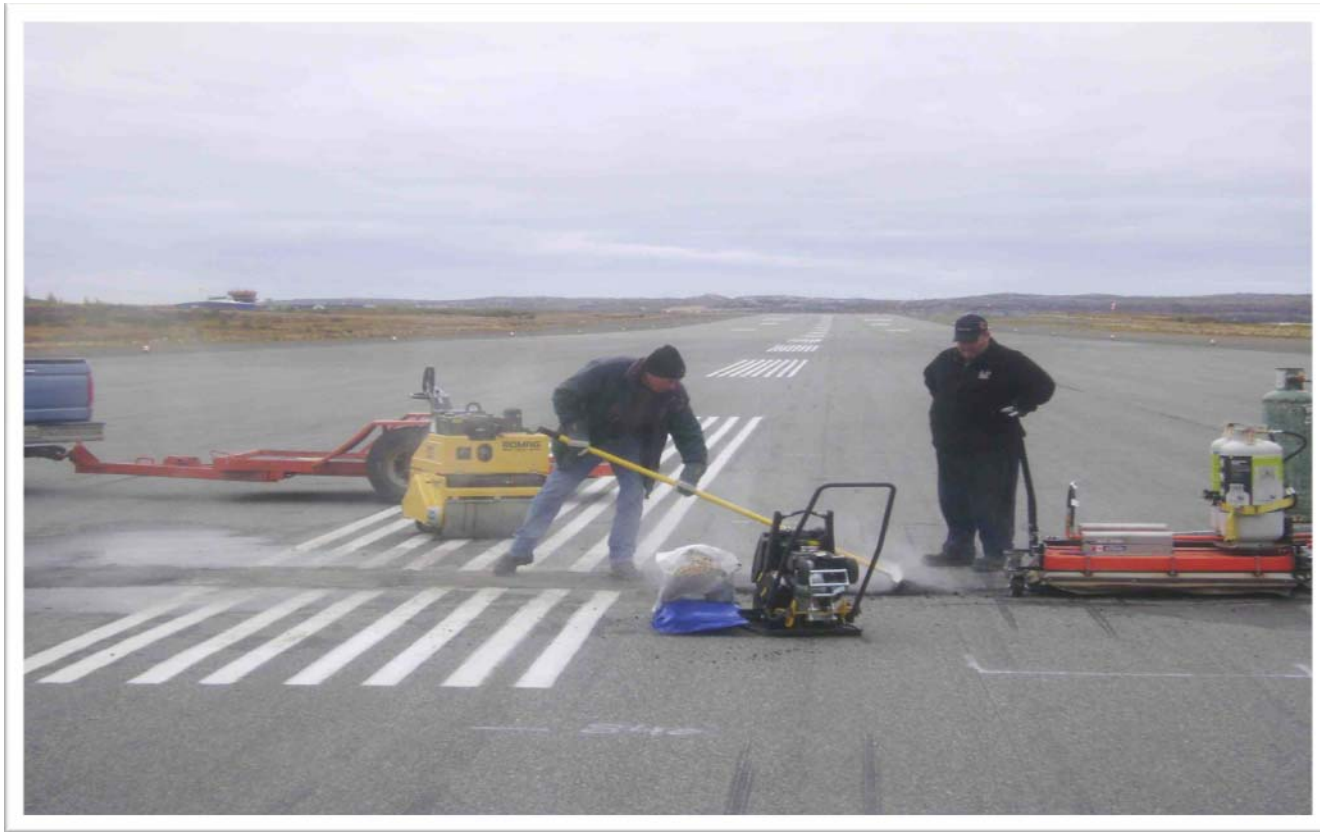
**Crack Repair at bottom end of runway
4'x3' Infrared heater, 200,000 Btu**

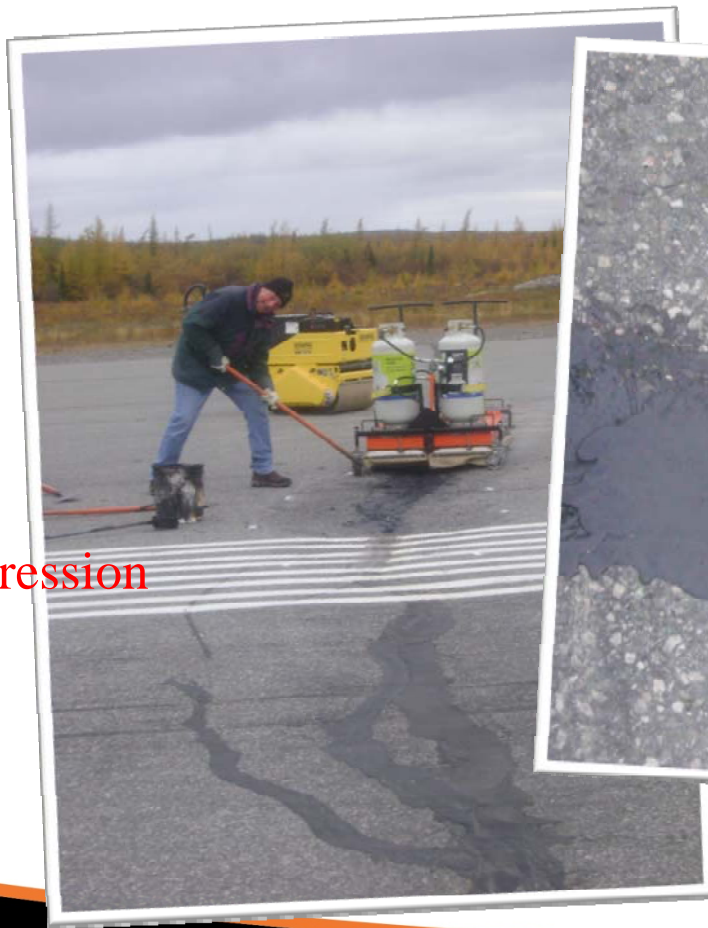
**First Challenge: Remove heavy lift of crackfiller
Heated with infrared heater for 2-3 minutes to gooiness
Scraped with Ice Scraper**

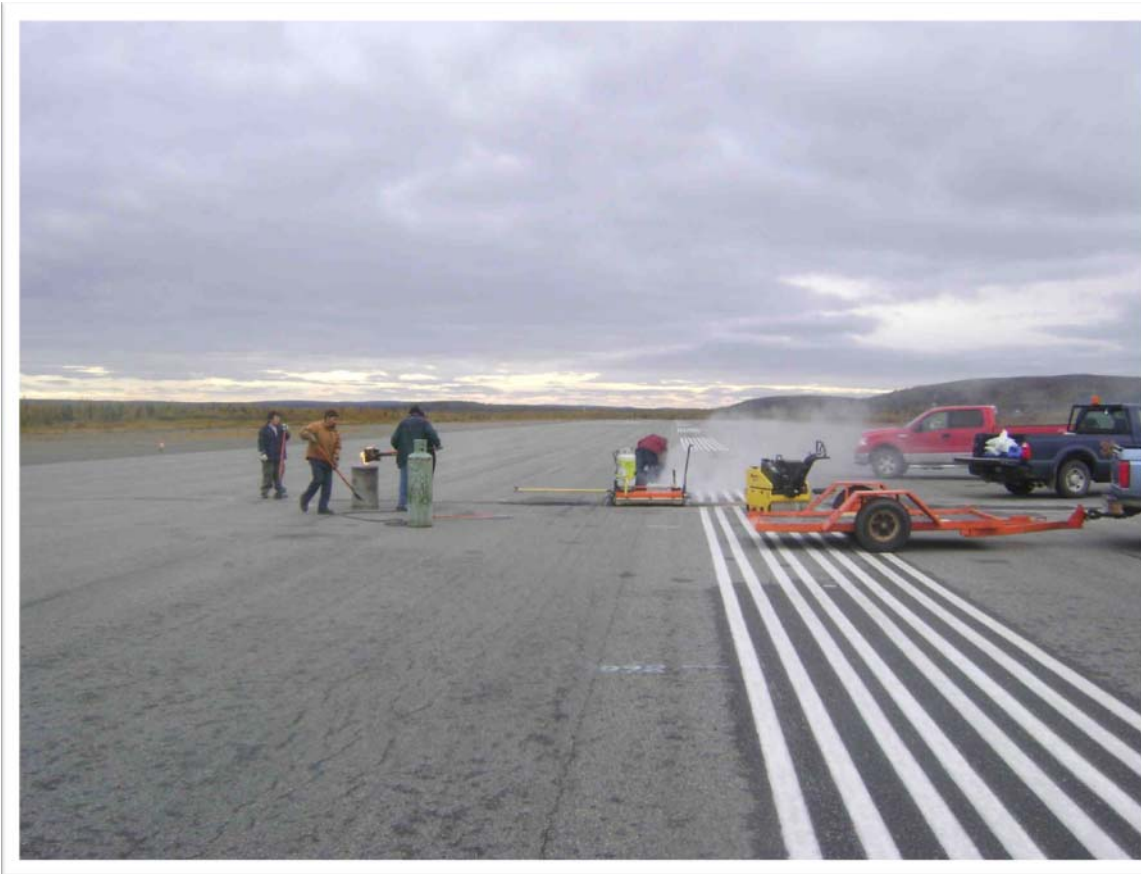
Removing crack filler from scraper impossible,
used a torch and melted into a 45 gallon drum
Next heated crack area to 2-2/2 inches and scarified

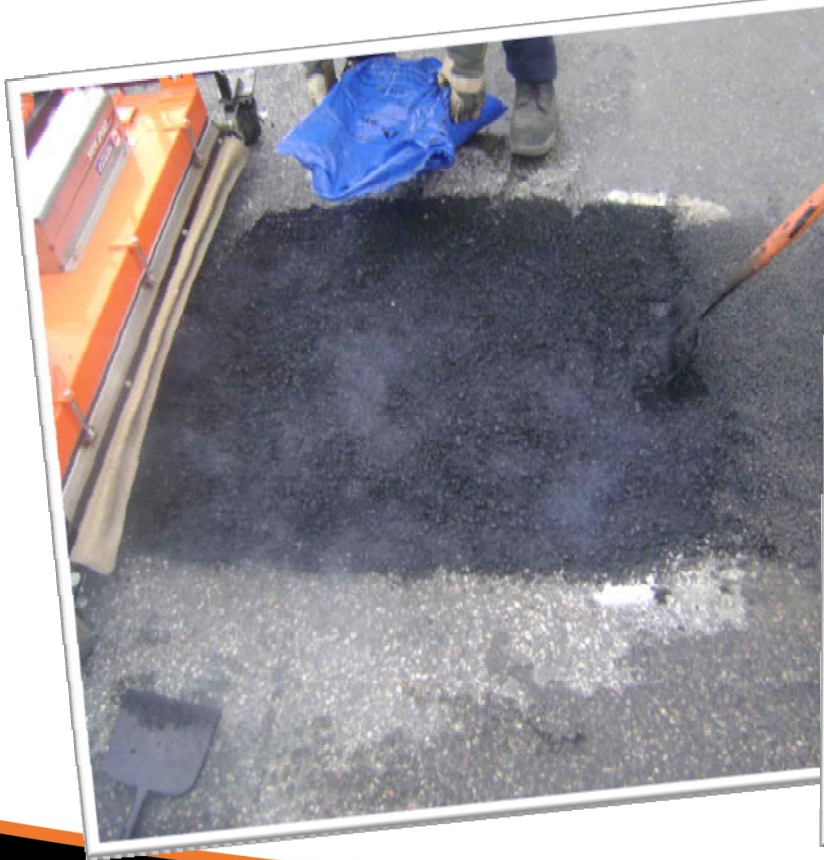
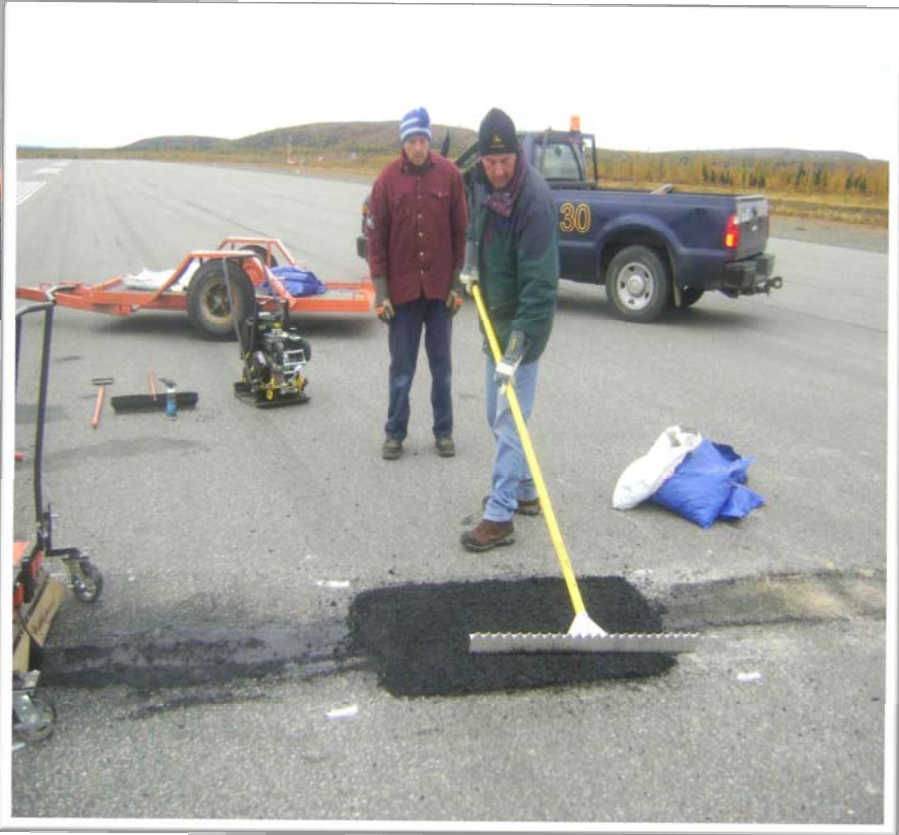
**Hot Mix Asphalt is available every 3-4 years when a plant is shipped in.
Instead we used bagged 3/ 8"(10mm) cold mix, sprinkled on,
scarified material, luted level**

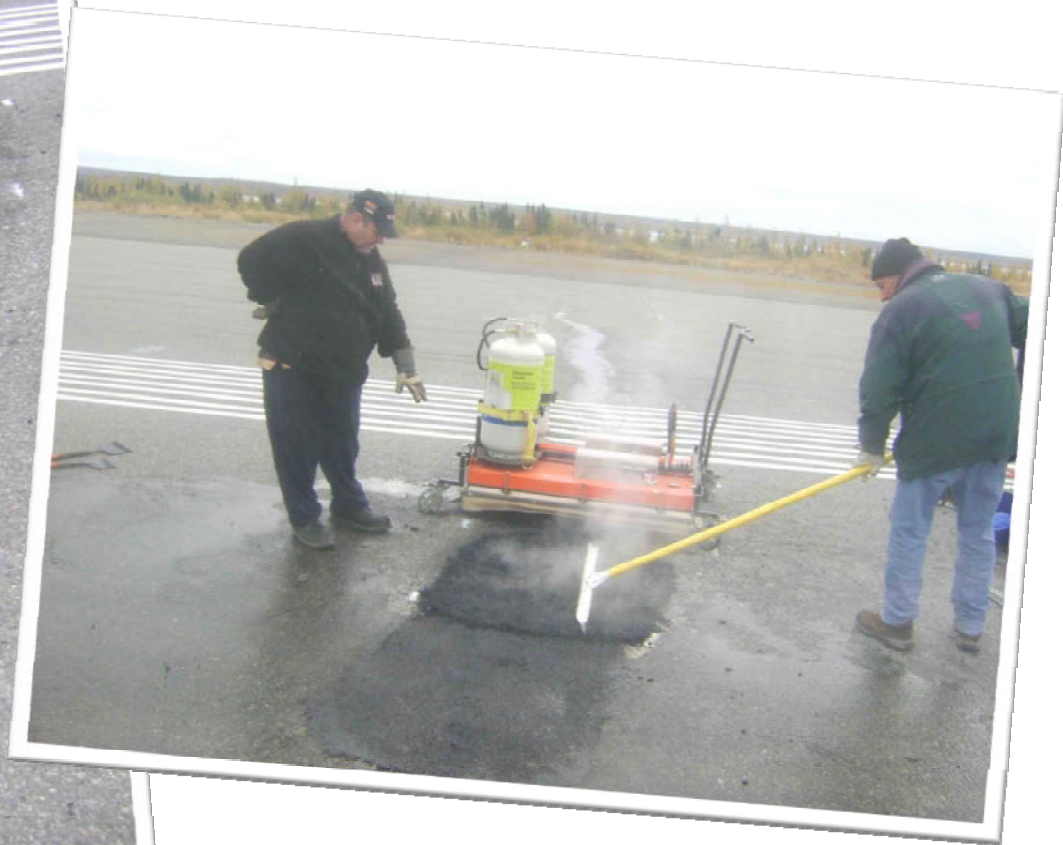
Cold Mix was then compacted lightly to tighten surface for heating
CAUTION: loose material does not transfer heat, so easily overheats

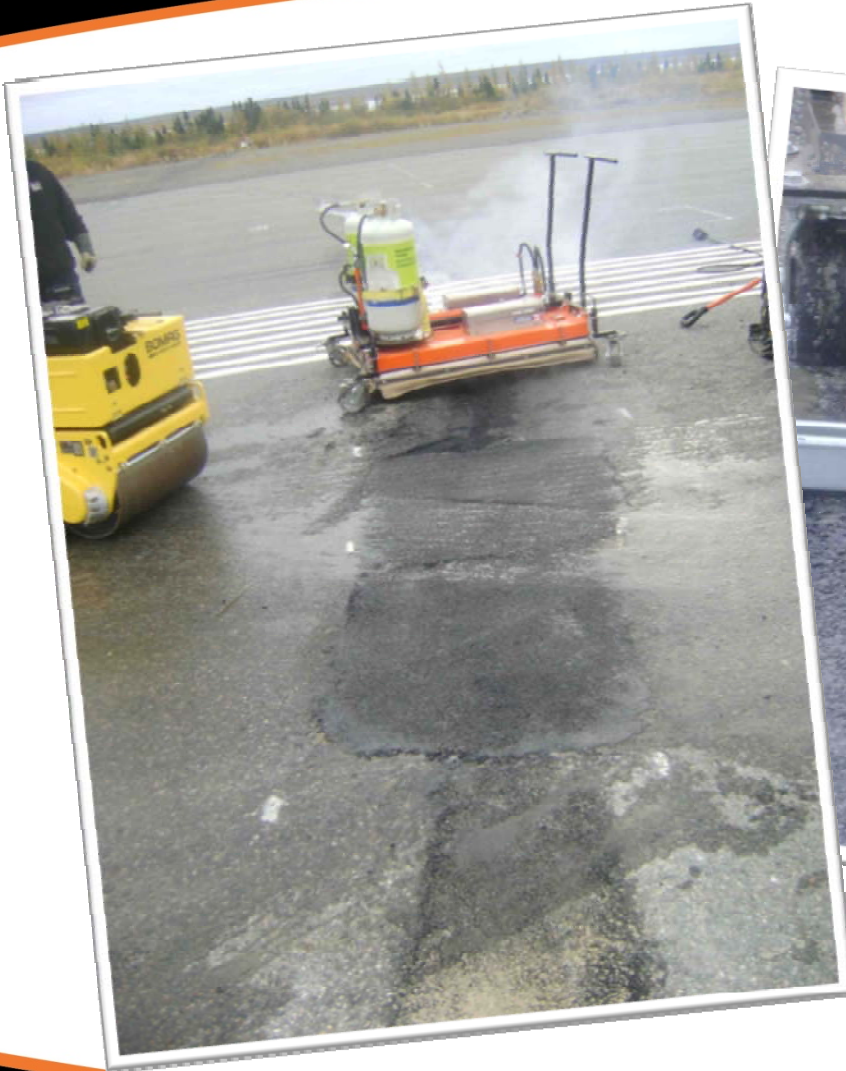
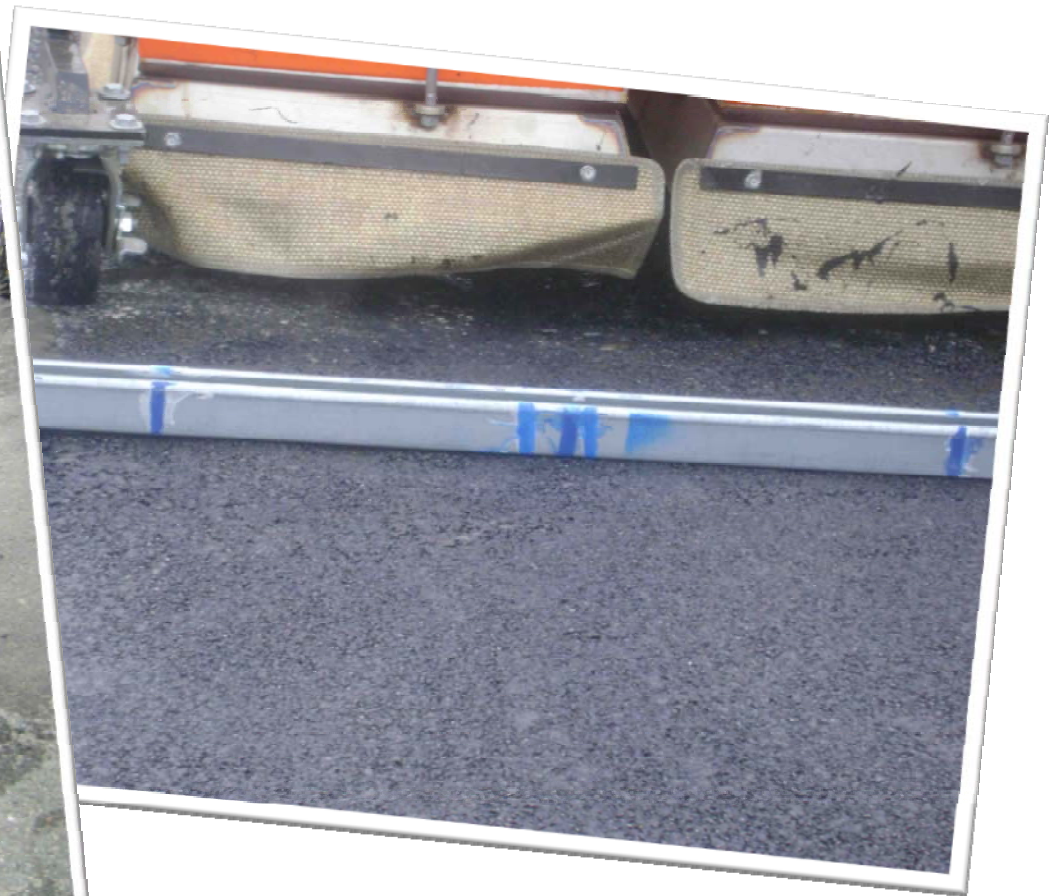
Level Check across crack

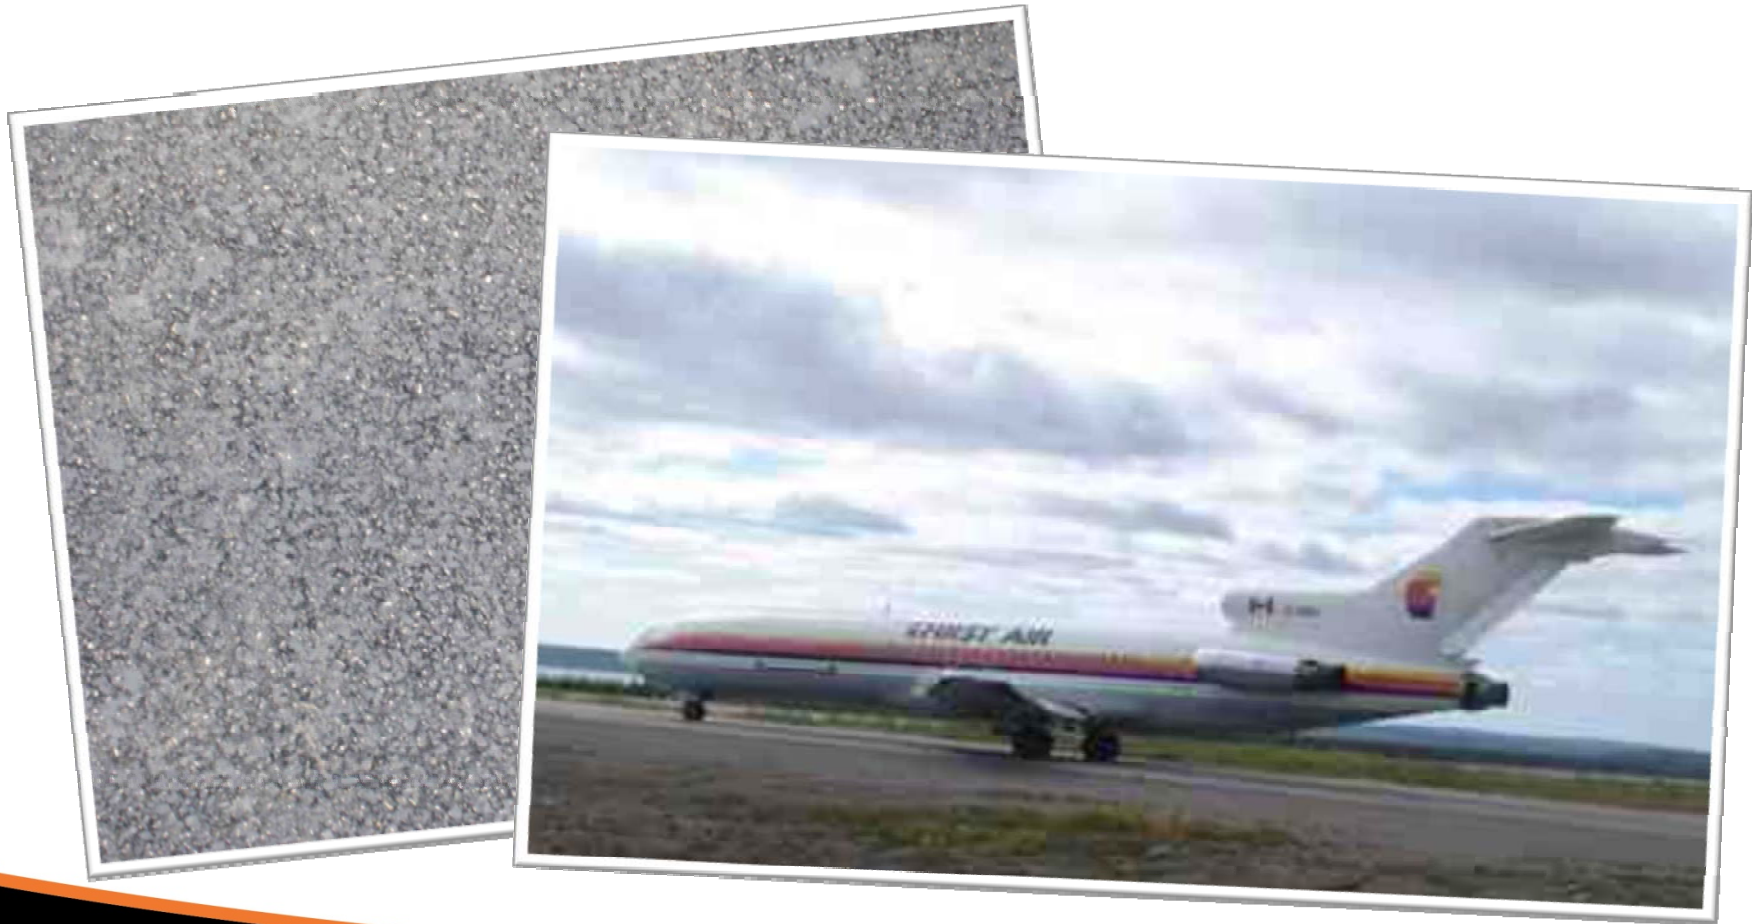
Finished Surface: withstood 747 landing 30 minutes later

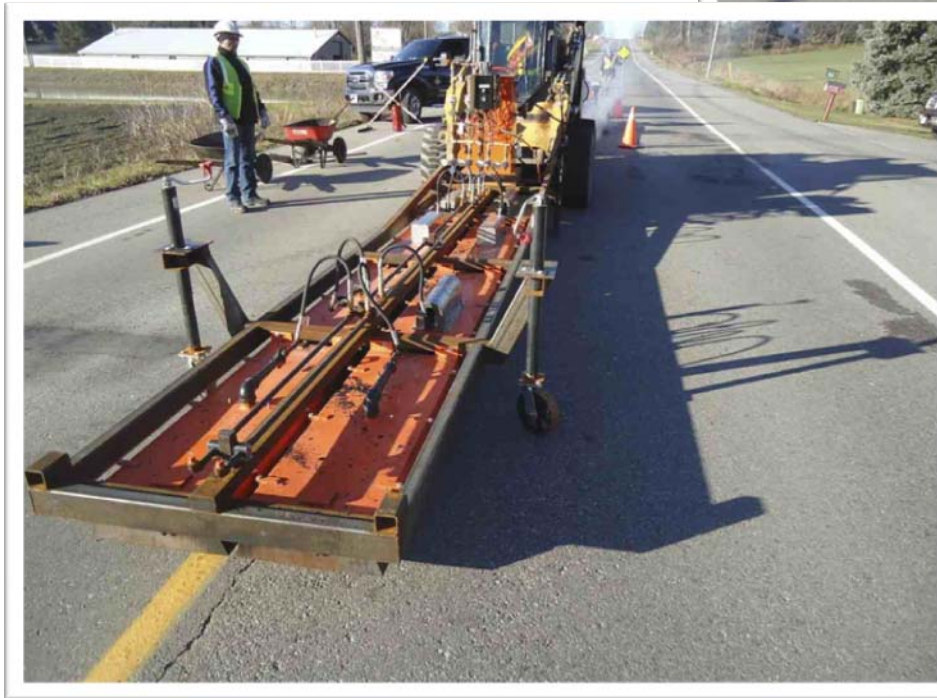
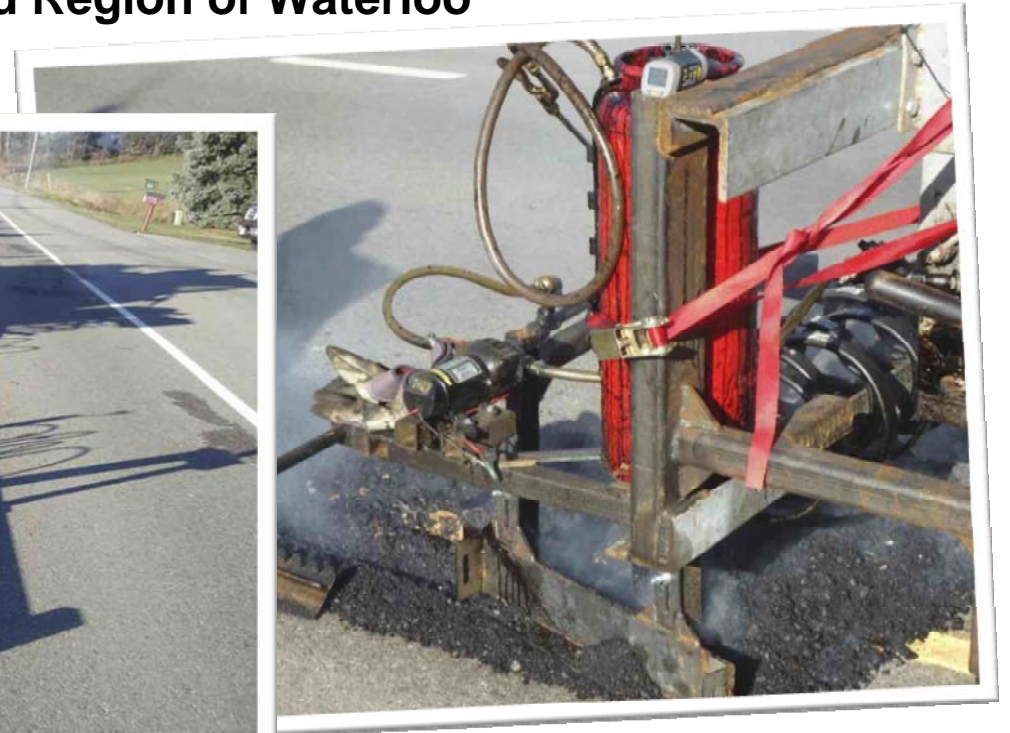
Longitudinal Joint Heater/Scarification & Repair Bleams Rd Region of Waterloo

- **Speeds of 1.5-2 meters per minute**

**Presentated as successful
by Dr Ludomir Uzarowski
of Golder Associates at
TAC 2011 in Edmonton**

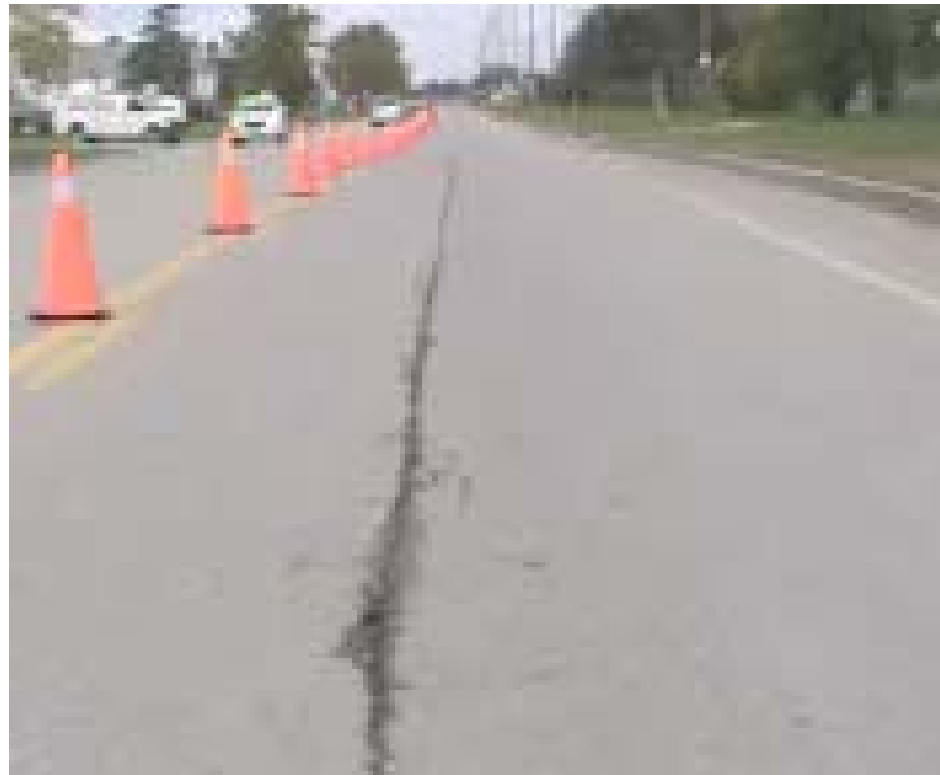
Longitudinal Joint Repair at 5 ft/minute

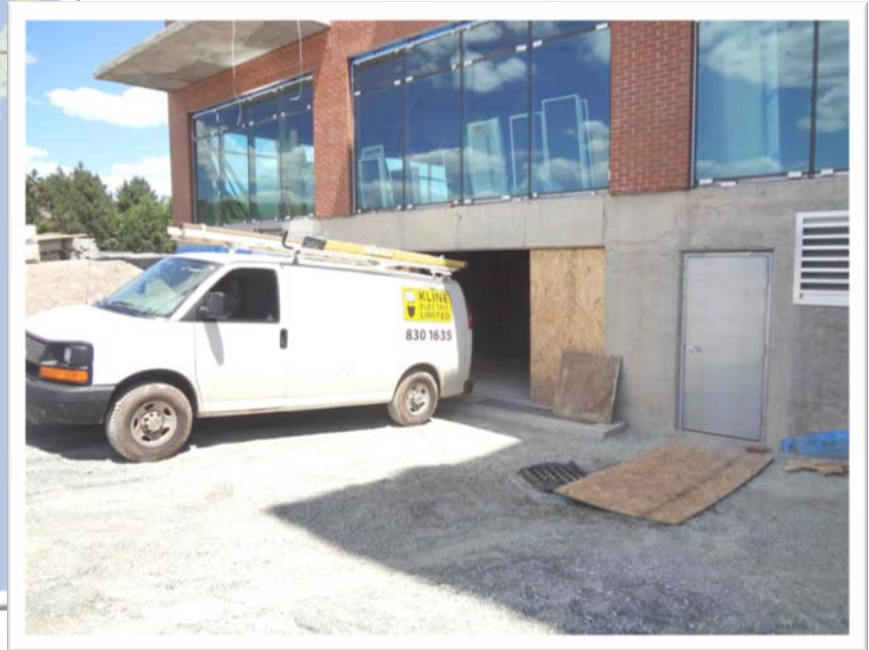
**Provident Parkade,
Halifax, NS,**

**Access to basement minimal
Asphalt carried in by bucket
Slow process cooled asphalt
Poor compaction of asphalt**

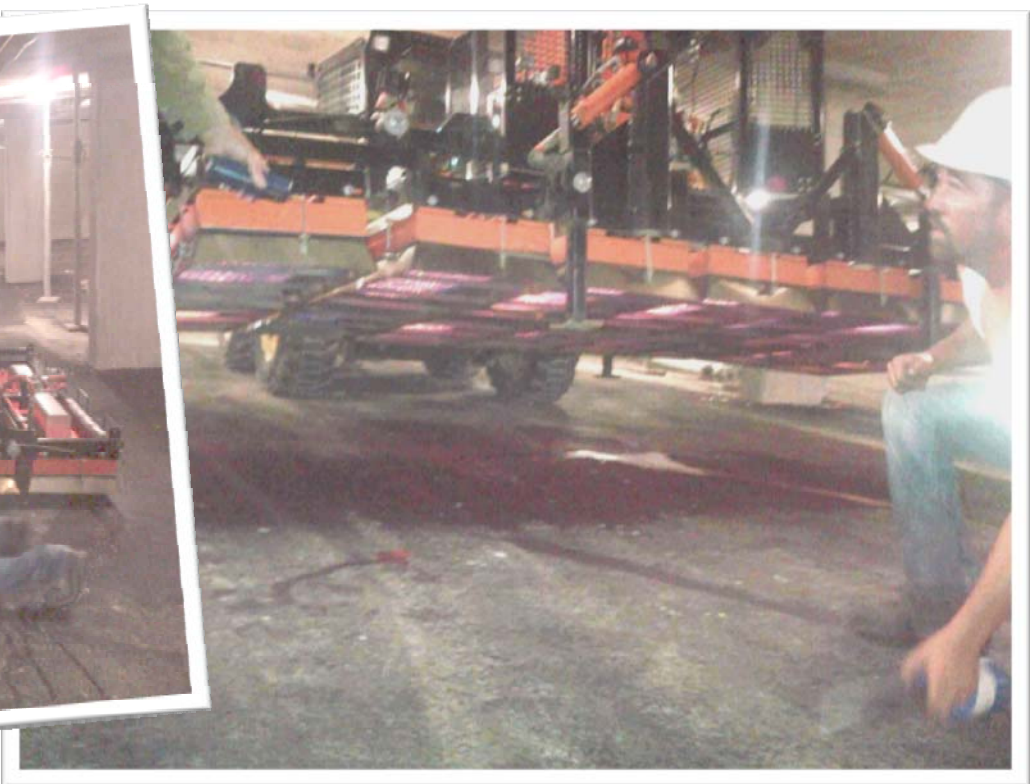
Check asphalt temperature with infrared gun

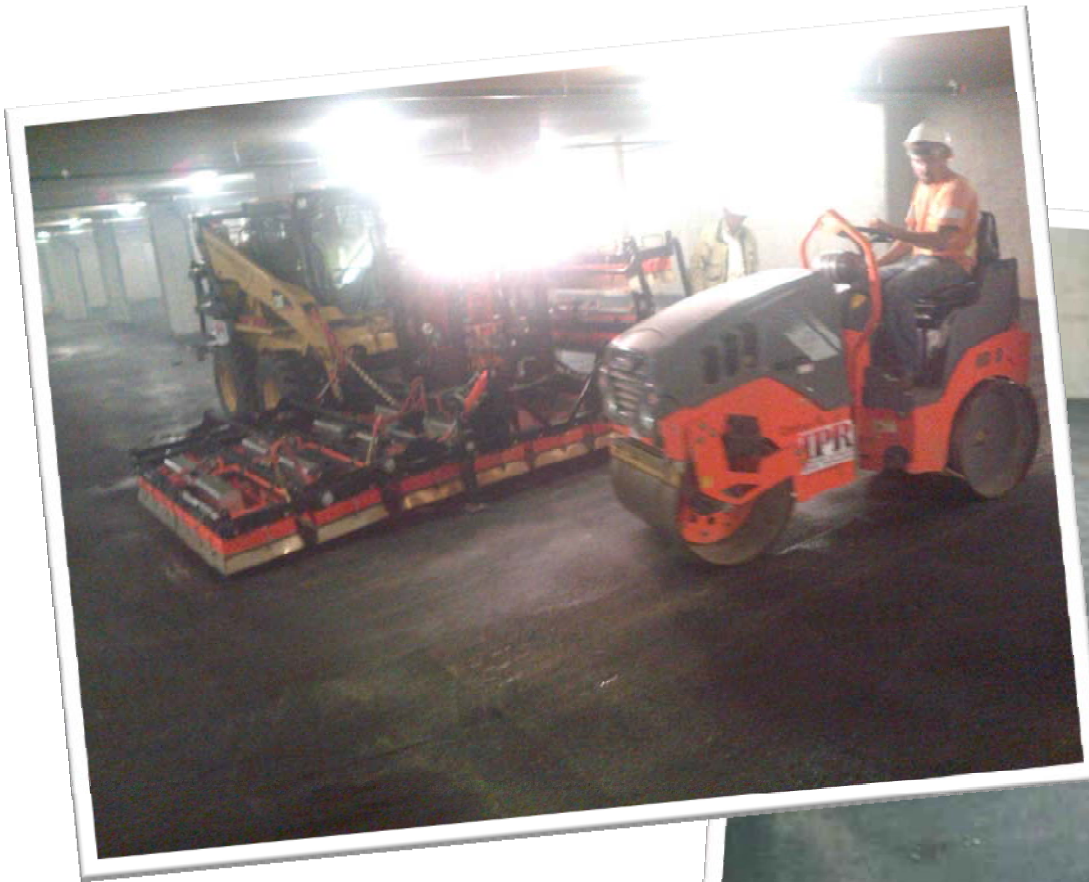
Compaction close
behind heating

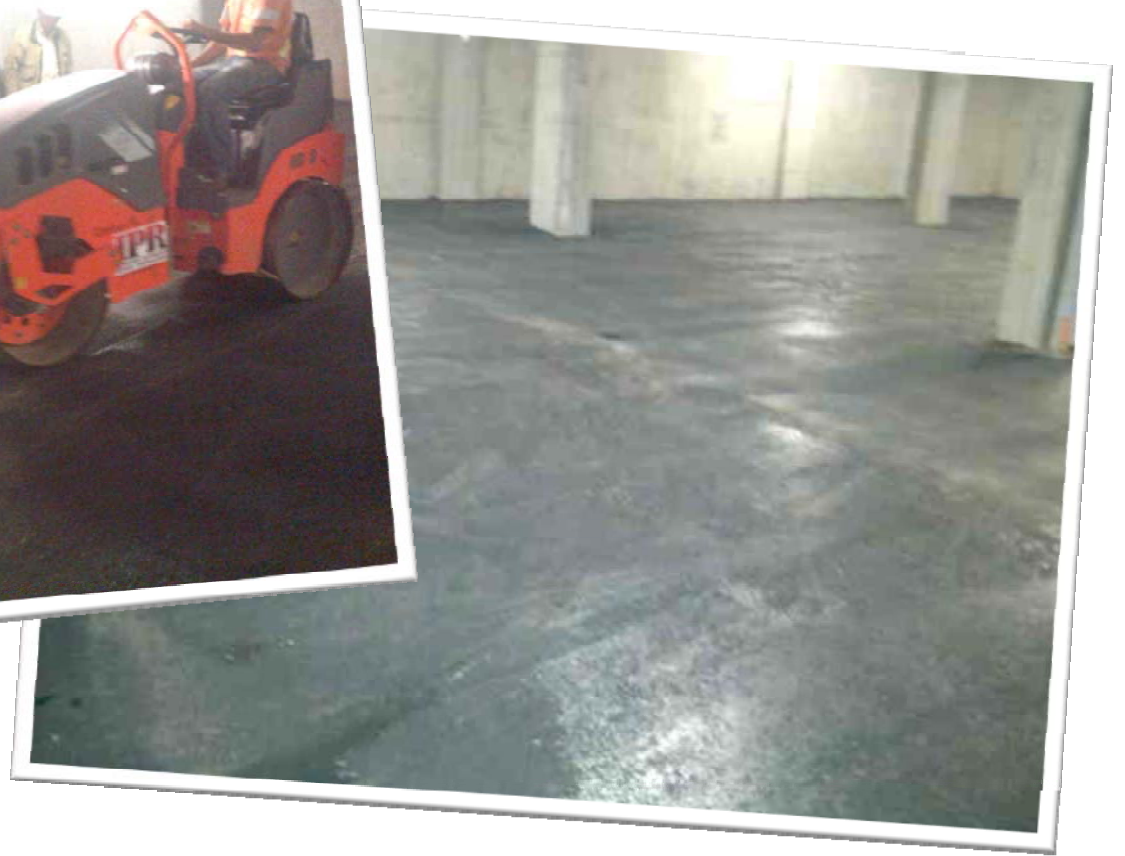
- INFRARED PRODUCES CARBON MONOXIDE
- Important to monitor CO while running heater inside
- Make sure to supply extra ventilation
- No problem till gas pressure washer used
- Required shut down to clear air

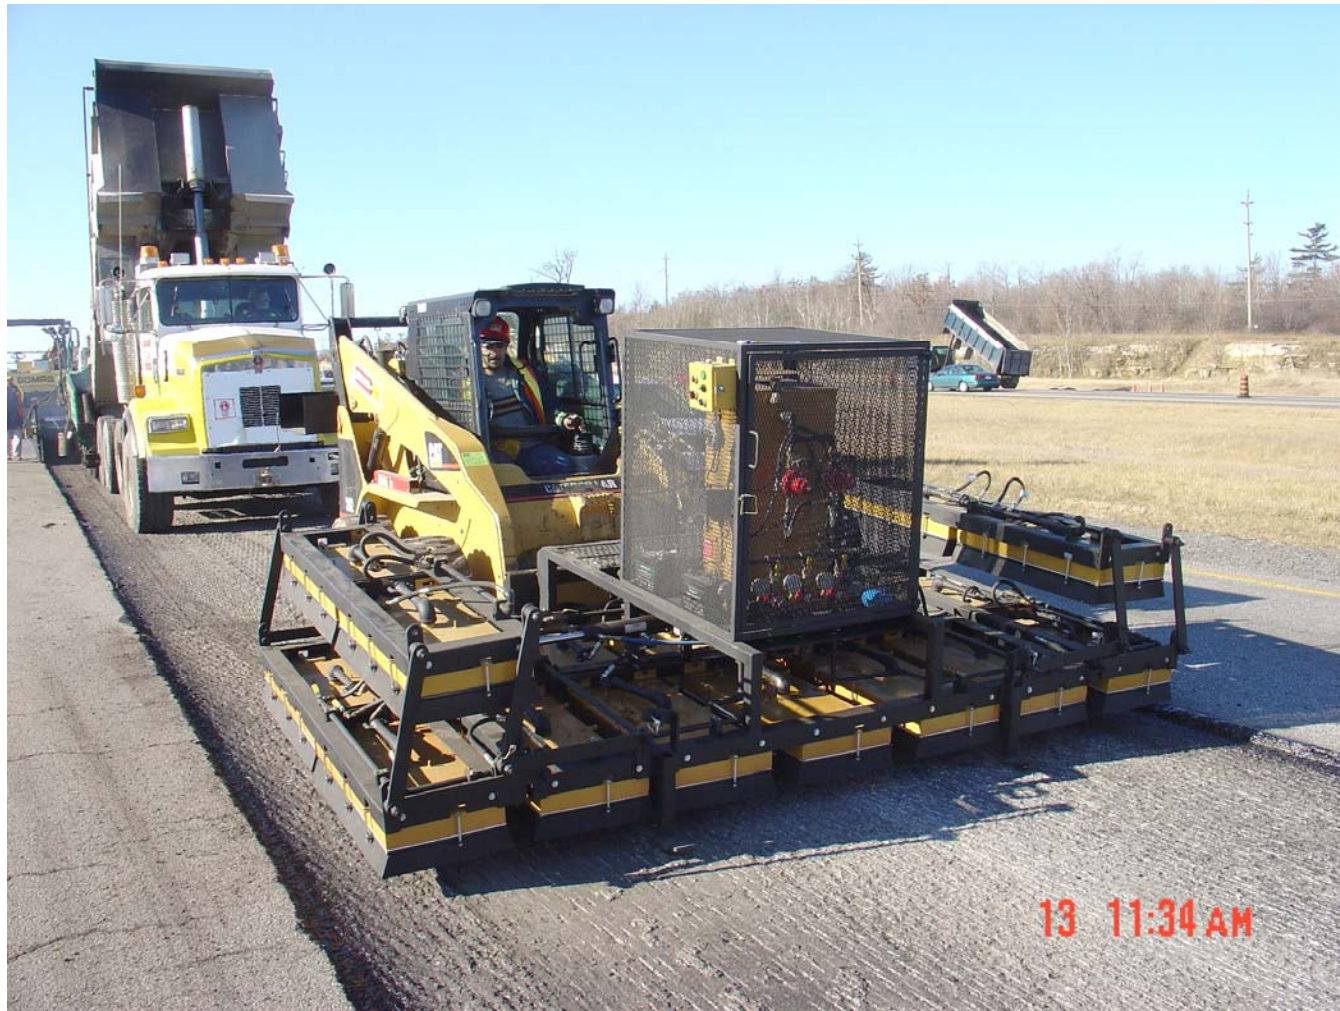
Nov 2004, Highway 417, OTTAWA, Canada

Paving temperature 23F, asphalt base heated to + 60F at 35 ft/min.

Temporary emergency mill and fill project turned into permanent lane replacement.
