USE OF INFRARED HEATERS IN ASPHALT PAVEMENT CONSTRUCTION & REPAIR

2013 SWIFT CONFERENCE
OTTAWA, CANADA
SEPT 10, 2013
Bob Kieswetter P. Eng

USE OF INFRARED HEATERS IN AIRPORT PAVEMENTS

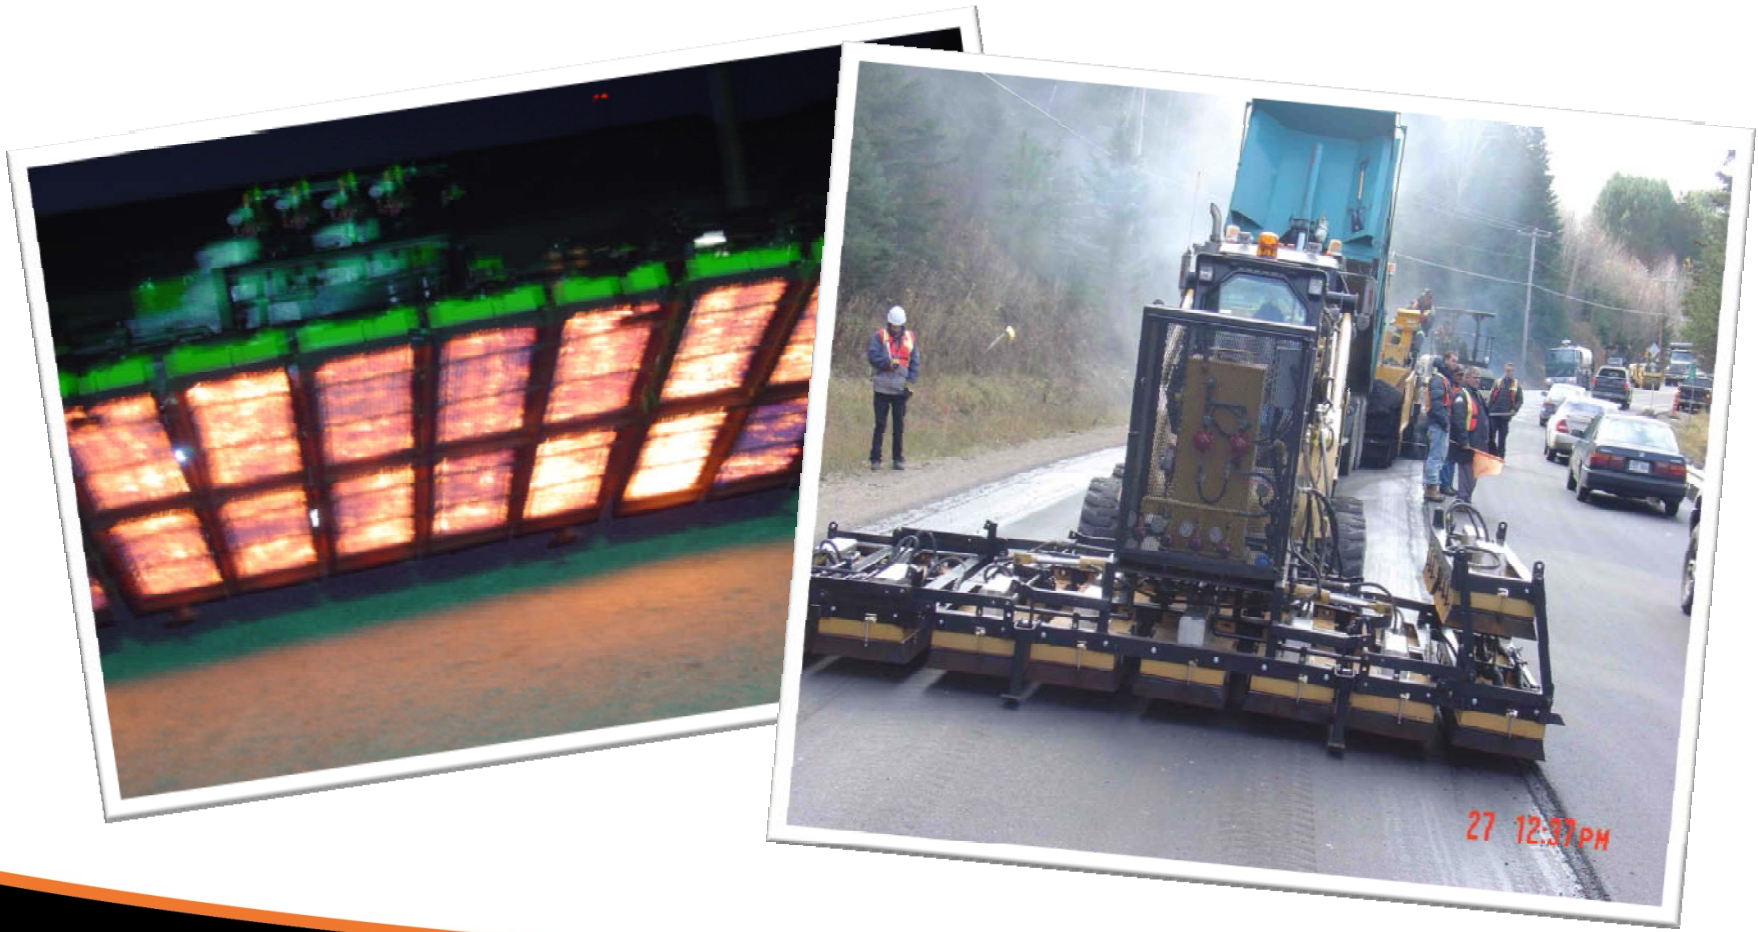
PRE-HEAT BASE ASPHALT TO MEET TEMPERATURE REQUIREMENTS
November 27, 2006, La Tuque, Quebec, Canada

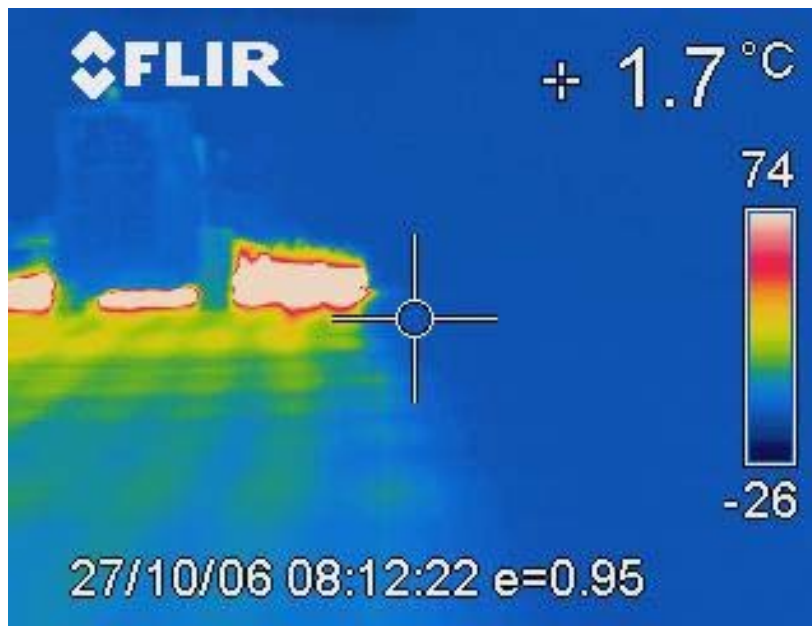
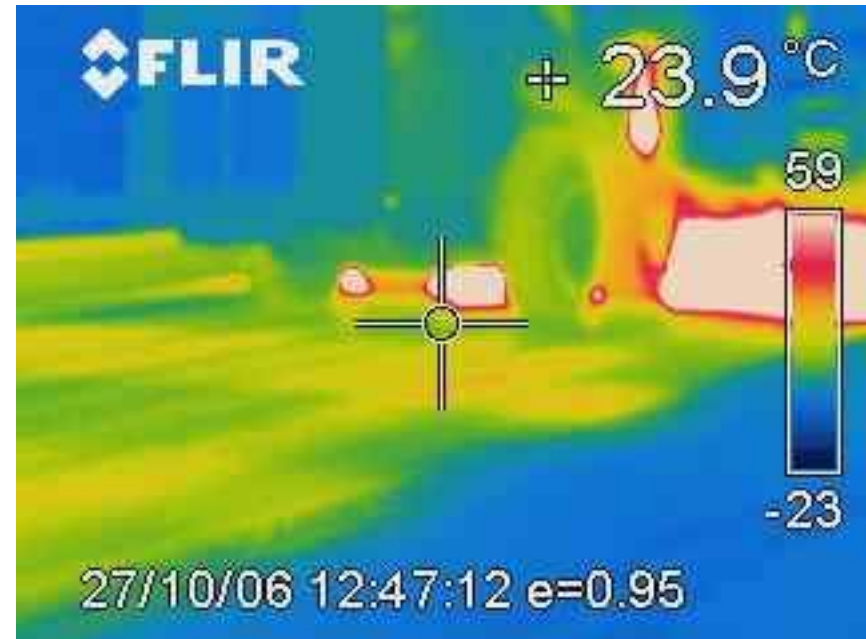
LaTuque, Quebec, Canada
paving speed 35 ft per min

- Upper left pavement temp 1.7C (35F)
- Middle right 23.9 C (75F) behind heater
- Lower left 13.8C (56.8F) in front of paver

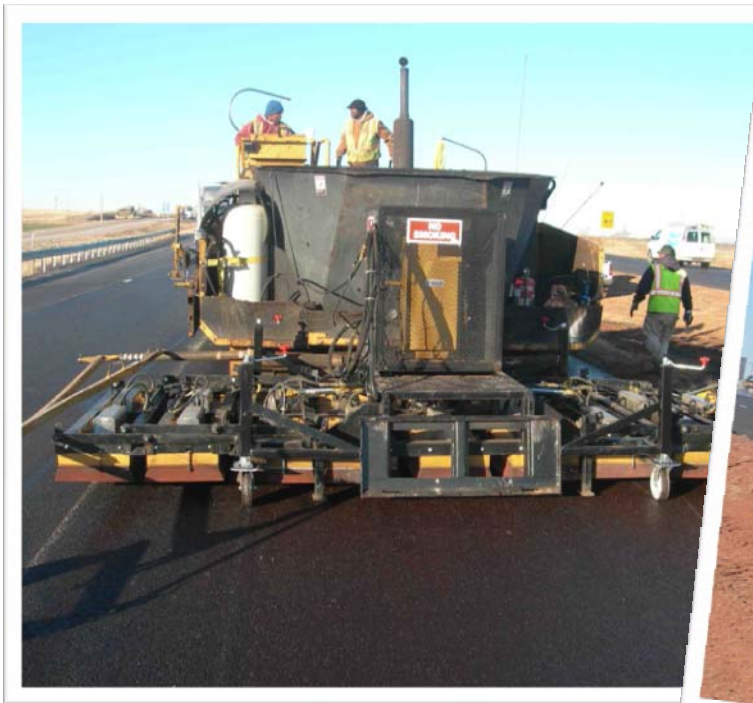
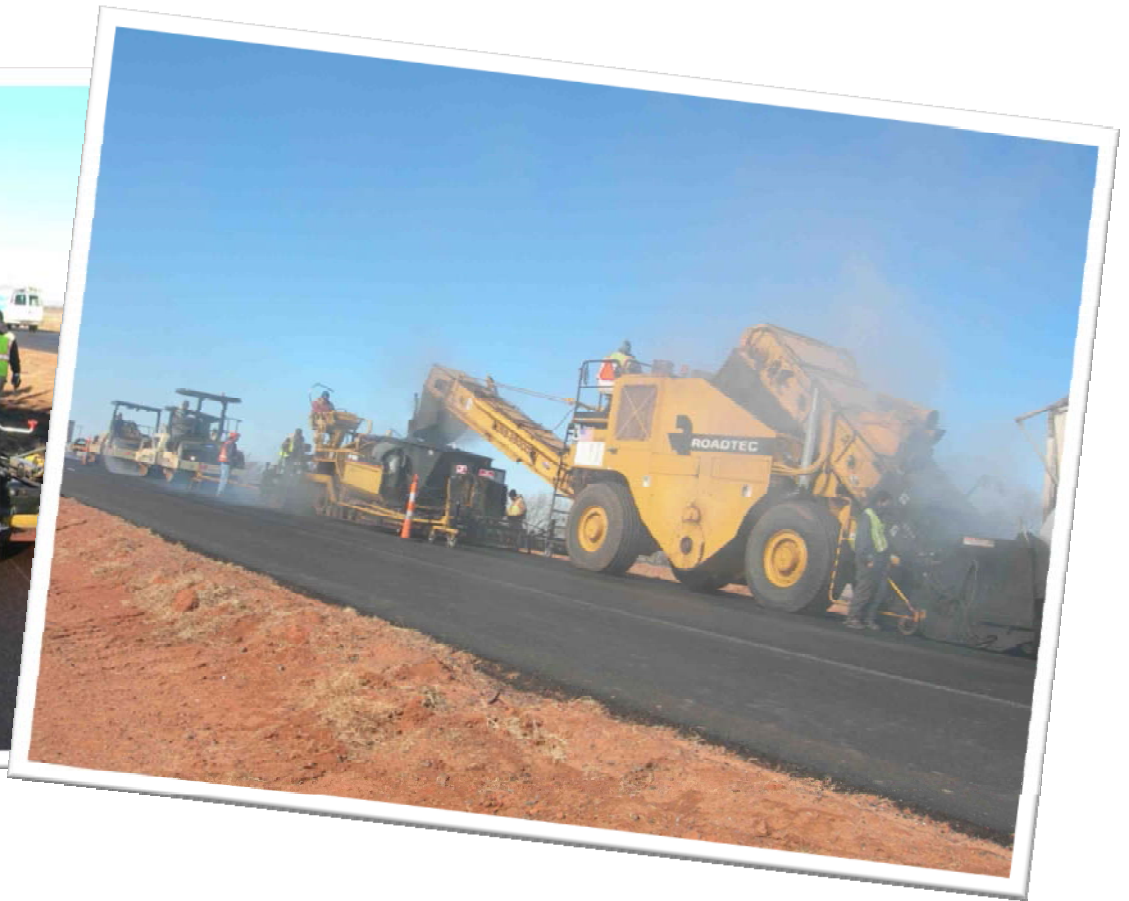
Jan 2007, Cornell Const. Clinton, Oklahoma
1.35 million Btu, 15x6' deck attached to paver

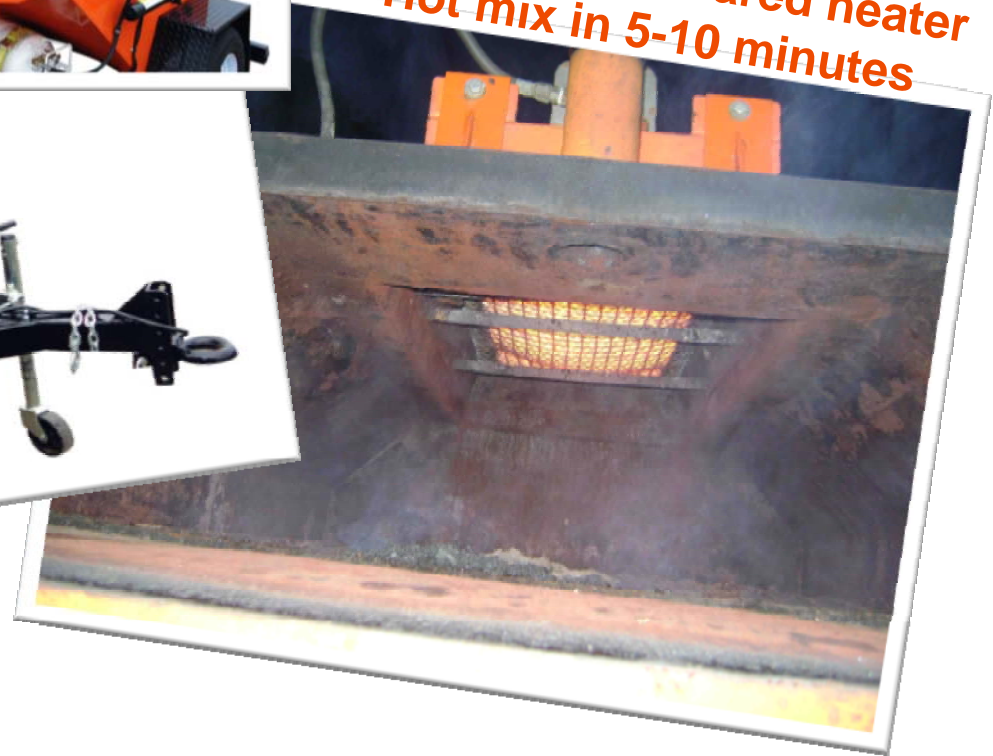
**Asphalt chunks on screen
deck
1 75,000 Btu infrared heater
Hot mix in 5-10 minutes**

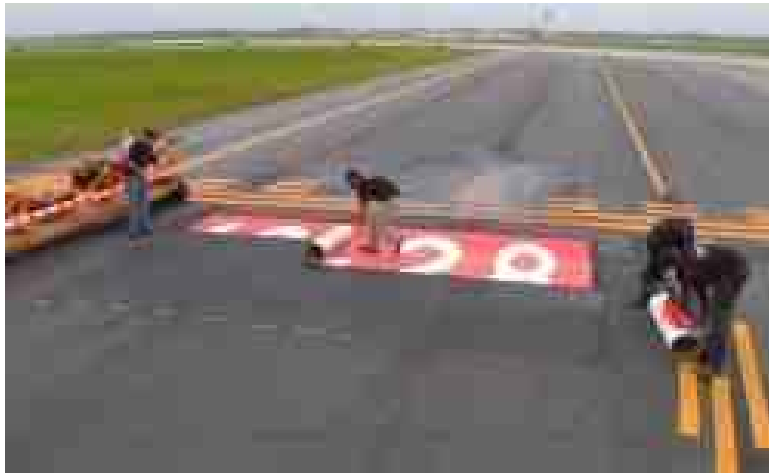
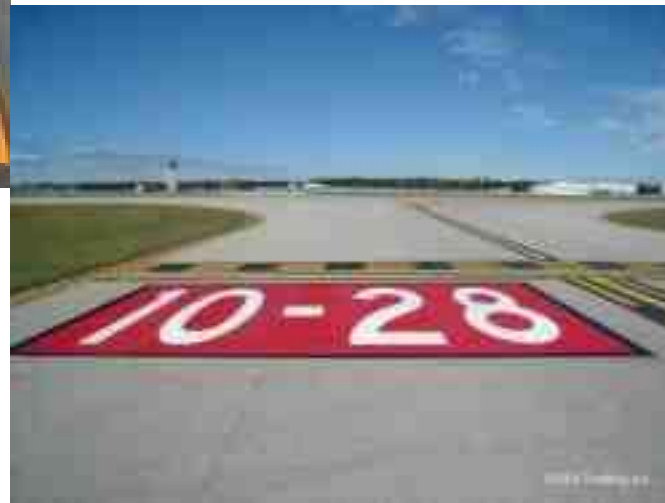
THERMO – PLASTICS

On airports: a popular, long term solution to pavement markings

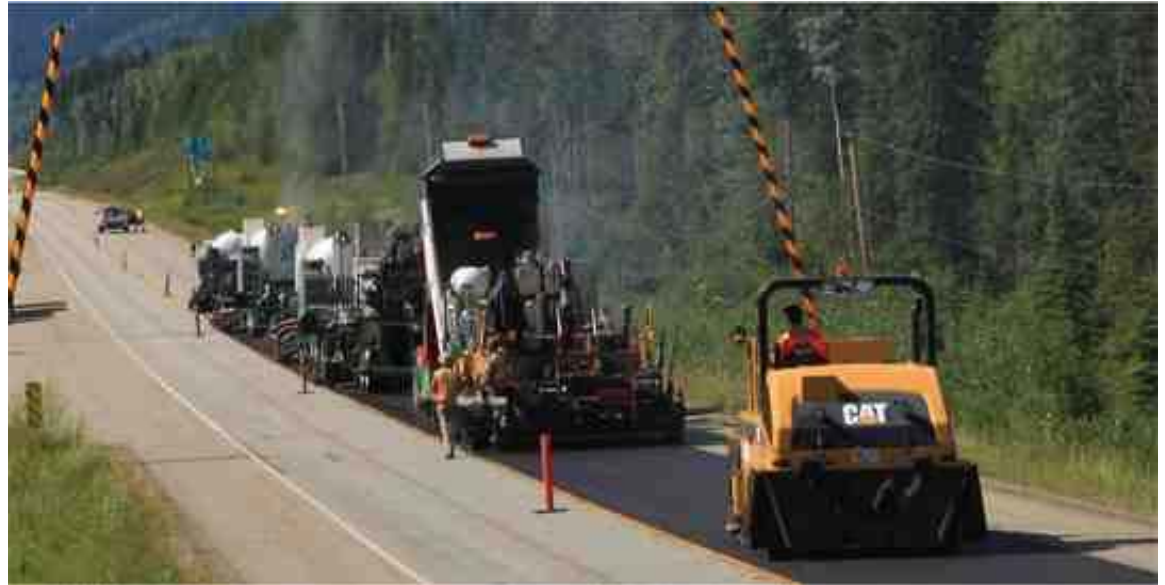
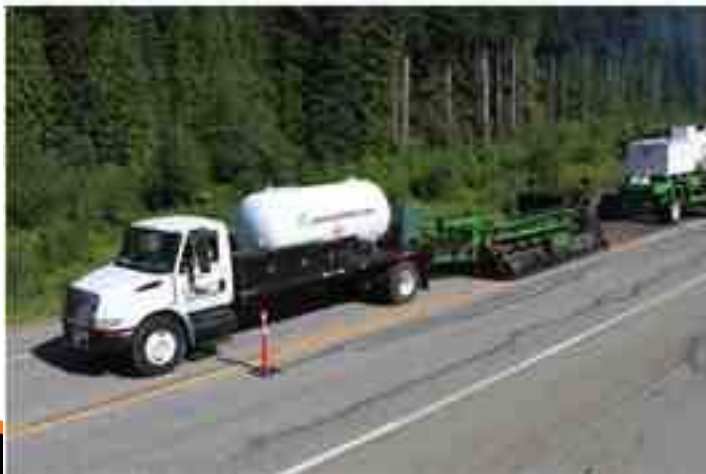
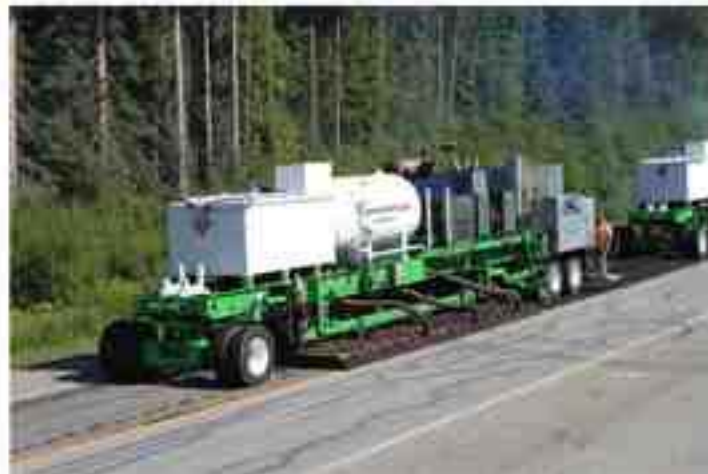
Hot In Place Asphalt Repair HIPAR

On airports: HIPAR
Ken Fyvie on Thursday
Source of heat is Infrared
