Challenges and Solutions to Airfield Pavement Design and Construction in the North with Severe Climatic Conditions – A Case Study

Ludomir Uzarowski, Ph.D., P.Eng. and Rabiah Rizvi, B.A.Sc.,
Pavement and Materials, Golder Associates Ltd., Ontario

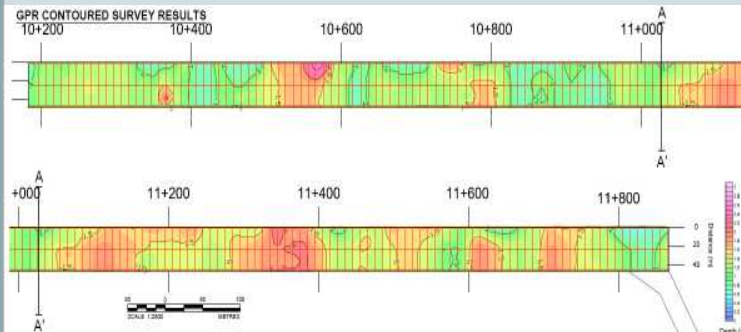
- Verified against AMEC and JW reports findings and Golder's test pits
- Produce a bedrock contour map
- Difficult to delineate due to fractured bedrock and presence of cobbles and boulders
- Bedrock depth ranged from 0.5 to 2.85 m

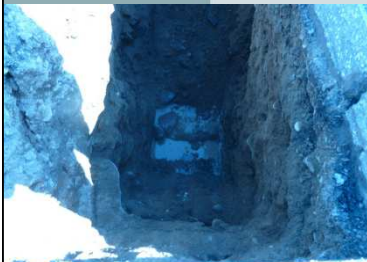
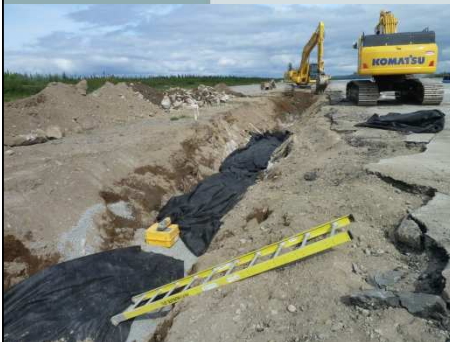
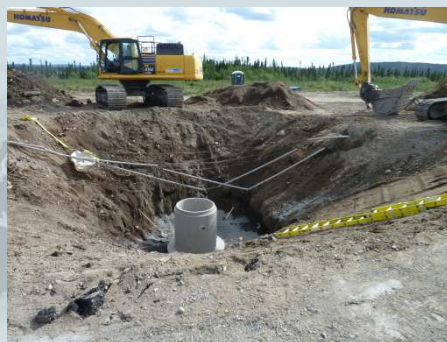
- Sub-drains construction
 - Extensive rock cutting
 - Large volume of excavation

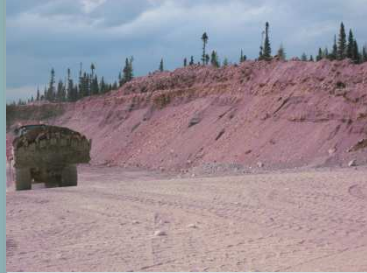
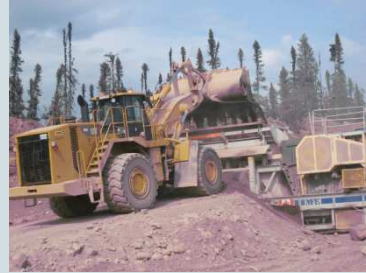
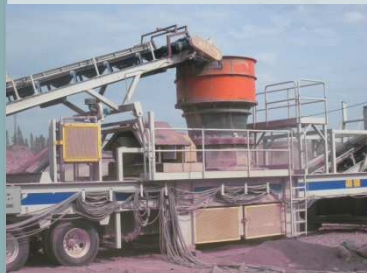
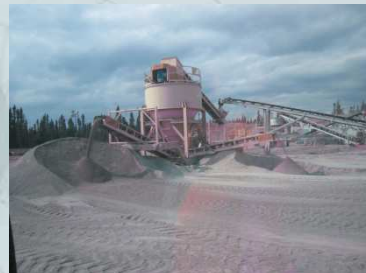
➤ Granular materials and aggregate production

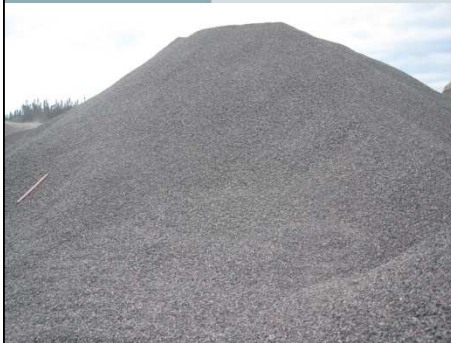
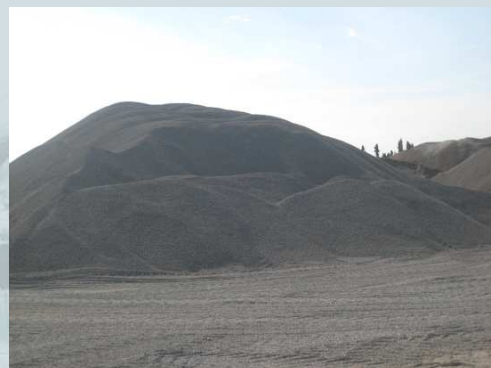
➤ Granular materials and aggregate production

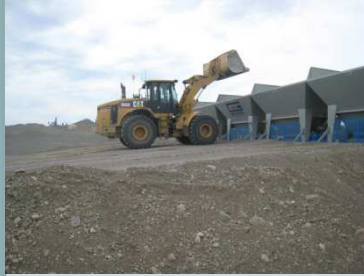
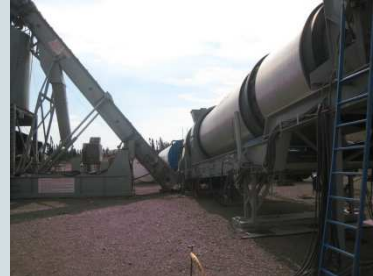
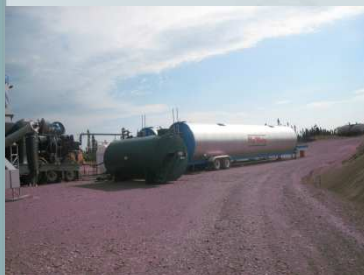
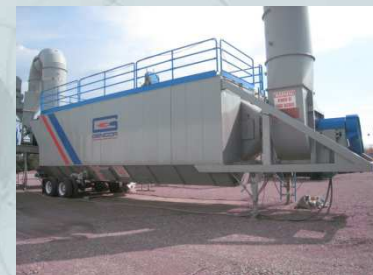
➤ HMA production

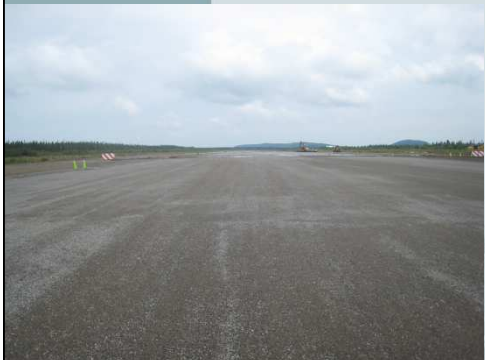
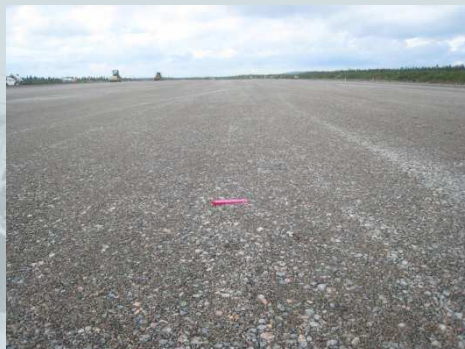
- **Granular base**
 - Generally good
 - Localized segregation

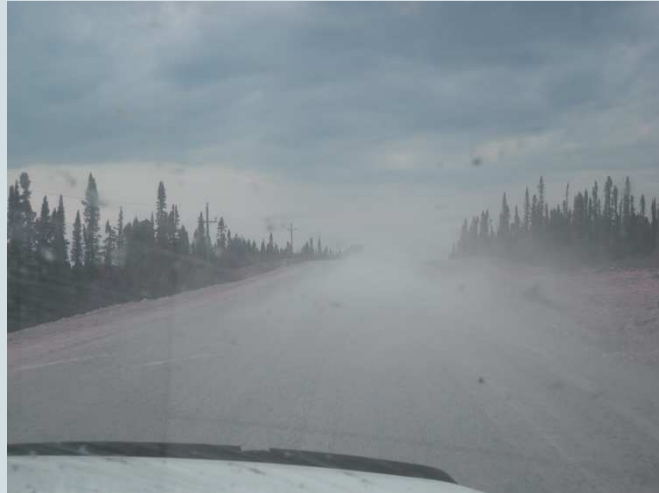
- **Material hauling issue**
 - Long distance
 - Gravel roads – dust

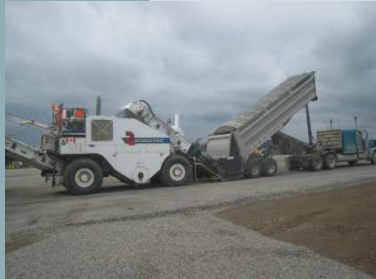
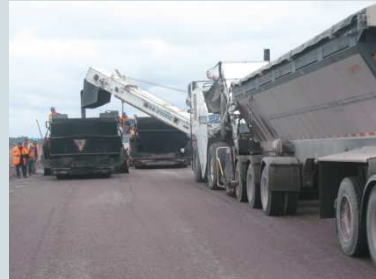
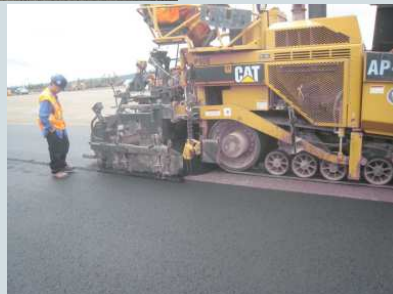
- **Paving in echelon using a ShuttleBuggy**

- **Customized to meet local conditions**
 - Aircraft loading – required strength
 - Surface texture
 - Available materials
 - Local experience
- **Granular base material**
 - 90% crushed, MicroDeval <25, LA <35
 - maximum 5% passing 75 µm sieve
- **Asphalt paving**
 - Durable asphalt mixes
 - Tight mat and joint compaction requirements
 - Paving in echelon using ShuttleBuggy
 - Infrared heaters

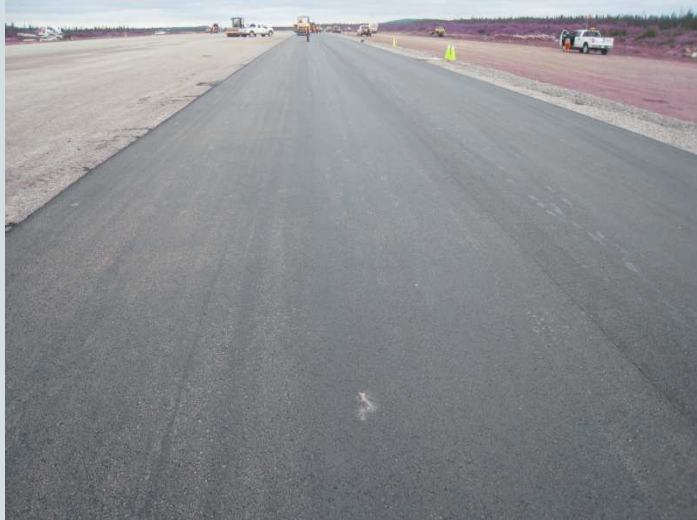
- HMA mat paved in echelon

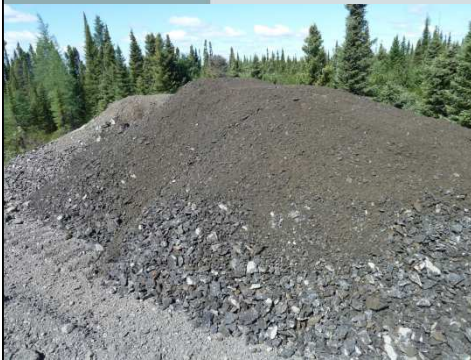
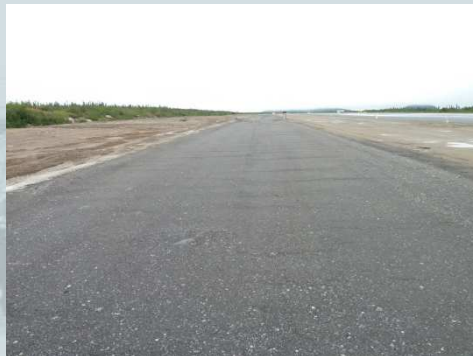
- Using millings for shoulders

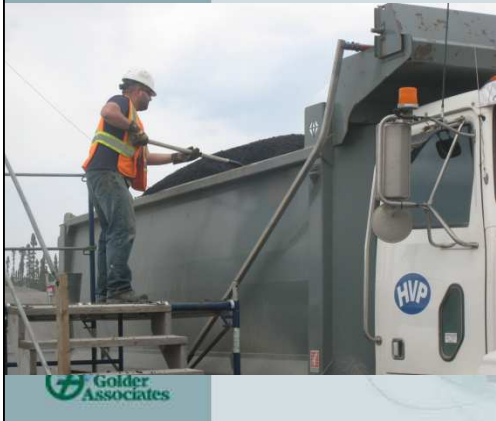
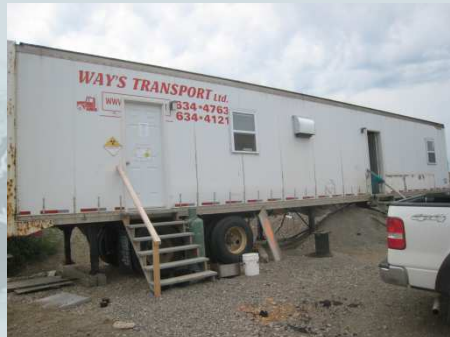
- Initial mix production
- QC/QA initial correlation
- Extraction/gradation versus ignition oven
- Marshall stability and laboratory air voids
